Riverside City College Academic Senate

FINAL REPORT

Riverside Community College District (RCCD) has assigned Salas O'Brien Engineers, Inc. and Aanko Technologies (SOBE/Aanko) to conduct a comprehensive physical security program review of all District campuses to establish a baseline status that can be used as a foundation to develop, grow, and strengthen its District-wide physical security program to better protect and serve its communities. This security program review involves site visits, existing documentation evaluation and stakeholder interviews to evaluate physical components including security electronic systems, policies and procedures, socio-environmental conditions, training programs, and security staffing levels. The physical site assessments for all campuses were conducted during their typical hours of operation, before and after hours of typical operation, with the assumption that the security components and electronic systems were in good working order and functioning normally.

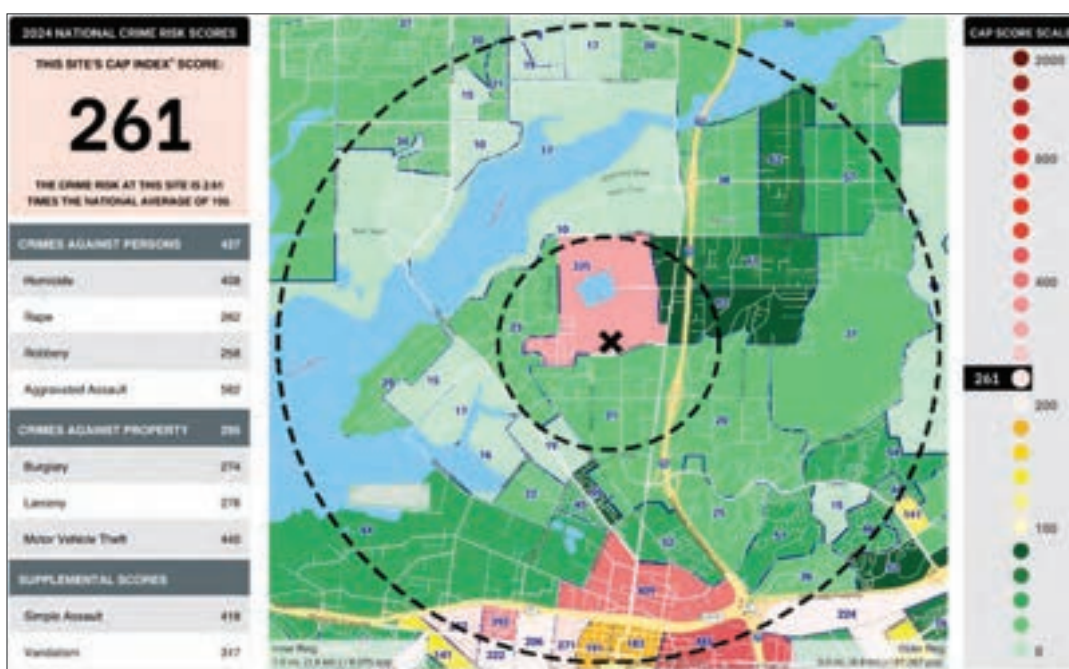
Figure 3 - NC CAP Index Mapping

The statistics generated by the CRIMECAST reports identified that NC is located within the area with the highest CAP Index score of the three campuses. NC scored 261 which is 2.6 times the national average from a risk perspective. RCC and MVC recorded scores of 229 and 202 respectively, see Table 2. Simply reviewing the scores alone does not provide a true reflection on the individual locations and crime that may or may not occur. The mapping provided in Figures 3, 4, and 5 illustrates the wider environment within the parameter of the crime statistic reach. This is important to provide context and understanding of how CAP Index scores are generated and reflect how specific areas and pockets of areas in the locality can have significant impact upon a generated score. For example, it is evident that although NC recorded the highest score of 261, the areas of high crime activity are restricted to certain areas shown in red on the map provided in Figure 3. The area specifically adjacent to the north of the college campus, and north and south of CA-91 have scores of 335, 392, 409, and 486, in contrast to areas close to the college immediate vicinity beyond the Naval Base that score below 50 extensively. The report is generating the CAP Index score based on the average of all of these locations and the map supports understanding of criminal activity within the wider geographical range, which may not be a direct reflection on the campus location itself. The potential threat, risk, and impact of high crime activity in the wider geographical location should be considered as potential influences on how security measures are deployed at the NC campus.

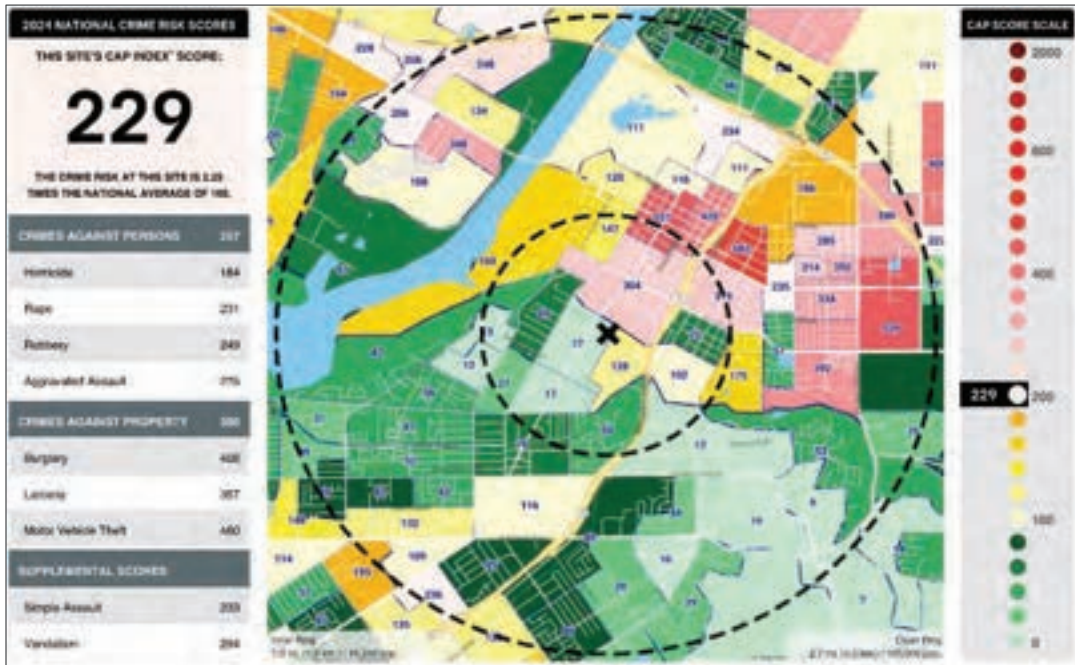
Figure 4 - RCC CAP Index Mapping

The map in Figure 4 clearly illustrates that the areas immediately north and to the east of the RCC Campus significantly impact the overall score (229) associated with the campus. Several pockets of the adjacent downtown area experience six-times the national average crime activity with burglary and motor vehicle theft frequently occurring. The higher crime scoring within a downtown area is typical and reflects the higher population density often found due to daily influx of commuters and visitors who inflate statistics as a downtown area may only have 10,000 residents but a daily population of 100,000 workers. Interestingly despite being an area of high population the homicide rate recorded at the RCC campus was the lowest recorded of the three campuses. The CAP Index score specific to the locale of the campus is 17 clearly representing that the crime that occurs (and is reported) at campus is below national average scores. It is important to consider the CAP Index crime activity as immediately adjacent to the campus the score is above 300, and criminal activity can easily creep into the campus if appropriate deterrent and detection measures are not deployed.

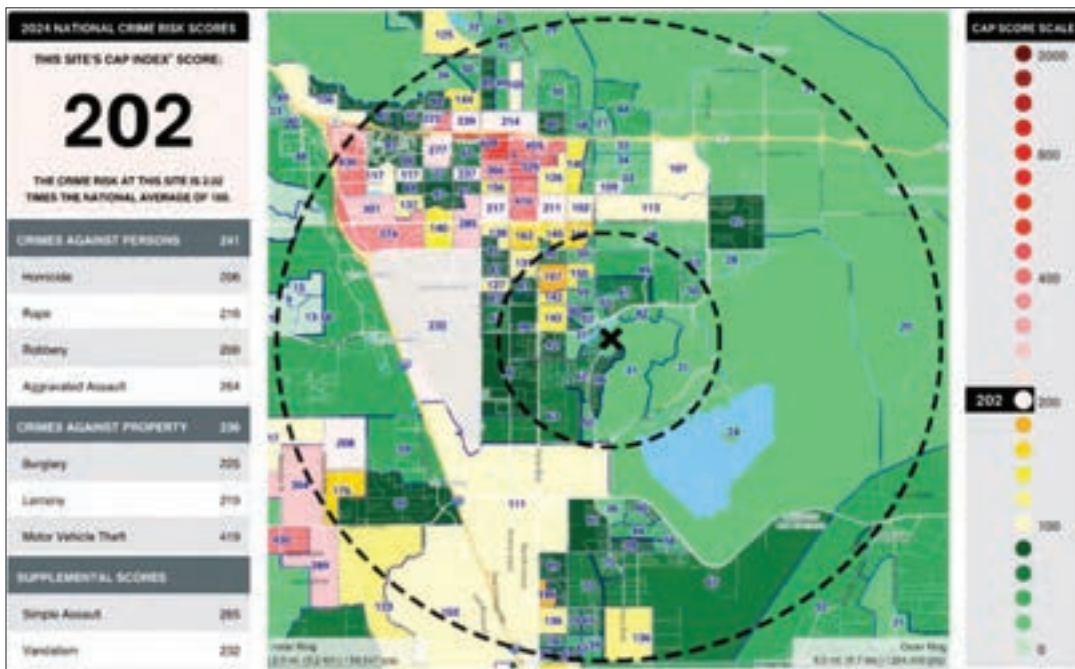
Figure 5 - MVC CAP Index Mapping

MVC campus recorded the lowest score (202) with this score impacted by a further out-reach of 6-miles to encompass the Ben Clark Training Center. The map in Figure 5, illustrates the areas of higher crime rates with one pocket recording above 600. The areas in the immediate locale score in most cases well below 100. The geographic location of the campus also contributes significantly to the lower crime activity with the campus adjacent to recreation areas and on the periphery of the city which has a population upwards of 205,000.

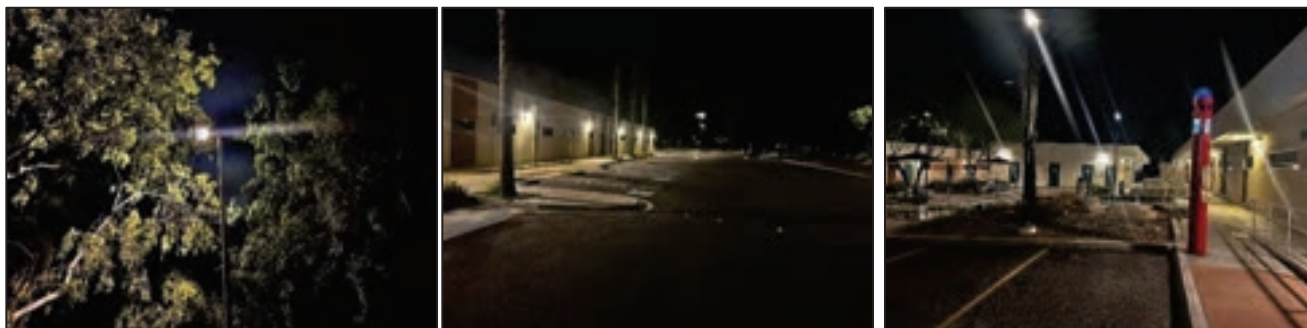
Image 1, Image 2, Image 3

- Maintenance is required at lighting fixtures where the luminaire fixture is not emitting any light, see Image 1. Power is available as indicated by the other luminaire fixture mounted at the same post.

- Lighting is not consistently placed throughout parking lots, there is some reliance on building mounted light fixtures to illuminate the parking lot areas, see Image 2, at the Dental Center.

- Some areas have excellent lighting as observed at the seating area between the Dental Center classroom blocks, see Image 3.
 - Shadows, and dark spots are eliminated by an even lighting spread, this provides a sense of safety and ease of identifying other pedestrians at night (there were people observed loitering at night).

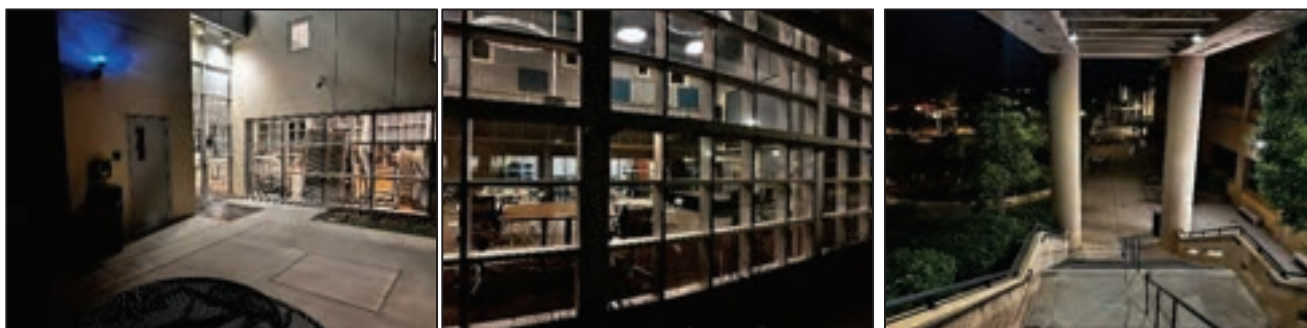
Images 4, Image 5, Image 6

- Lighting at night reduces 100% the reflective performance feature of glazing film that reduces visibility from the public side during hours of daylight. See Images 4 and 5.

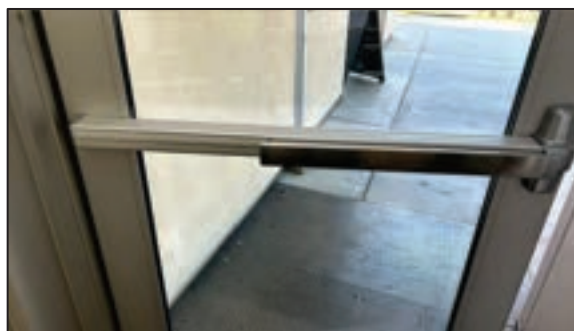
Figure 84 - Electrified panic bar with no dogging – SAS Building (MVC)

- Panic bar hardware with no dogging capability.
 - No ability to retract the latch using a key cylinder or special tool, this trim style should be applied to access control openings where panic bars are installed.

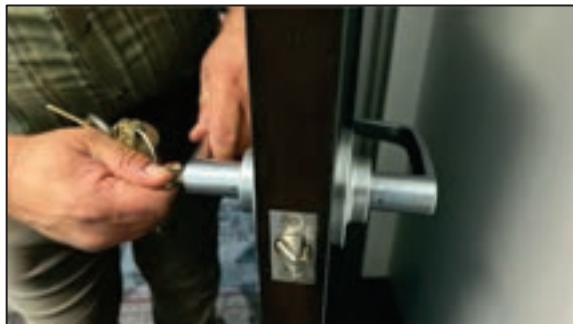
Figure 96 - Cylindrical lockset with no internal locking option – SSV Building (NC)

- Cylindrical locksets.
 - Simple installation through the door rather than within, latch is locked with a key and often can be retracted or secured from the interior using a key or thumb-turn/push button. These locksets do not include dead bolts.

It is recommended that all occupants of classrooms and office spaces be able to quickly secure themselves in a lockdown using via an interior trim push-button or thumb-turn lever that indicates the door status. Training and review of door hardware functionality is recommended with all space users as part of employee annual training and space orientation for students at the beginning of each semester.

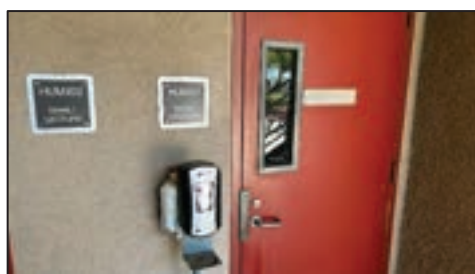
Figure 118 - Traditional classroom function interior locking hardware (Exterior) – HUM Building (NC)

- Traditional mechanical classroom function hardware with no internal locking capability i.e., key cylinder, push button etc.
 - Observed across the campuses, in the event of a lockdown the brass key holder must exit the space to secure the door from the public side if the door is operating in an unlocked state. This hardware function inherently could place a person or persons at risk in a lockdown event where they must lock the door. Policy could mandate that all classrooms function in a closed-door locked door state. Operational expectation of doors across colleges varies.

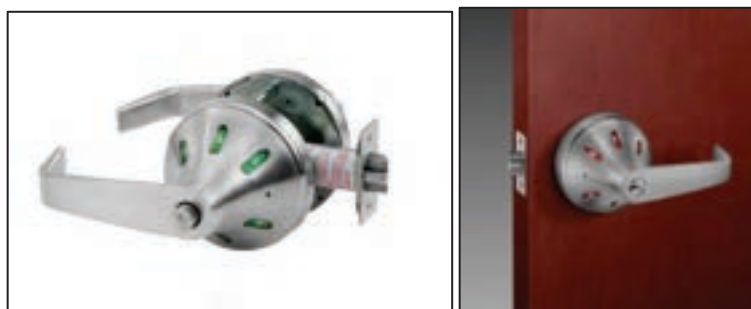
Figure 21 - CLX3300 Series with Status Indicator⁸

The CLX3300 Series cylindrical lock with status indicators delivers style, security, and enhanced privacy for both new construction and retrofit projects. Its six customizable indicator windows provide instant visibility of the door's lock status on the inside, outside, or both sides of the door. Engineered for easy installation in any setting, it features one-motion egress, non-handed design, and keyed functions. Exceeding Grade 1 standards, it is ideal for high-traffic restrooms, classrooms, and anywhere safety and privacy are crucial.

The following mechanical locksets are all manufactured by Corbin Russwin, similar locksets are available within the wider Assa Abloy range of products and are also available from Schlage. Each of the options provided provides ability for the door position status to be always known from the interior side of a space. Furthermore, the images illustrate the internal locking mechanisms specific to cylindrical and mortise locksets that allow ease of locking from the interior.

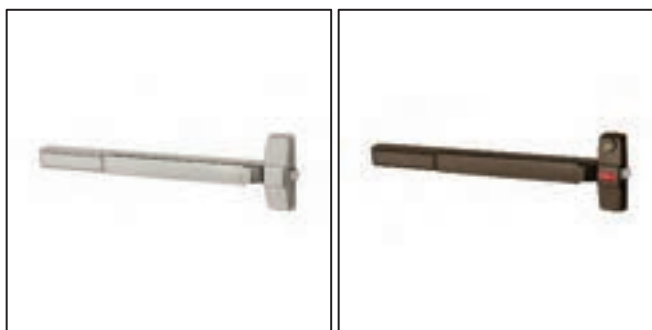
Figure 23 - PED5000 Series Exit Device with Status Indicators¹⁰

Elevate your facility's safety and security with the PED5000 Series exit device with status indicators. Choose from three intuitive options to gain immediate visual confirmation of your door's status. The Active Dogging Indicator provides clear assurance that your door is secure, while the M48 Passive Dogging option offers a subtle visual cue. For enhanced classroom safety, the M47 Trim Status Indicator features a large display ideal for our Classroom Intruder function. With the PED5000 Series, you can rest assured that your occupants are protected.

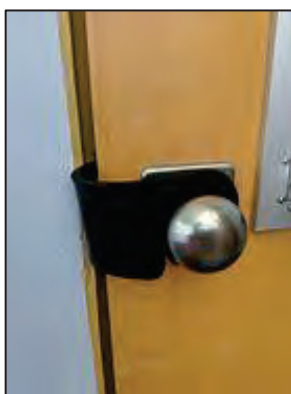
Figure 26 - Lock Blok Strap

A number of lock blok straps were observed across campuses, these are not recommended for use as they require the door to be opened for strap removal and door closure for positive latching.

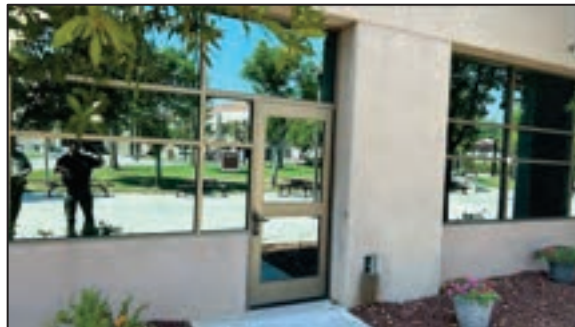
Figure 29 - NC Presidents Office

Visibility into the President’s Office is excellent during the hours of daylight. During hours of darkness visibility into the space is reversed and the occupants fully exposed to external visibility. The glazing has no ballistic protective measures applied to it.

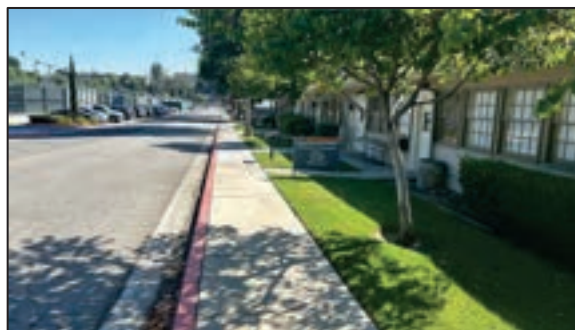
Figure 12 - RCC Facilities Building

Window blinds are lowered at the Facilities Department restricting visibility from the public side in. Glazing is old and illustrates the different levels of glazing in use across the campus. Reflective film is not applied to the glazing.

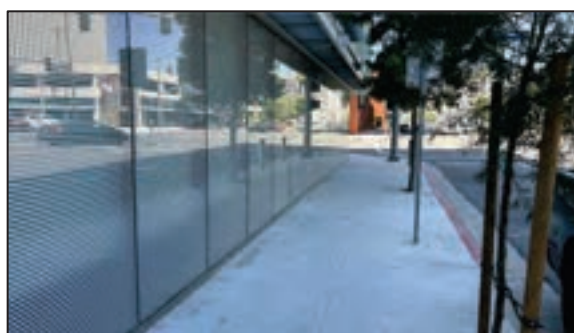
Figure 33 - Culinary Arts Academy

Floor to ceiling glazing with restrictive visibility frosted film is applied to the first-floor windows at the Culinary Arts Center. It is understood that there is no ballistic protective elements to the film. The glazing is adjacent to the public sidewalk and University Ave., which experiences heavy traffic throughout the day and night. Incidents involving the brandishing of firearms have occurred in the immediate vicinity as shared during stakeholder interviews.

Modern education institution-built environment conditions must consider glazing protective measures as a critical component of the safety and security program. The threat of an active shooter incident occurring remains statistically low, however the protection of students, faculty, and staff is paramount and can be supported by intelligently designed and fortified windows.

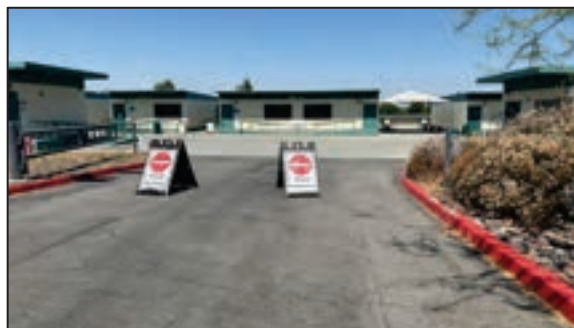
Figure 146 - Unsecured Swing Arm Barrier (MVC Portables)

Figure 36 illustrates an example of an unsecured swing arm barrier at MVC that remains open and always unlocked for convenience despite mobile A-frame signage indicating that the road is closed. The roadway is free access from the adjacent parking lot into a classroom area presenting risk that can easily be mitigated with closure and securing of the swing arm barrier.

It is recommended that the district take a holistic approach to reviewing and refreshing, adjusting, implementing traffic control, and calming measures. Traffic calming is a strategy of CPTED and can contribute to CPTED principles:

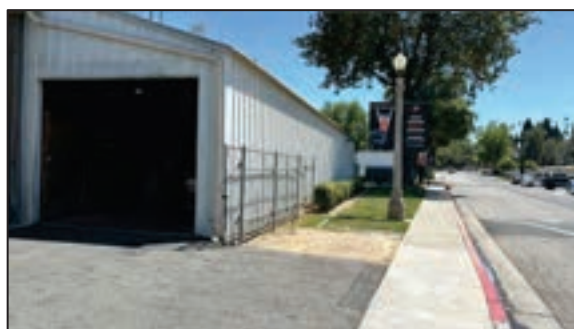
Figure 157 - Speed bump (RCC Warehouse)

Speed bumps are deployed across the campuses but sparingly. Speed cushions are not used across any campuses restricting general vehicle speeds but allowing buses and first responder units to easily traverse. Supporting speed restriction signage is minimal in deployment with no consistency in speed amount, signage sizing, font, and text deployed.

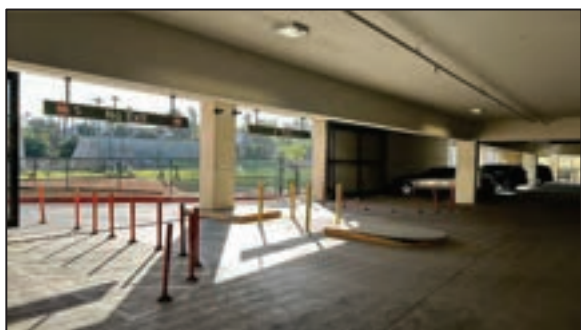
Figure 168 - Parking Garage Gates (RCC)

Parking garage gates were observed at both RCC and the District Office. RCC garage gates are mechanical and typically remain open 24/7, the gates are located at the lower entrance, with an upper entrance devoid of any vehicle control measures to support restriction of parking garage vehicle activity. An electrified gate at the District Office parking garage is manually closed each evening and reopened daily to restrict vehicle access after a predetermined time. Free egress of vehicles is always available with vehicle loops embedded in the floor triggering the gate to unlock when activated by a vehicle presence. Circular speed bumps are present in the parking garages with intent to reduce vehicle speeds between 2-10 miles per hour. Vehicles were observed by passing these speed bumps at the RCC parking garage for convenience and speed of ingress and egress.

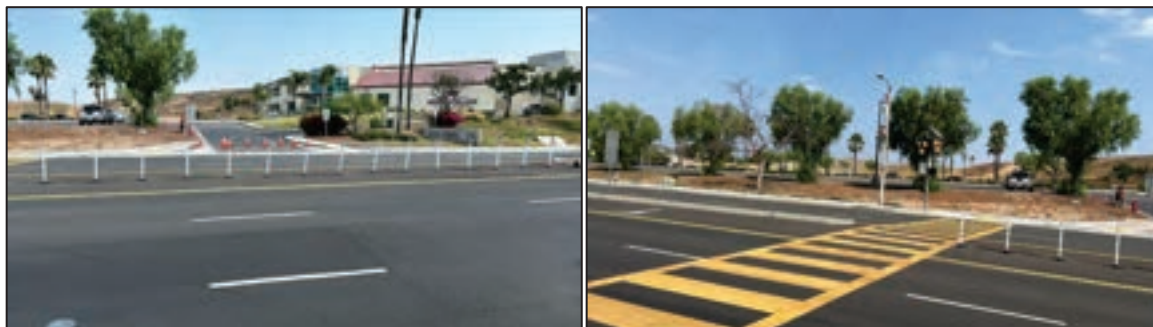
Figure 40 - Third St. (NC)

An observation of significant safety and security risk is the NC Third St. main entrance access road. As detailed within the individual findings report, the shared access to JFK Middle College High School and NC is a 1,000ft + multi-laned road with minimal physical roadway speed control measures. Vehicles can easily hit speeds more than 65 miles-per-hour from point of entry onto Third St. up to the Sports Complex. Speed control signage, raised crosswalk, speed cushions, roadway painted signage are all traffic calming measures that are not used to support speed restrictions. It should be noted that this area was specifically brought to the assessment teams' attention by a member of faculty while the team was observing the area. It was shared that several near misses of pedestrian and vehicle collisions have occurred at the crosswalk area. There is no delineation of school and college traffic points of entry, with minimal directional signage used to support better traffic control.

Pavement Markings – Guidance markings that communicate directional information to approaching vehicles. For example, pavement markings providing vehicle access direction at Third St. (NC) would support the traffic management required for safe vehicle entry at JFK Middle College High School. Pavement markings support reinforcement of accessibility for vehicles to areas that they require access to.

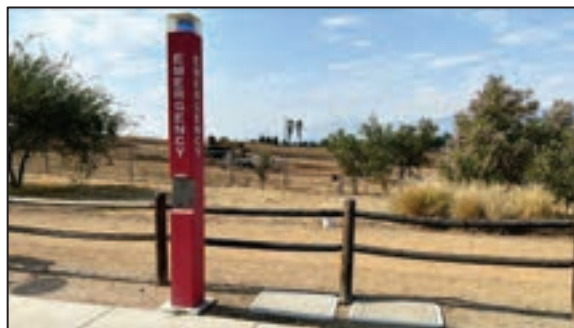
Figure 41 - Wooden lodge pole rail fence line with rotting posts at NC

Wooden lodge pole rail fencing at NC adjacent to the horse trail is rotting and requires replacement. There is potential that the fence could collapse if leaned against by a person leaning against it, causing injury. Cross beams of the fencing are reusable, but posts require replacement at several locations along the fence line.

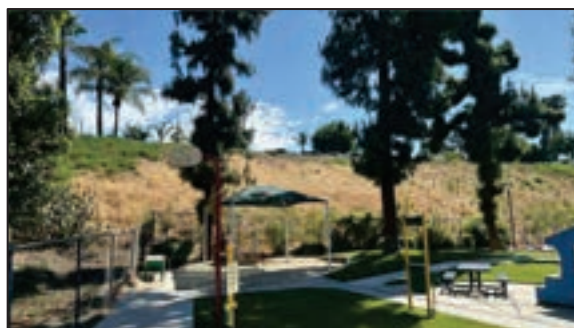
Figure 42 - Fencing at the ECEC at RCC Playground

The chain-link fencing at the ECEC at RCC provides no reduction in visibility from the public sidewalk and is easily scalable as its height is approximately 4'. Inconsistent height of the fence line further supports ease of unauthorized access (a frequent occurrence at RCC) as the 6' tall vinyl fencing provides support for climbing over the chain-link fence. The fence line at the RCC ECEC fails to restrict both visibility of activity and entry into the playground and is an item of concern for ECEC staff.

Chain link fencing with slats provides the most cost-efficient means of fence installation with visibility restriction. It is recommended that regardless of fence material that minimum fence heights be 8' (10' preferred). Consideration should be given to limit the potential for bad actors to simply use the fence material to support their scaling of the fence. Some options are to use a 1" chain link providing some anti-climb deterrent or use 2" chain link with visibility slats. In addition to mitigating the climb possibility, these options will support restriction on the public or bad actors loitering and observing activity at sensitive areas i.e., ECEC at both MVC and RCC.

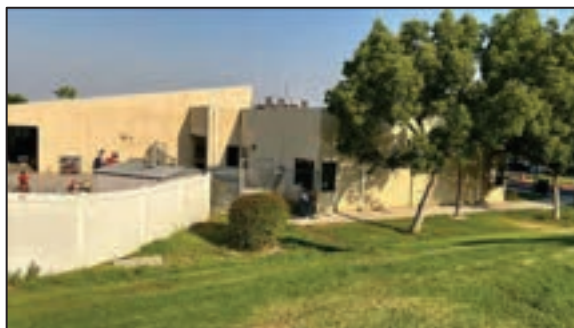
Figure 183 - Fencing and Gates at ECEC MVC Playground

Fencing at the MVC ECEC is similar in application to that found at the RCC campus. A combination of vinyl fencing, and chain-link fencing and gates fail to reduce visibility of the childcare playground as the adjacent sidewalks are elevated. Furthermore, side access gates at the playground were found unlocked providing both unrestricted entry for both authorized and unauthorized persons, and gates could easily be passed through by children if they were intent on running away. Gates are not monitored, providing staff with notification of gate status i.e., closed, or open.

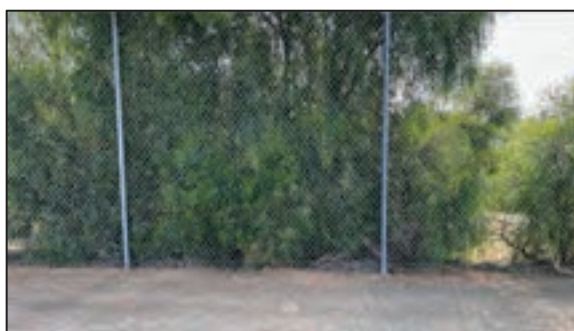
Figure 205 - Overgrowth protruding through the fence at NC Sports Complex

Other observations made included chain-link roller gates with gaps below the gate that provide ease of access by crawling underneath (i.e., both gates at the NC Operations Center and RCC Facilities Yard), damaged fence lines at RCC above the Facilities Yard and at the ECEC parking lot, gaps in level one fencing at the parking garage downtown creating entry vulnerability, and plant overgrowth protruding into fencing at NC Sports Complex. All are examples of additional issues with existing fencing.

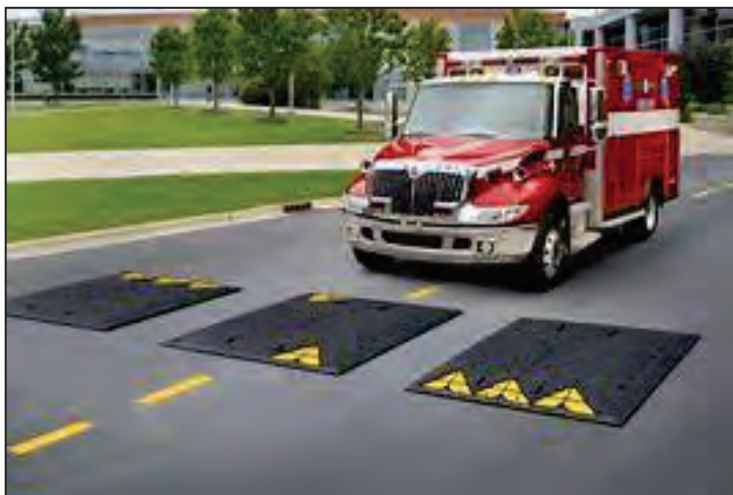
Figure 216 - Speed Cushions

Speed Cushions - Speed cushions are either speed humps or speed tables that include wheel cutouts to allow large vehicles to pass unaffected, while reducing passenger car speeds. They can be offset to allow unimpeded passage by emergency vehicles and are typically used on key emergency response routes. Speed cushions extend across one direction of travel from the centerline, with longitudinal gap provided to allow wide wheelbase vehicles to avoid going over the hump. Third St. at NC should be considered a prime location for use of speed cushions, liaison with emergency response officials is recommended prior to any action that results in installation.

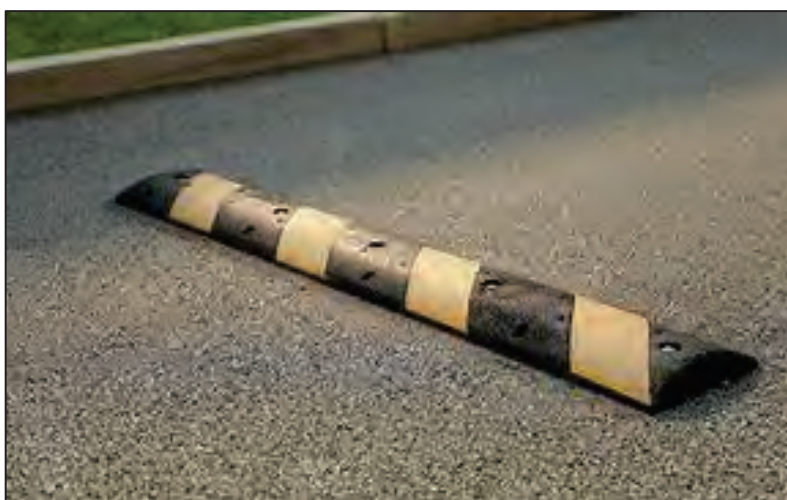
Figure 227 - Speed Bump

Speed Bumps – speed bumps are typically raised 2” or 3” above the roadway and are no more than 12” wide. Travel over them at speed delivers an abrupt disturbance that cannot be ignored and typically a slow speed is required to travel over them comfortably without experiencing an abrupt “thud” impact. Placement of speed bumps within parking lots and access roads would support restricted speed intent.

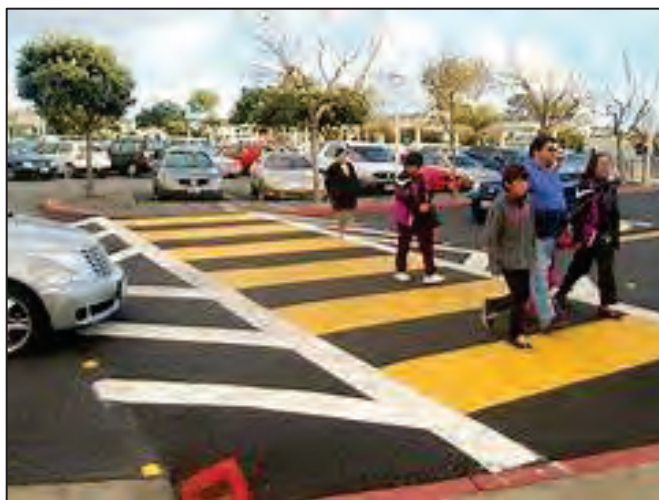
Figure 238 - Raised Crosswalk

Raised Crosswalk - Raised pedestrian crosswalks serve as traffic calming measures by extending the sidewalk across the road and bringing motor vehicles to the pedestrian level. Raised crosswalks also improve accessibility by allowing a pedestrian to cross at a constant grade without the need for a curb ramp and makes the pedestrian more visible to approaching motorists. Roadways are not the only places traffic calming devices can be useful. Raised crosswalks can be used in school parking lots to slow traffic and more safely allow pedestrians to cross the parking lots. When used,

care must be taken to accommodate drainage in the parking lot and to prevent water from pooling.¹⁶ There are several locations across RCCD campuses where raised crosswalks would support reduction in vehicle speed. Again, most predominantly at Third St. NC, as well as at areas already defined with pavement crosswalks at RCC and MVC. Evaluation of appropriate solutions is encouraged as development of existing pavement only crosswalks to raised crosswalks may be adequate to provide speed controls at specific locations.

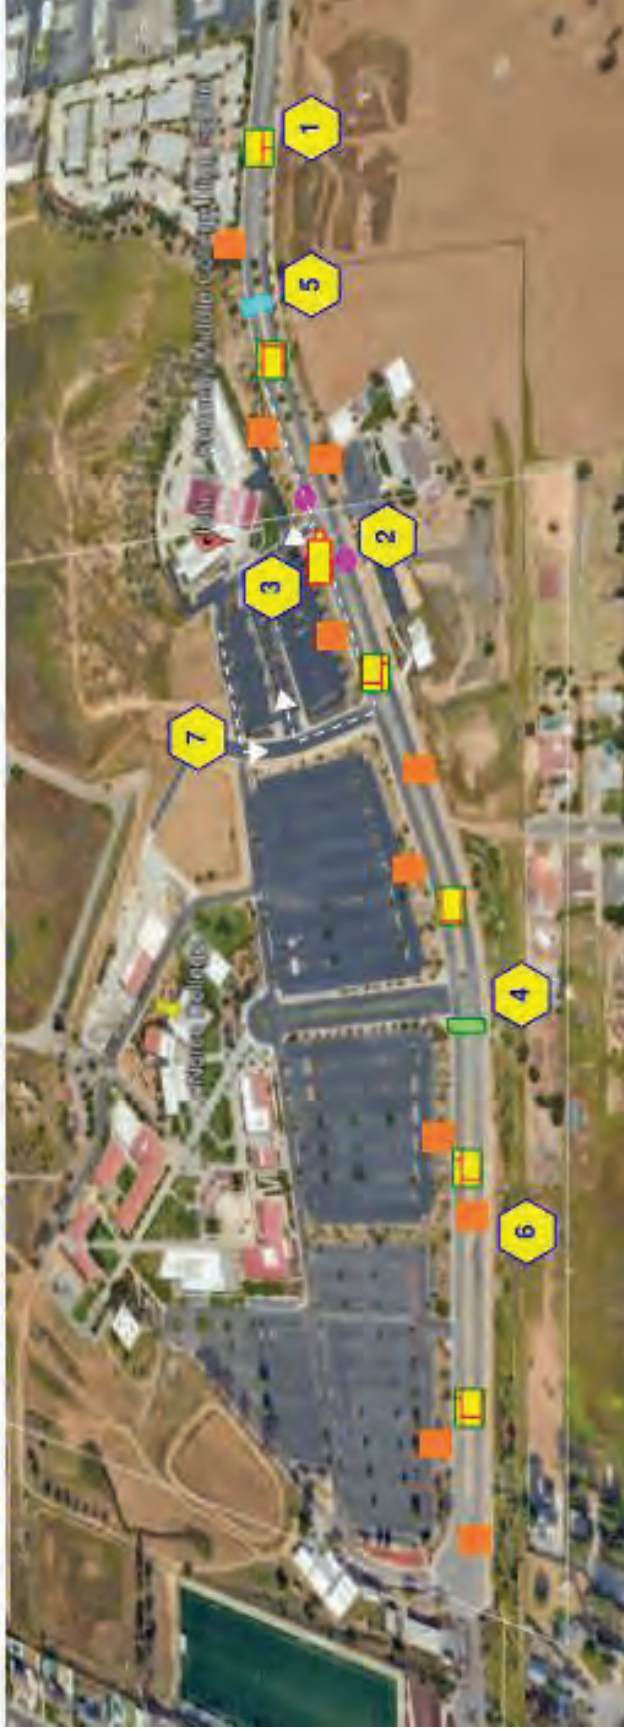
Snapshot 2: NC Third Street

1. SPEED HUMPS SIZED TO ALLOW UNRESTRICTED EMERGENCY VEHICLE ACCESS WITHOUT SPEED REDUCTION
2. RUMBLE STRIPS
3. LICENSE PLATE RECOGNITION CAMERA
4. RAISED PEDESTRIAN CROSSING
5. FUTURE SWING ARM GATES (CONTROL BY ACCESS CONTROL AS NECESSARY) ALLOWING ABILITY TO CLOSE ENTIRE CAMPUS TO PUBLIC VEHICLE ACCESS
6. SPEED CONTROL SIGNAGE
7. ONE-WAY TRAFFIC FLOW THROUGH THE PARKING LOT

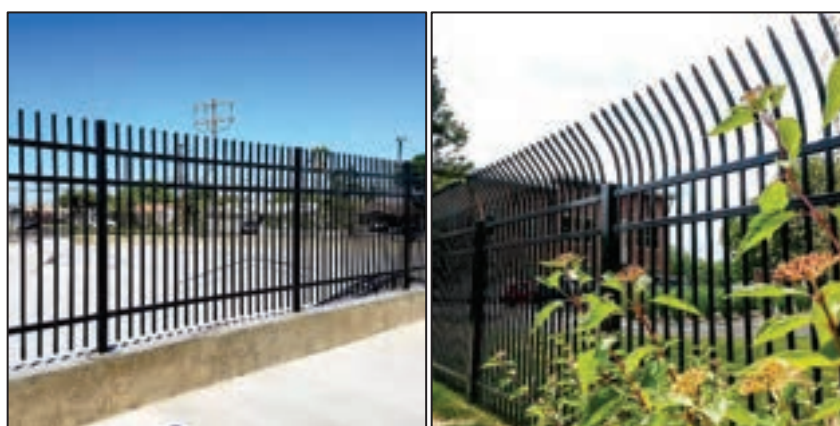
Figure 51 - Ameristar Decorative Fencing

To improve security, we recommend using decorative fencing with spiked toppers facing straight up or outward. This will make it more difficult for intruders to easily climb over the fence. When choosing fence materials, it can be difficult to balance cost and security. Using design standards can help ensure that the right type of fence is chosen based on operational needs, security requirements, and budget allowance, providing a consistent look to district facilities.

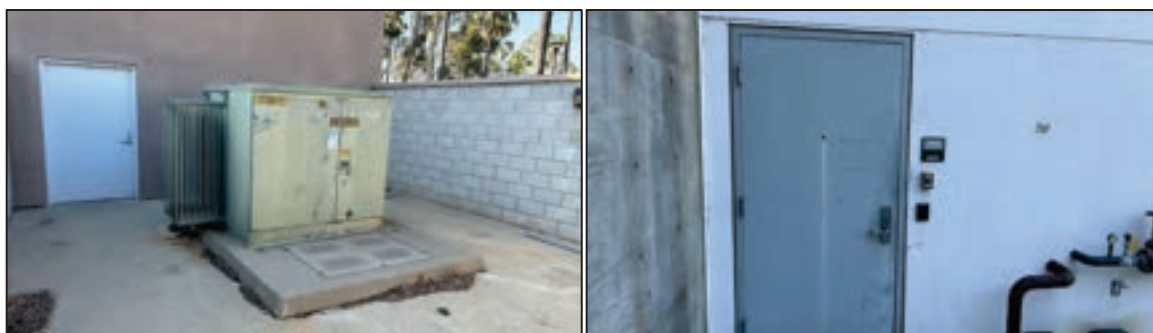
Figure 52 - Lack of Door/Opening Numbering displayed (RCC)

Application of door numbering signage in general lacks a consistent application on the exterior of all openings to support potential first responder response to an incident. Roof signage identifying buildings by number or type is not applied at any campus or administrative building, visibility from above can be critical if air response is required for an emergency incident.

Priority areas for immediate review and consideration are improvements to wayfinding signage and application of door numbering at all doors to support first responder identification. Future consideration to building identification from above is also recommended for future consideration.

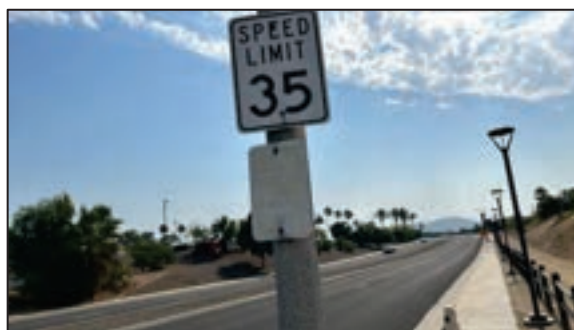
Figure 53 - Sun bleached signage at Third St. (NC)

Many signs across the collective campuses need maintenance review with sun bleaching a common observation that has resulted in the intended information no longer being displayed or completely disappearing. Other maintenance related issues pertain to signposts being present but physical signage removed. Poorly maintained signage gives a negative impression that does not provide an immediate positive image for RCCD.

It is recommended that a consistent appearance of signage across all campuses occur presenting a single RCCD image that will drive cohesion across the district sites and present a positive and welcoming environment for campus users. Currently MVC and NC have some alignment in appearance of signage and emergency plans in terms of color, a review and consideration of district standardization on appearance would be beneficial. Consistency of signage visually has wider implications than just physical appearance, it promotes community, belonging, identity, and efficiency in procurement.

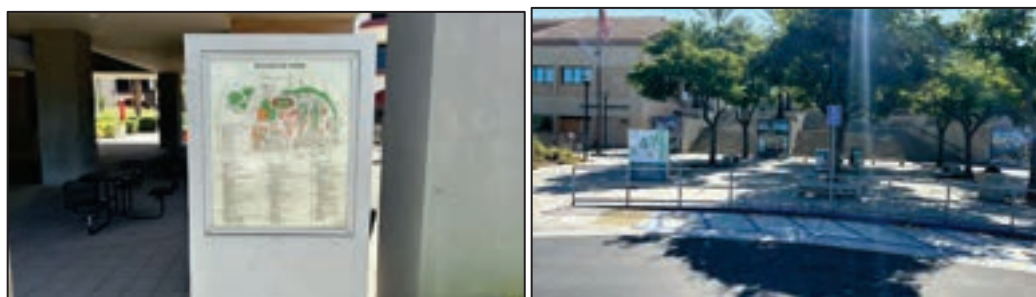
Figure 55 - Wayfinding Signage at RCC and MVC

General wayfinding maps are poorly distributed across all campuses, presenting challenges to visitors and other campus users unfamiliar with campus layout. It is difficult to identify current location and the desired travel endpoint. Campus maps in some cases (i.e., NC) have only one general campus wayfinding map on campus. The information displayed is dated and known to require updating. Placement of wayfinding maps lacks cohesion with no consideration to aligning map placement adjacent to parking lots pedestrian access points for ease of identification and observation. Digital, web-based, options are not made available to allow campus users to access maps via cell phones using QR codes.

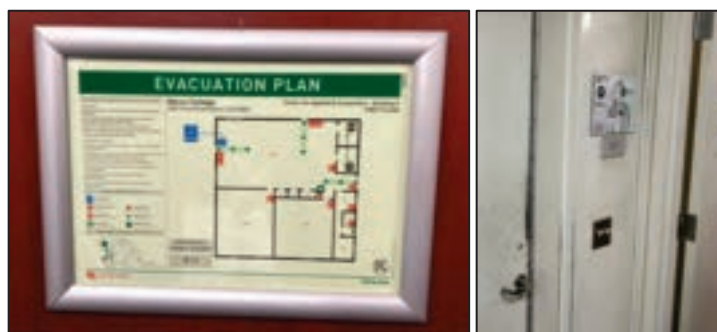
Figure 5625 - Emergency Evacuation Plans at RCC and MVC

Emergency evacuation plans across all district facilities appear to be well deployed with focus on ensuring that they are displayed in all classrooms, an initiative that has been performed at all locations. The action taken regarding emergency evacuation plans display is excellent. There is, however, a lack of district driven expectation and direction regarding the imaging and material used to present the plans, resulting in local oversight rather than district management driving consistency in map appearance and material performance features. NC emergency evacuation maps are manufactured by Everlux and are compliant with NFPA 101 and NFPA 170. *NFPA 170, Standard for Fire Safety and Emergency Symbols, establishes the design principles of Evacuation Plans that are to be displayed throughout the building. These principles establish that the design of Evacuation Plans must include information relevant to fire safety, means of egress, and rescue of the occupants of the building. The Evacuation Plans shall be designed in accordance with the evacuation strategy of the building and address the specific needs of the occupants of the premises.*¹⁸

The Everlux plans in use at NC are market leading product and should be rolled out across all RCCD facilities as they provide visibility and sustainability benefits not associated with card maps observed at other locations.

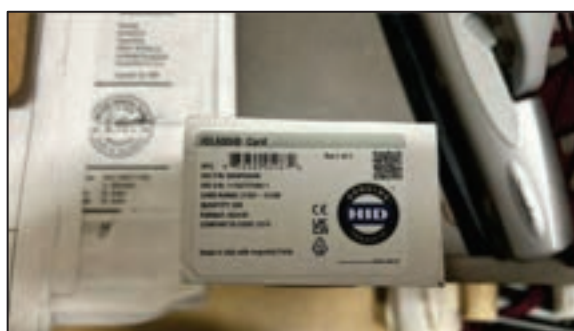
Figure 61 - HID iCLASS Credentials

Access credentials in use across all locations vary in appearance but appear to be HID iCLASS cards. Security credential appearances differ across campuses with photo images applied at RCC and NC, but not at MVC. Security credentials function as informal identification badges when photo images of the authorized credential holder are applied. There is no district policy in place that governs appearance or display of either security credentials or identification badges in general. The iCLASS credentials use the 13.56 MHz frequency rather than the 125 kHz frequency, this is excellent and reduces the ease of potential credentials being copied (the assessment team was unable to copy a District access control card with an off the shelf copying machine).

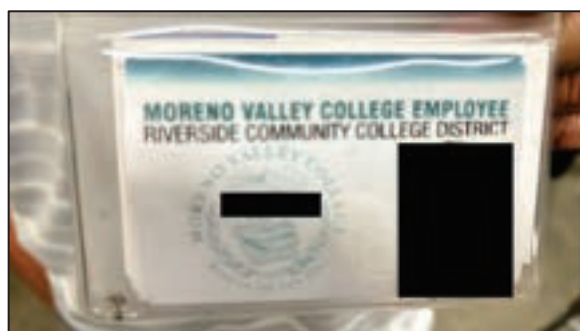
Figure 275 - MVC Security Credential

As observed, the existing iCLASS credentials appear to use the encrypted 13.56 MHz frequency rather than the easily copied 125 kHz communication frequency. The card type and appearance should be standardized across RCCD along with policy regarding their display. The sample security credential badge shown in Figure 65 illustrates an existing MVC security credential where the credential owner had personally added a photographic image of themselves to the badge. It is recommended that the practice of photographic images of the authorized credential holder be applied as typical across all RCCD security credentials. Use of photographic identification can enhance the security program in a variety of ways. Visual verification discourages imposters from using someone else's credential when a culture of challenging things that do not appear right is established. Photo identification supports verification of persons via the video surveillance system if their image is stored, and also supports verification of persons making unauthorized entry attempts at controlled openings where they have no permission to enter. Persons displaying credentials support positive reinforcement that they are authorized to be in secured spaces and help employees and visitors identify each other. Policy is required to govern both the security credential information displayed and the use and display of credentials. It is important to factor that photo images cannot be displayed on other types of security credentials such as fobs or can be "hidden" if mobile credentialing is used. Security cards should be considered for issuance as the

standard district means of identification for all staff and employees, rather than issued when a person requires access to a space that is access controlled, as is the current process. Other credentials such as mobile credentials may be used but they should not be the primary credential issued across District facilities.

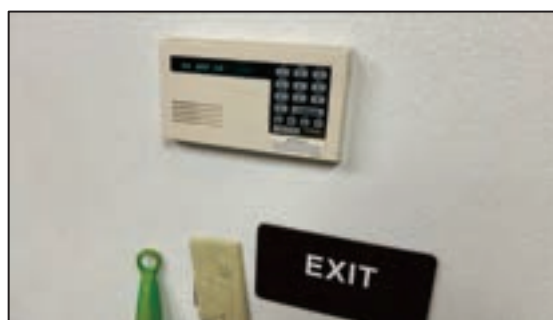
Figure 67 - Bosch Arming Station

At several locations, the interface between the systems simply consists of a CMP communicator providing alarm events received within the CCure 9000 platform to be communicated out to the off-site monitoring company. Several Bosch arming stations were also observed across some buildings, the Bosch systems are understood to be non-operational.

It is recommended that the district transition all non-DMP systems to the DMP intrusion detection alarm panels as a standardized solution providing ability to interface with other security electronics systems. Transition to cellular communication where not done would also modernize the system and reduce the requirement for provision of plain old telephone (POTs) lines, reducing infrastructure costs, potential points of failure, and enhancing communication capability to the monitoring vendor. Additional network connection and systems integration would allow for management and administration of the intrusion systems locally by an assigned security systems administrator.

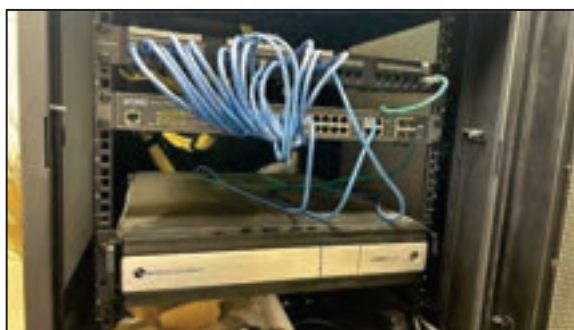
Figure 68 - American Dynamics NVR

Differing, NVRs offer different video retention, framerate, and resolution rates with no district standard available as governance. Lack of governance associated with video retention and access rights is concerning as it is important to ensure compliance with its own district policy (when developed) that video footage is retained, identify who can access it, and under what circumstances. A well-defined policy ensures that the district complies with its own governance, and it helps to avoid penalties, fines, or legal disputes related to mishandling of video data. For example, signage at the STEM Center at NC indicates that video surveillance is monitoring all activities that are recorded to aid in the prosecution of any crime committed against the facility. This could be problematic if the district is subpoenaed to provide video footage as the cameras are non-operational. Furthermore, signage does not indicate the duration of video storage retention. The District should establish a video retention policy noting the duration for which recorded video will be kept mitigating risk in the event of a request to retrieve recorded video.

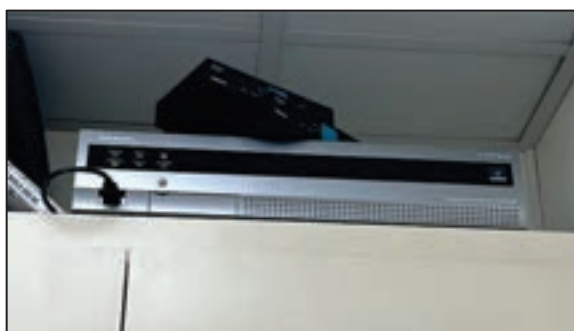
Figure 289 - Panasonic NVR

Management and location of NVRs lack best governance with several NVRs observed outside of areas where they are typically housed as best practice within secure data closets/rooms. For example, Figure 66, above illustrates a video storage unit located on the top of a wall mounted cabinet at the Cafeteria at MVC. Lack of secure housing of storage units can provide wider vulnerability implications including risk of cyber-attack if bad actors are able to access live network ports that support the video retention equipment easily. The different installations of NVRs across the district also fails to support any standardized or consistent approach to cable management and cable labeling. Lack of

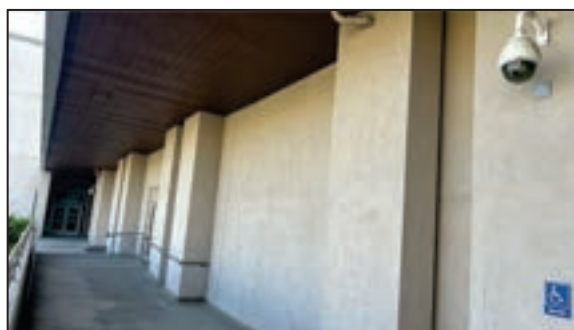
Figure 70 - PTZ Exterior Camera

A myriad of fixed field of view cameras and pan-tilt-zoom (PTZ) cameras were observed with no verification made that PTZ cameras are programmed to return to a home position once manual use has been completed. It is assumed that the PTZ cameras are not used to track and monitor area activity as there is no physical monitoring of cameras across the district from either local or centralized location. Camera placement is ad-hoc with no consistent application of cameras at areas that have access control installed to support an alarm event-based camera call-up interface. Positioning of cameras to monitor emergency call stations is not typical. Parking lots also lack video surveillance

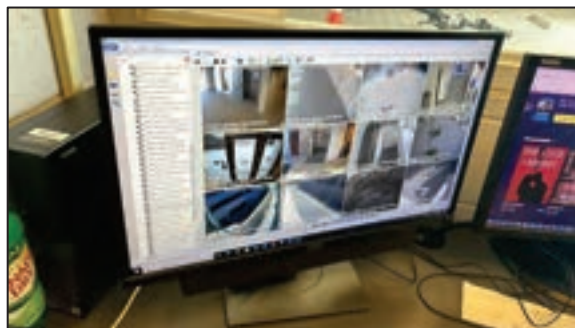
Figure 72 - Riverside Police Department Parking Services Office Monitor

The downtown Riverside Police Department Parking Services Office located on level one of the parking garage has a monitor that provides visibility of all video surveillance cameras installed at the District Office, Henry W. and Alice Edna Coil School for the Arts, and the Culinary Arts Academy. The assessment team are not aware of any other district police video surveillance monitoring stations.

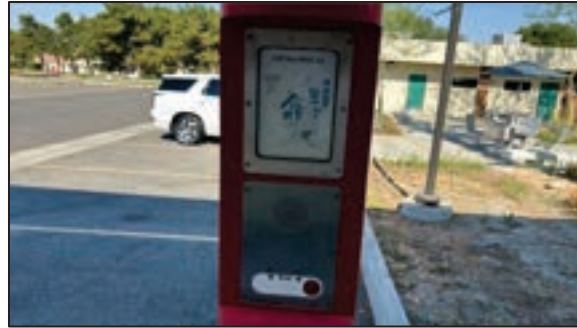
Figure 293 - Emergency Call Station with Campus Map at MVC

There is no communication call stations-standard applied to district facilities, and most units have single emergency call buttons with no button available for general assistance calls to be made. Provision of instructions on how to use the call stations and information on where calls are received is not provided. Several call stations at MVC did display the location of the phone on campus with a campus map present. These are exceptions to the norm.

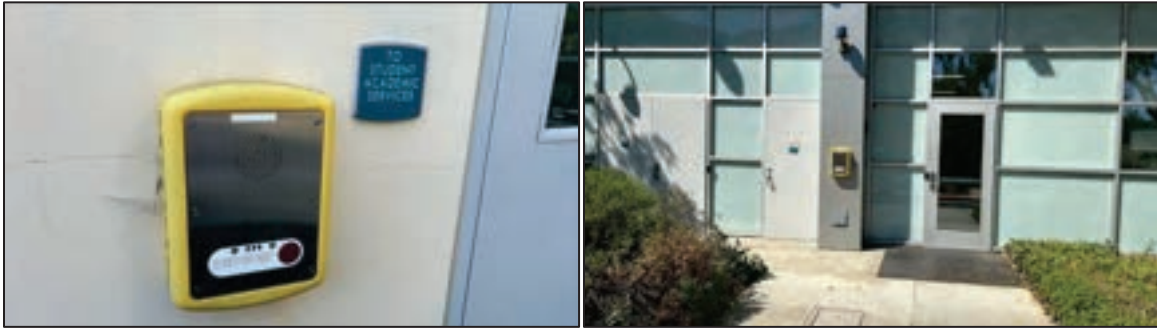
Figure 304 - Code Blue Wall Mount Call Stations w/ Independent Blue Strobe

Examples of some of the different form factors, operational state and manufacturer units in use are illustrated in the following images. Placement of units such as exterior rated units within interior spaces demonstrates a lack of standardized approach supported by governance reference documentation. Equipment appears to have been

installed as campuses have evolved with no consideration for existing conditions, resulting in disparity in form factor and performance features of each unit type installed on a project-by-project basis.

It is recommended that the district identify and standardize upon both an edge communication unit and form factor for deployment of emergency phones. Technology applied, form factor (i.e., towers and wall mount), use of strobes, and color are all critical and should be consistent across all RCCD campuses and facilities. Newer technology supports integration with mass notification platforms via Session Initiation Protocol (SIP) and also provide notification of calls to several monitoring outputs through alarm event trigger programming (i.e., access control notification and camera call-up), supporting efficient response.

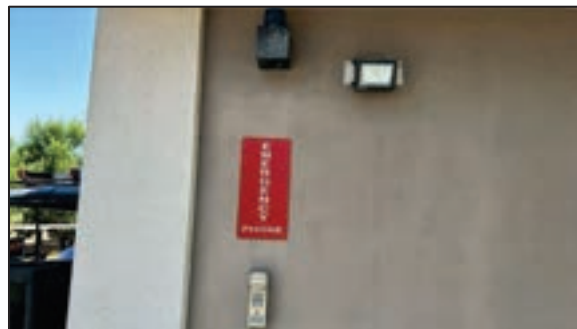
Figure 326 - Trigon Wall Mount Call Station w/ Independent Blue Strobe

An item of note at NC was the installation of call station units that appear to protrude beyond 4” from the wall. The 4” protrusion is non-compliant with current American with Disabilities Act regulations that state that “Protruding objects shall comply with 307. 307.2 Protrusion Limits Objects with leading edges more than 27 inches (685 mm) and not more than 80 inches (2030 mm) above the finish floor or ground shall protrude 4 inches (100

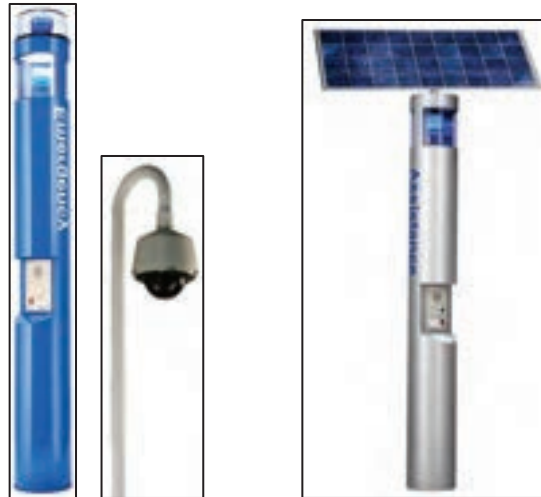
Figure 348 - Code Blue CB 1-s, Video Camera Extension, and CB 1-w

Subject to wider stakeholder engagement and desired communication options preferred by RCCD, Code Blue offers a wide range of product types with the CB 1-s and CB 1-w. Two options that provide comprehensive features that would meet the majority of operational considerations likely to be encountered. The CB 1-s provides communication through hardware, cellular, and IP wireless, powered by AC/DC and optional PoE. The CB 1-w offers cellular and IP wireless communication only but is powered by solar offering unrivalled flexibility of installation in areas that have challenges with providing power, or require significant trenching costs to provide communication cables etc.

It is suggested that overhead camera mounts be installed providing ability to receive real time awareness of activity at the location of call placement through integration with video surveillance. Code Blue also offer audio paging units that sit on the top of both the CB 1-s and CB 1-w towers that should be considered as part of any mass communication public address roll out.

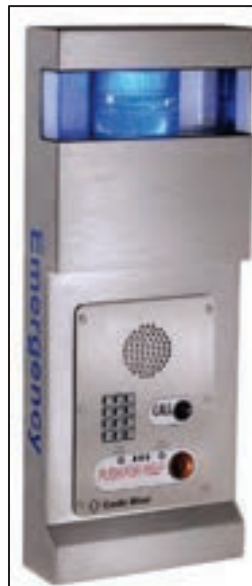
Figure 359 - Code Blue CB 2-a

As with the tower options Code Blue offers wall mount enclosure options, several with built-in strobes (preferred). The CB 2-a wall-mounted Help Point® has a sleek profile that is slim enough to be ADA compliant on any wall, it is a lightweight durable two-piece stainless steel construction unit that makes installation easy for a single person. A high intensity LED beacon/strobe and faceplate lights provide high visibility for the hands-free emergency speakerphone and makes it an excellent choice for parking decks, building entrances, exterior and interior corridors, and lobbies etc. The unit supports hardwired, cellular and IP wireless communication and powered by 12/24 VDC with PoE optional.
