Riverside City College Academic Senate

FINAL REPORT

Riverside Community College District (RCCD) has assigned Salas O'Brien Engineers, Inc. and Aanko Technologies (SOBE/Aanko) to conduct a comprehensive physical security program review of all District campuses to establish a baseline status that can be used as a foundation to develop, grow, and strengthen its District-wide physical security program to better protect and serve its communities. This security program review involves site visits, existing documentation evaluation and stakeholder interviews to evaluate physical components including security electronic systems, policies and procedures, socio-environmental conditions, training programs, and security staffing levels. The physical site assessments for all campuses were conducted during their typical hours of operation, before and after hours of typical operation, with the assumption that the security components and electronic systems were in good working order and functioning normally.

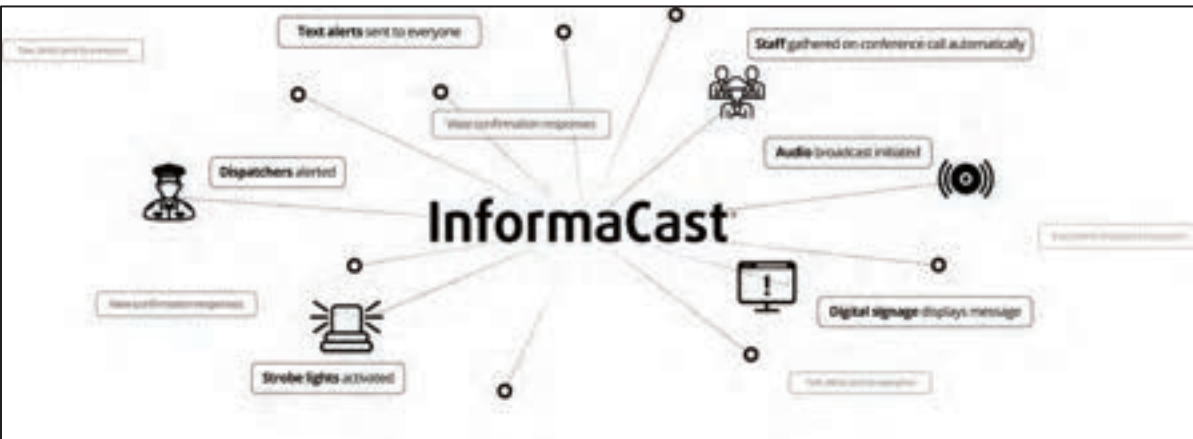
Figure 80 - Informacast Mass Communication Solution

Leading alternate solutions such as the Singlewire Software Informacast²⁴ platform is an expansive communication platform that supports input from multiple devices and other systems with ability to then transmit communications through a wide array of tools and interfaced platforms. The Informacast platform also provides ability to unify communication channels into a single “pane of glass” to manage and administer communications.

The system supports mass text notification similar to how RAVE Alert messaging is currently used but through one platform that also supports indoor and outdoor speakers, digital signage, desktop computers, and mobile devices. Informacast also offers its own visitor management solution Visitor Aware²⁵ providing an alternate consideration to the CCure 900 visitor management module, managed from within one pane of glass.

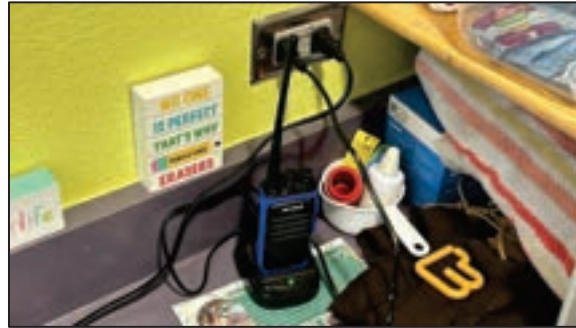
Figure 82 – MVC Early Childhood Center Radios

Radios in general are robust, with inconsistency in manufacturer and model types deployed. A concern regarding radios observed at the MVC Early Childhood Center, was feedback provided by staff that the radios experience frequent intermittent failure. This is problematic as the operational expectation is that radios are taken by playground supervising staff as a means to request immediate assistance when overseeing playground activity. If they are non-operational ability to request assistance is diminished. Note at the time of this assessment radios

were not on the person of yard supervisors. These radios are also procured directly from an online shopping source and are not district or local college issued.

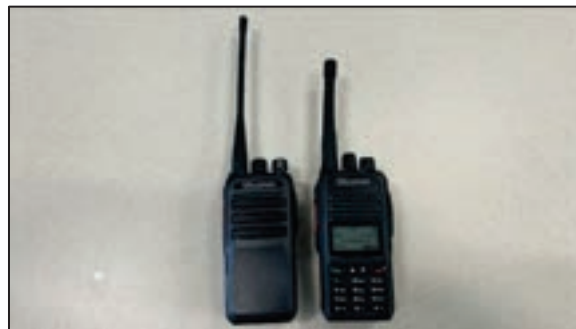
Figure 363 - SRcomm Radios at NC

Robust SRcomm radios are used at NC with two different form factors in operation. The higher performance SRCOMM SR-D3U specification handheld radios are used on a day-to-day basis to support operations. The lesser performance feature SRCOMM SR-D1U radios are those that are used by the EOC. Dedicated channels are programmed for Facilities, Special Events, and Emergency Communications with several others available for general talk traffic. NC has established local operational guidelines that provide clear and concise instructions on “How-to” use the radios. This documentation is excellent and provides easy to follow reference material for radio users.

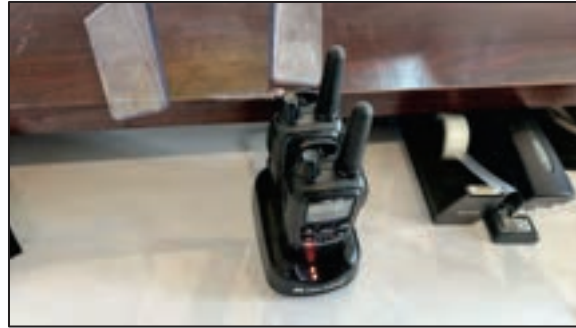
Figure 374 - Radios at Center for Social Justice and Civil Liberties

The radios illustrated at the Center for Social Justice and Civil Liberties are manufactured by Midland Radio and are used locally.

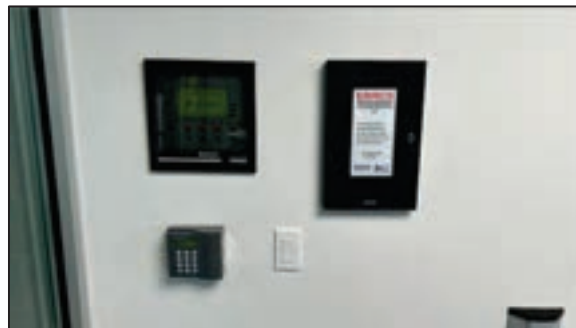
Figure 85 - Emergency Responder Radio Communication System (ERRCS) panel at the Building of Business and Law, RCC

Radio repeaters are in use across several campuses providing reinforcement to the transmittal of radio communications. In addition to repeaters, an Emergency Responder Radio Communication System (ERRCS) was observed at the newly renovated Building of Business and Law, at RCC. ERRCS, as the name suggests, is designed to ensure mission critical radio coverage for emergency services within buildings. Many jurisdictions enforce the code defined mandates for their deployment to provide reliable communication for first responders throughout the entirety of a facility including the critical areas such as pump rooms, utility spaces, and stairwells. Building materials can affect radio frequency strength, the Building of Business and Law consists of concrete block that significantly impacts communication frequencies. This location was the only ERRCS observed across the district buildings.

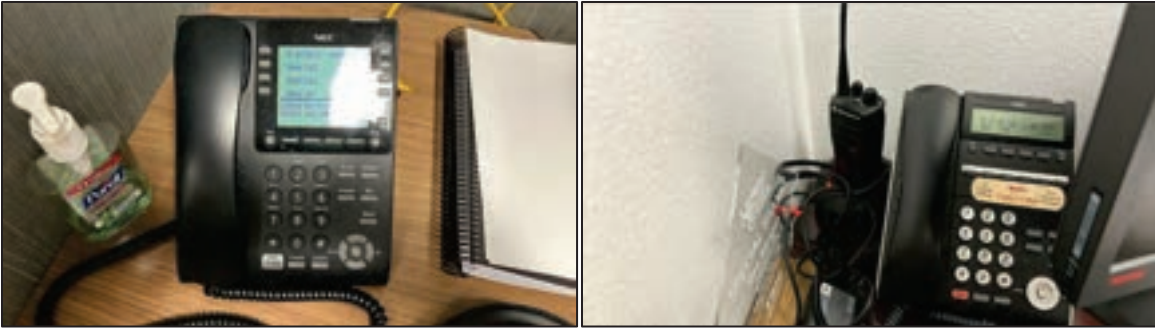
Figure 386 - NEC VoIP Telephone Handsets (New and Old)

VoIP handsets typically observed are NEC Univerge DT700 series which have been in operation since pre-2010. These handsets are near end of life and lack sufficient performance features to support mass communication needs with intercoms that are unavailable. Newer NEC Univerge DT800 series phones were observed within office spaces and open staff workstations. The DT800 series includes models like the DT820 IP Entry-Level Phone, which offers a monochrome 3.5" or 4" LCD display, and the DT830 IP Desktop Phone, which features a full-color 3.5" backlit LCD display. These phones are designed to be customizable to fit the specific needs of each employee within an organization, supporting a wide range of applications to improve efficiency and productivity. They also come with features for the visually impaired, such as audio key action feedback and large character display.

Provided telephone handsets appear to be used inconsistently regardless of office or classroom space, with cell phones being the preferred means of communication. The current VoIP telephone system supported by an NEC PBX²⁶ (private branch exchange) requires migration to another service provider as NEC have announced that they will no longer support systems after December 31, 2024. Consideration should be given to ensuring that existing hardware is compatible with any new digital PBX selected.

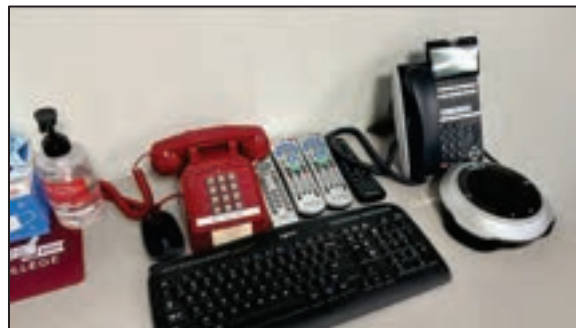
Figure 397 - POTS Landline at NC

Traditional landline telephones are restricted to (as informed) one landline per campus. These Plain Old Telephone Service (POTS) lines are provided for single emergency communication phones and are used if loss of power to the network VoIP system. The only landline visually identified was at NC, the phone number displayed on the red handset (see Figure 84) was called and verified as still active. POTS lines typically remain as a means of backup communication in the event of loss of local network or wider cellular network outages. They are often seen as insurance for use in emergencies when cell towers may be overloaded with communication efforts and are seen as more reliable. Costs of maintaining POTS lines is increasingly expensive as fewer remain in operation. POTS lines are sunsetting. Post Federal Communications Commission (FCC) Order 19-72A1 directed that all POTS lines in the U.S. be replaced with an alternative service beginning August 2, 2022. Transition from POTS line also affects security electronics and life safety systems that have traditionally relied upon POTS lines for communication offsite to third-party monitoring stations.

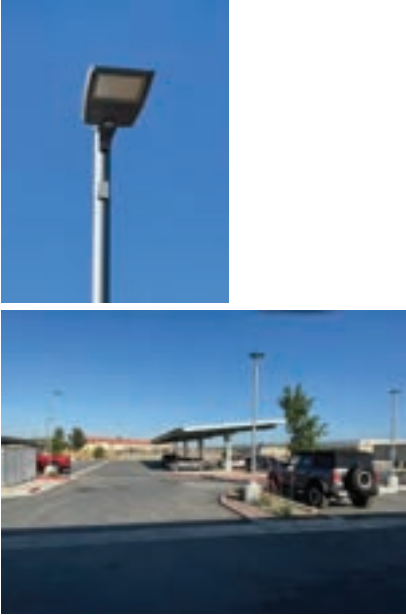
<p>Cobra-head luminaires operate on motion and provide controlled lighting distribution via Light Emitting Diodes (LEDs). Placement of lighting is consistent around the parking lot perimeter.</p>	<p>General observation only. The lighting deployed is appropriate for the space use and embraces technology and lighting heads that support minimalization of light pollution.</p>	0
3

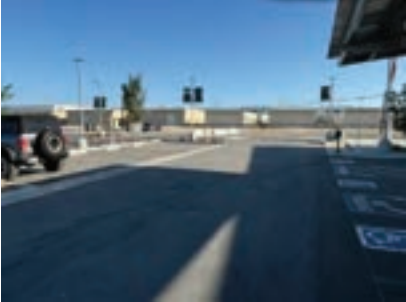
<p>Covered parking ADA spaces are clearly identified with physical and tarmac painted signage. The cover consists of solar panels, a video surveillance camera was removed during the construction process and has not been reinstalled.</p>	<p>Reinstall the removed video surveillance camera to enhance the real-time and forensic viewing capabilities.</p>	3

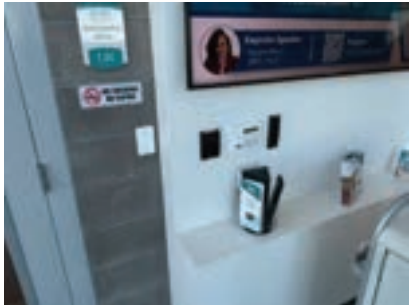
The building intrusion detection system is armed and disarmed locally using a security credential that is presented by authorized persons at the adjacent card reader. Access control card reader is provided for controlled entry into the North Hallway.	General observation only.	0
10

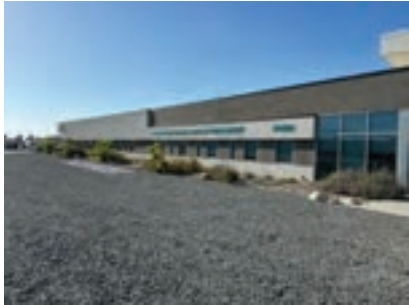
11

Window treatments are installed providing ability to lower and restrict visibility from the public exterior side into the public safety space. Ground covering shrubs are above the CPTED recommended 2' height obscuring visibility of some exterior windows and supporting potential bad actor concealment.	Perform landscaping maintenance to reduce ground covering height to no more than 2'. Add additional exterior lighting and video surveillance to provide visibility and monitoring of activity during the hours of darkness.	3
12

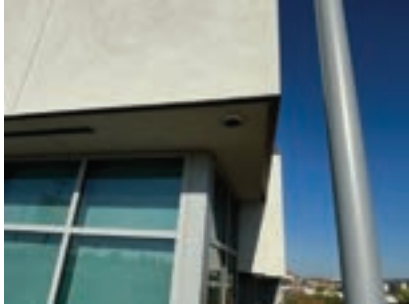
Exterior 360 camera ceiling surface mounted. Unable to verify of the camera field of view is impeded negatively by the adjacent pole.	Review the camera field of view and verify that there is no blocking of visibility by the post.	2

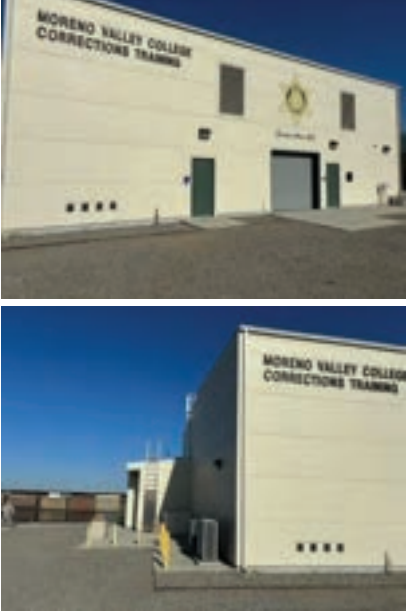
16

<p>Access into the training center is by brass key only with no access control measures applied for controlled and audited entry. There are no exterior video surveillance cameras installed providing situational awareness of general activity or monitoring of authorized and unauthorized entry attempts. Bollards provide protection from potential vehicle impact at the HVAC units. Roof access by exterior ladder is restricted but placement of metal storage cabinets supports potential unauthorized scaling of the roof by bad actors.</p>	<p>Add access control to the building entry points providing full audit capability of persons who access the space with permission and those who may attempt entry without authorization. Add exterior video surveillance providing situational awareness and forensic viewing with integration with the access control system. Consider relocation of the cabinets to mitigate their potential misuse for scaling of the roof by providing access to the wall ladder.</p>	3

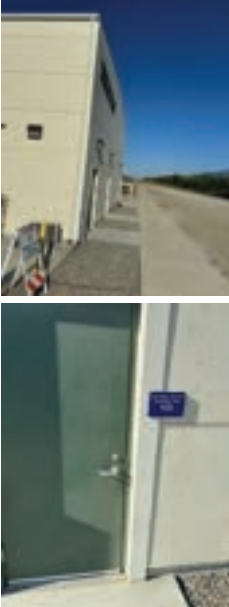
17

<p>Wall mounted sconces provide sufficient lighting during the hours of darkness. Lighting is located above each entry opening. Door hardware is storeroom function, there are no latch guards installed to restrict potential tampering and forced entry.</p>	<p>Review Division 08 standards (if available) and install latch guards at openings to restricted areas providing additional protection mitigating potential tampering opportunity for bad actors.</p>	3

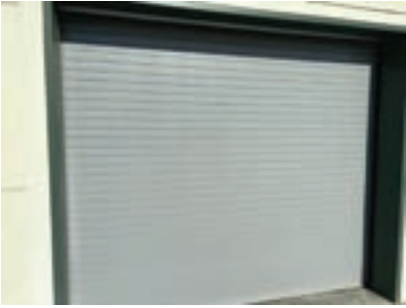
<p>The roller door located on the east side of the building is not monitored by access control door position contacts or external video surveillance.</p>	<p>Monitor the roll-up door on both the intrusion detection and access control systems. Double-pole-double-throw door position contacts would support hardwired termination to both system control panels. Installation of exterior video surveillance integrated with the access control system would support camera call-up on alarm event trigger.</p>	3
19

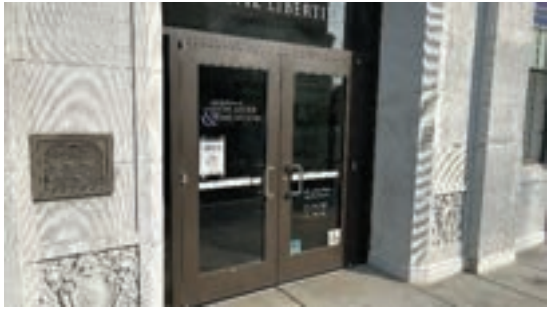
2	 	<p>The main entry doors are not electrified and are to remain unlocked during hours of business. There is no ability to remotely lock these doors from the reception desk or any other location. There are no window treatments applied to the glass doors reducing visibility from the public side. Doors require manually locking in a lockdown and lock blocks are not applied. Activity on approach to entry from the public side is not available on the interior as no video surveillance installed.</p>	<p>Main entry doors should be access controlled similar to the district office main entry. A remote release/locking button should be installed at the reception desk when doors are electrified to eliminate the vulnerability currently in place of mechanically locking doors in a lockdown. Consider a video intercom at the main entry providing ability to communicate with persons requesting entry visually and audibly if the building is secured due to heightened security conditions. A video surveillance camera should be installed on the exterior of the</p>	4

<p>main entrance providing visibility of the entry approach. Consider installation of window film on all door window vision and side panels to restrict visibility in from the public side, frosted film would minimize impact on natural light and does not require to fill glazing from bottom to top.</p>	
3

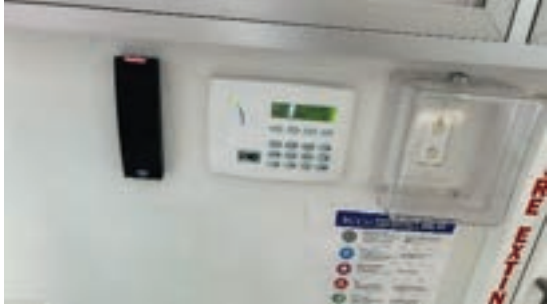
<p>The DMP intrusion panel is armed and disarmed using the associated HID card reader. There are two arming stations located in the building, one at the main entrance and another at the rear entrance.</p>	<p>The use of card readers to activate and deactivate the intrusion detection system is excellent, this should be a standard approach across the entire district.</p>	0
4

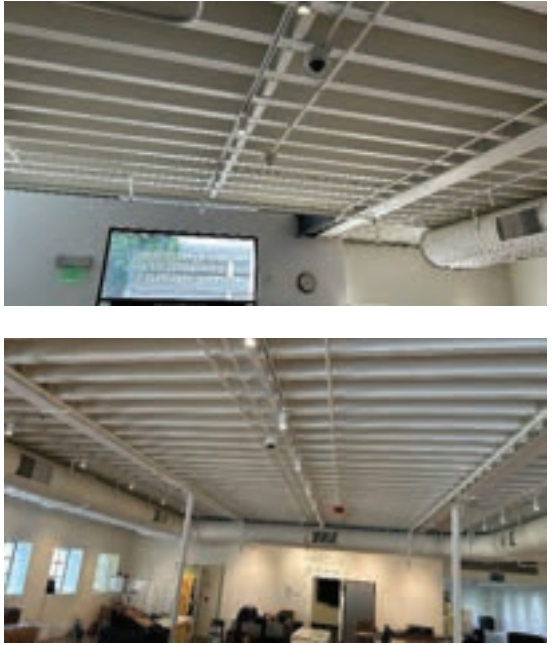
<p>A video surveillance camera monitors the main entry from the interior, there is a 360-camera installed in the middle of the level one gallery space. These are the only cameras installed on level one of the building.</p>	<p>Review the need for additional video surveillance cameras to provide complete coverage of the public areas of the center. The open nature of the center to the general public justifies additional video surveillance eliminating areas for potential bad behavior to occur undetected.</p>	3

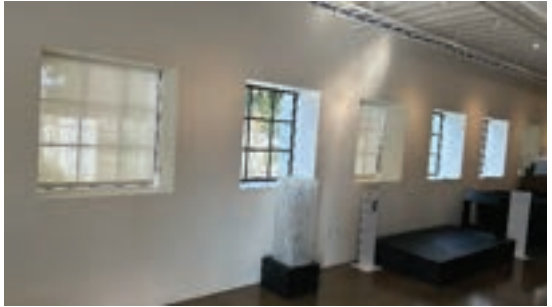
5

<p>There have been incidents of glass being smashed and vandalized. Interior window treatments are installed that can be lowered to reduce visibility from the public side in. During the hours of darkness visibility from the public side into the space can be achieved as the</p>	<p>Reference recommendation #1 regarding additional video surveillance and lighting applies. Window treatment blinds would provide better visibility restriction if black out style were installed. Glass breaks often provide false alarms, but due to the extensive amount of first</p>	3

ID#	PHOTO	OBSERVATION	RECOMMENDATION	RISK
		blinds are not blackout blinds. Glass breaks are not installed.	floor windows, there installation may be of benefit if terminated to the intrusion detection system. Glass breaks are not recommended for installation as standard across district facilities, but they do have value in specific applications.	
6	 	<p>Located at the reception desk there is a wireless panic button installed on the left-hand side workstation. There is only one panic button located here with the desk often occupied by more than one person. Panic buttons are tested once a year typically in August to verify if the monitoring company receives communication. Wireless panic buttons present more points of failure than hardwired and annual testing is not frequent enough to ensure that if needed they will function as intended.</p>	<p>Consider replacement of wireless panic buttons with hardwired and perform more frequent testing of the panic buttons to confirm that they communicate as intended upon activation. Install an additional panic button at the second workspace at the reception desk.</p>	3

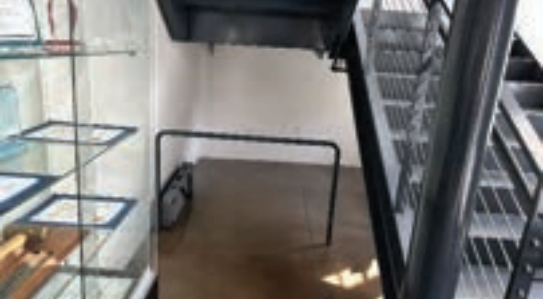
8

<p>The stairwell on the right of the main entry provides an area for concealment underneath them stairs as there is no framing enclosing or gating the area off. The facility is an open public space with events occurring throughout the year during the day, the evening, and weekends. There is no security staffing provided when there are public events open to all.</p>	<p>Consider closing off of the space under the stairwell to restrict concealment by a bad actor. If the space is needed for storage install a cage/grill with secured opening. Provide district police presence or private security personnel upon request for public events. The concerns and previous experiences with agitated members of the public should be mitigated as best possible. Regardless of the building being a public welcoming facility, there is liability and care of duty that should be afforded to the district employees. Create policy and protocol that support provision of security staffing at public events.</p>	2

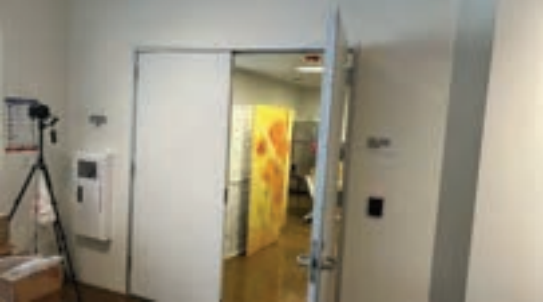
9

<p>A staff break room is access controlled but remains propped open frequently. The door has no door closer to ensure positive latching upon closure. The space can be used for refuge if needed, there is no secondary egress point from within the room.</p>	<p>If the space to be used for multi-purpose and general access is required, unlock the door with the double-tap presentation of a security credential. This approach will eliminate door held alarms in the access control system. Install a telephone in the space to support communications if the space is used for refuge in an emergency or lockdown.</p>	3

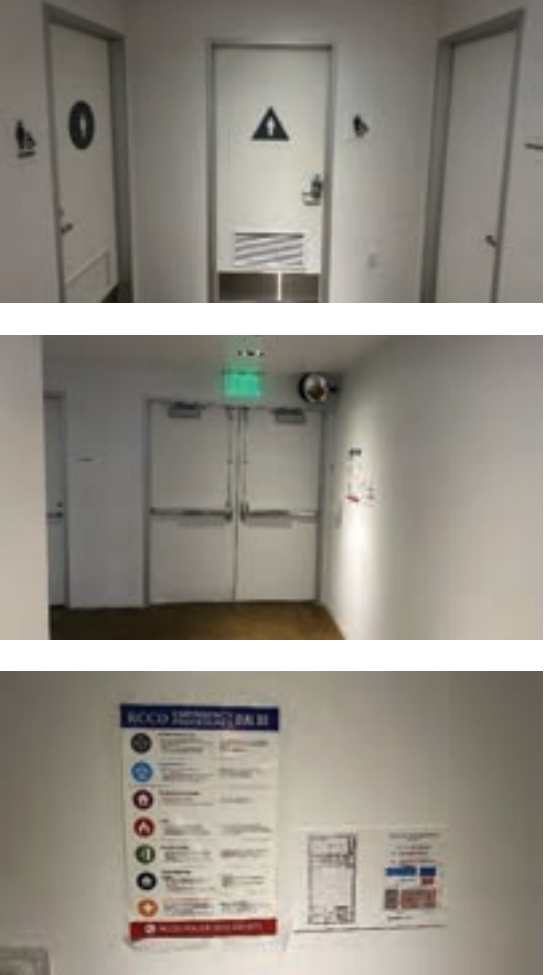
<p>The level one restrooms are set back from the main floor area within the corridor leading to the rear entry/exit vestibule. There is no video surveillance monitoring activity within the interior corridor or the access vestibule. The rear entry is outside of the controlled yard area with no ability to monitor public side activity.</p>	<p>Install video surveillance to provide situational awareness and forensic review capability of activity within the internal corridor and restroom entrance area, add an additional camera within the rear point of entry vestibule. Install a video intercom that allows for visual and audible communication with persons on the exterior who may be requesting entry. Install a spy hole in the exterior facing doors. Recommend live video stream of activity on the exterior of the opening to appear on the proposed monitor at the reception area.</p>	3

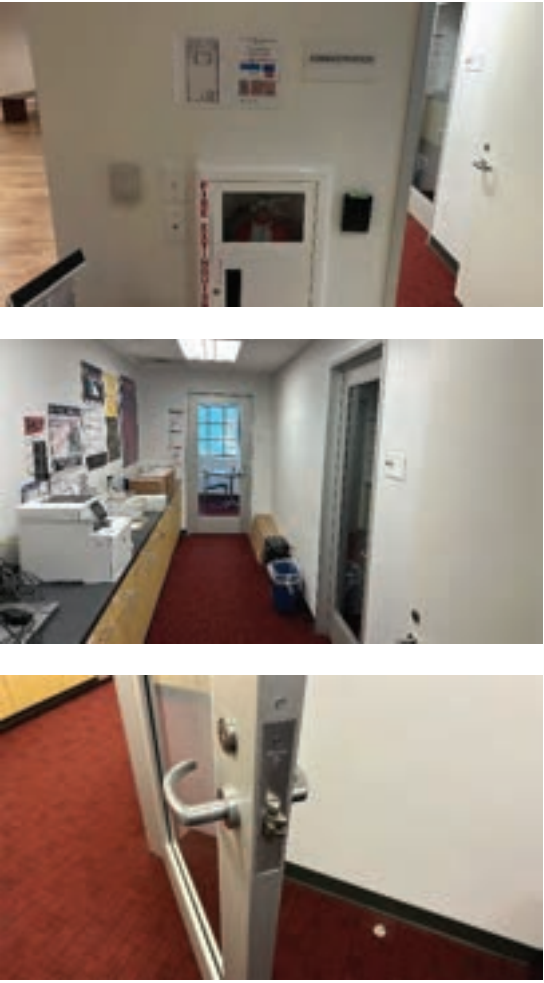
<p>Staff offices are installed within an access controlled secured corridor space, individual offices have no access control measures, lack visibility measures on the door glass, and hardware cannot be locked from the interior side. The position of the offices provides no natural surveillance or eyes on activity vision. Staff prop the door daily as they feel isolated when the door is closed. Panic buttons are installed in each office, use wireless communication, and are tested annually. There is apprehension that the single annual testing is not sufficient.</p>	<p>Provide frosted film and internal locking hardware at the staff offices. Panic buttons should be hardwired, and more frequent testing of the buttons is encouraged to allay staff concerns regarding confidence in the panic buttons to function as intended if activated. Past events with agitated members of the public have resulted in staff deescalating incidents themselves, rather than activating the panic buttons, as concerns regarding response time to requests for help are present. Install a video monitor in the office corridor providing the same video stream as that to be displayed on the proposed reception monitor. Install a lock blok on the corridor-controlled entry, the door should remain in a locked state at all times.</p>	3

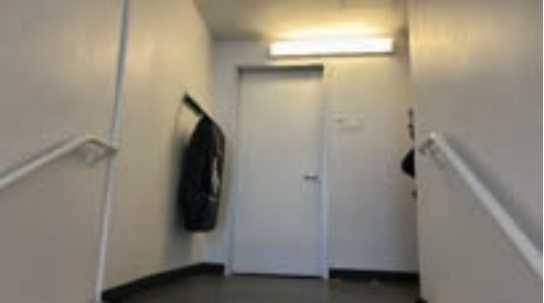
15

<p>Access to the second level from level one is always available from the stairwell side as the entry door is equipped with a passage trim remaining unlocked. Lack of video surveillance fails to support both real-time situational awareness and forensic viewing. The lack of card reader on this entry from the stairwell fails to provide ability to monitor entry activity via an audit trail in the access control system. There is no 'Exit' sign above the door indicating a path of egress from level one. This opening is similar to the main level one building entry doors with lack of access control technology in use, eliminating the ability to track access via an audit report.</p>	<p>Install video surveillance on the stairwell side to monitor approach from level one. Review the path of egress with the AHJ, if permitted add a card reader to the stairwell side of the door. Free ingress, if possible, should be removed as this opening leads directly to the staff office space and archive room-controlled entry point. Develop protocol that facilities and maintenance staff use their security credentials to enter the building and secured spaces rather than using a brass key. There should be an audit trail of all persons entering the building and rooms when secured.</p>	4

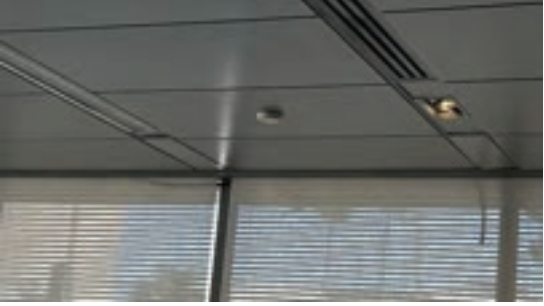
<p>Glass breaks are installed on the ceiling of the dining room and are terminated to the intrusion detection system. There is no interface of glass breaks with video surveillance to support visibility of activity if an alarm event is triggered by a glass break.</p>	<p>Interface the security electronics systems to provide camera call-up in the event of an alarm event trigger. Utilize the existing security electronics to support security staffing measures and district police.</p>	2
7

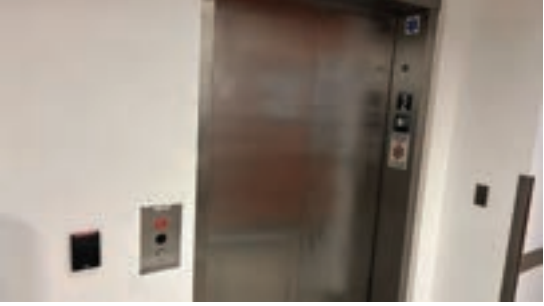
ID#	PHOTO	OBSERVATION	RECOMMENDATION	RISK
9

<p>Ability to call the elevator requires a security credential be presented at the card reader adjacent to the elevator call button. Ability to call an elevator is permissions based through access control system programming.</p>	<p>General observation.</p>	0
10

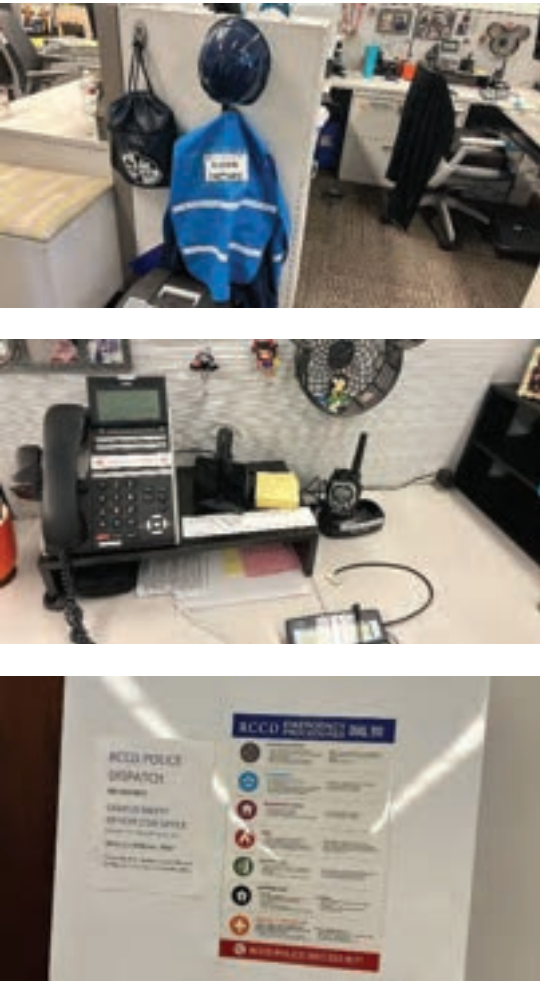
<p>Floor Captains are provided with blue vests that clearly identify their role in an emergency situation. Walkie-talkies are also provided and serve as the primary communication tool in an emergency. Each workstation has a VoIP telephone, emergency procedures are well distributed throughout the building.</p>	<p>General observation. Identify a floor captain or marshal who is responsible for each floor or tenant of the site (whichever is more applicable). The captain or marshal is responsible for implementing each floor's or tenant's appropriate emergency plan and ensuring that it is carried out properly. In the case of evacuations, check for stay-behinds. Ensure that all persons of responsibility are provided appropriate attire to wear in an incident response situation. Locate and address the needs of people who require special attention during a disaster (e.g., the disabled, non-English speakers, etc.).</p>	0

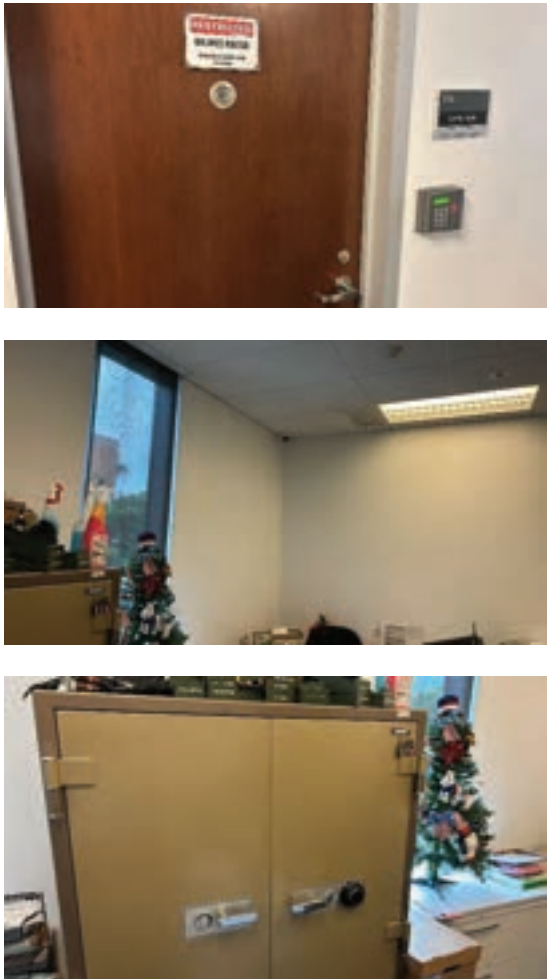
<p>The Cashiers Office is located on the second level and is nondescript with no signage outside drawing attention by indicating the function of the space. Access into the room is by restricted permissions-based access control security credential. The space is an independent zone on the DMP intrusion alarm system and is armed by the space users whenever they are leaving the room unoccupied. Approximately \$5000 float is carried, and monies are collected by a contracted courier Monday, Tuesday, Wednesday, and Thursday each week. Couriers also bring funds from each of the district college campuses into the central district space. The courier has an access control credential that provides access into the secured courtyard, and into the building but not directly into the cashier's office. Office occupants can physically observe the arrival of the courier from the second-floor window. There is a video surveillance camera installed within the office but no</p>	<p>Consider providing hardwired panic buttons at both staff members desks. Provide radios for communication with floor captains over a dedicated radio channel in the event of a lockdown or other emergency, rather than reliance on personal cell phones if the network telephones lose power. Recommend a monitor be installed within the room providing live video stream from the camera monitoring the room entry door from the public side; allowing visibility of room occupants to observe person(s) requesting entry.</p>	3

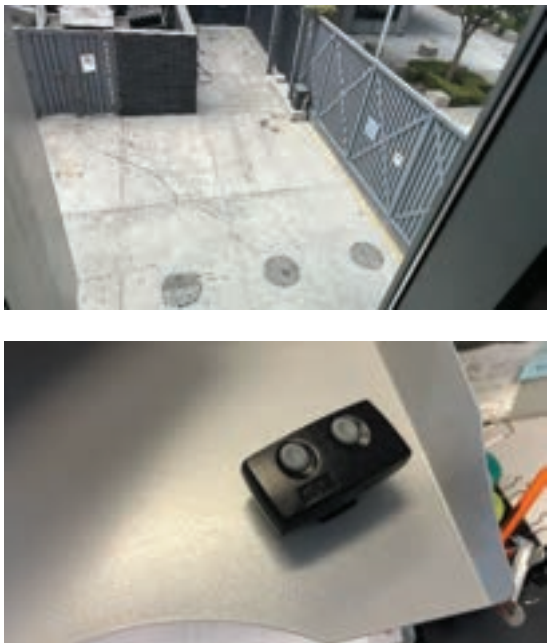
<p>visibility of activity on the exterior of the approach to the office from within. The existing spyhole has limitations in visibility provided. A single wireless DMP lockdown button was observed in the space, this is not fixed to a desk or wall and is tested annually. Cashiers Office staff do not have walkie-talkies/radios for use in the event of shelter-in-place or lockdown. If the building network was compromised, and the VoIP telephones were out of service, there is reliance on personal cell phone to communicate outwardly.</p>		
11

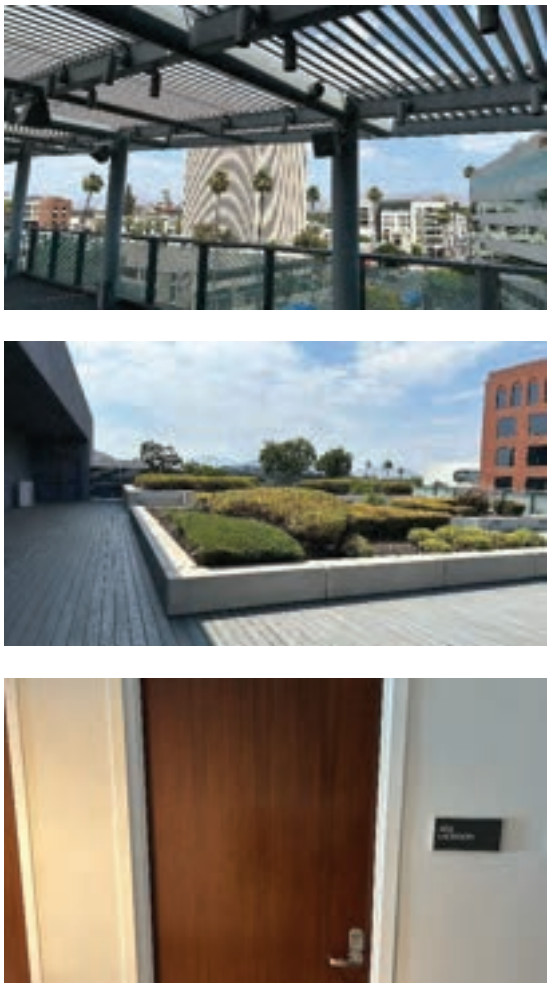
<p>Access to the rooftop entertaining area is controlled with card reader. A single exterior video surveillance camera monitors the activity onto the roof from the stairwell. There is no video surveillance installed to monitor general rooftop activity. The security electronics systems are not integrated to support immediate visibility via camera call-up if a door forced or door held alarm was received. The lactation room has a privacy indicator installed which is excellent.</p>	<p>Additional video surveillance should be provided to support situational awareness of activity on the rooftop. Security electronics system standards should be created, and systems interfaced.</p>	2

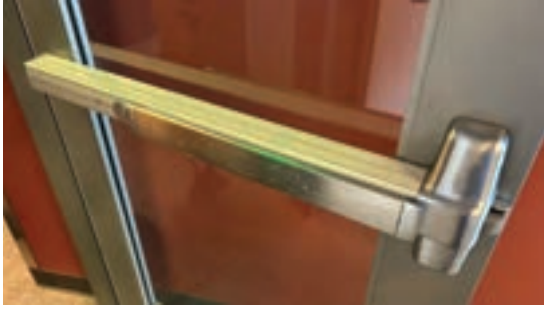
<p>The door at opening 123 is unlocked daily, the interior panic bar can be dogged, and the public side lever unlocked. This has potential risk as the lever and the panic bar could both be left in an unlocked state causing extra effort to secure in a lockdown as both sides of the door require locking. These doors have no electrification that would support immediate lockdown and lock/unlock on schedule if controlled by the access control system.</p>	<p>Remove the dogging feature and replace the panic bar key cylinder with a blanking plate. These doors should be electrified to support immediate locking upon lockdown activation and allow for remote locking/unlock.</p>	4
8

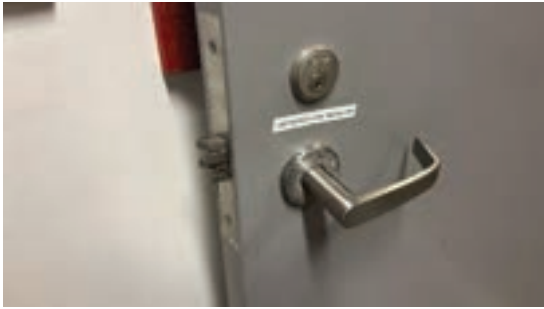
<p>Practice Rm. 124 has a sticker underneath the deadbolt key cylinder indicating that the door should remain locked when unoccupied. The door was found in an unlocked and open state. There is a throw on the interior that allows for the door to be locked from the interior. There is no door closer installed that would support positive latching and closure at all times. The side window panel has no window treatment applied allowing opportunity to eliminate visibility from the corridor in the event of a lockdown. Practice Rm's without the instruction displayed reference</p>	<p>Review door hardware installed and ensure that the ability to lock the door from the interior is available when occupied. Apply window treatments to restrict visibility from the corridor inwards.</p>	3

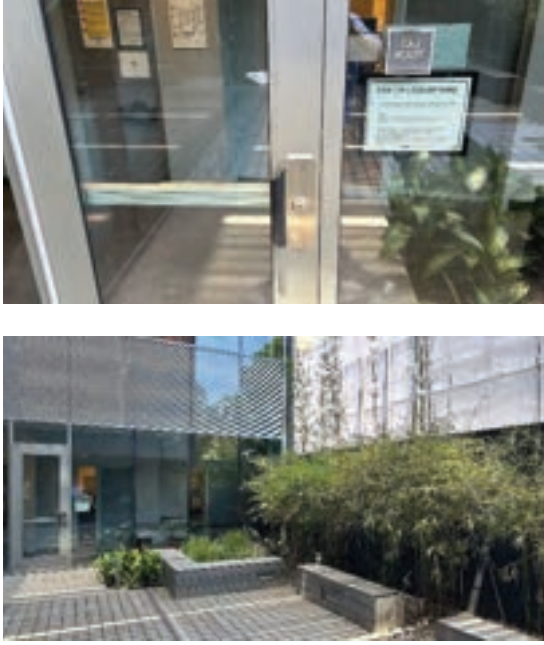
<p>The inner outdoor courtyard doors have panic hardware on the interior of the openings, these are dogged providing free egress at all times. Phone numbers applied to the openings on the exterior are small in text size and suggest that persons have been locked in this area. This was confirmed by faculty as an occurrence at one time. The doors are locked at the end of each day to eliminate opportunity for scaling of the courtyard wall and unauthorized entry occurring. Video surveillance is not installed monitoring activity.</p>	<p>Confirmed that doors are locked and unlocked on schedule. Install video surveillance to monitor activity after-hours, monitor the top of the courtyard wall for unauthorized scaling. Design text and finishes on signs for clarity and ease of reading.</p>	1

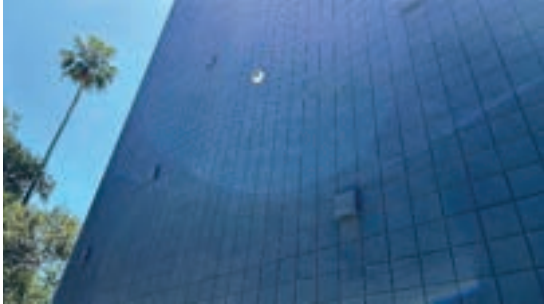
<p>they have found them propped on several occasions without notification which allows unauthorized entry. A video surveillance camera mounted directly above the opening provides visibility of activity. Exterior video surveillance cameras are equipped with sun caps which are intended to negate glare.</p>		
11

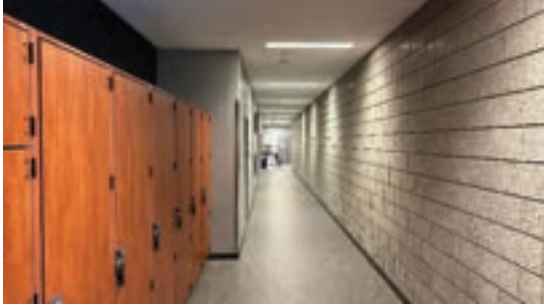
<p>Video surveillance is not installed at this location to provide visibility of activity at the lockers and within the corridor.</p>	<p>Install video surveillance to monitor activity, consider a multi-sensor at the top of the stairwell landing to provide full 360 coverage of activity within and approaching the corridor.</p>	3
12

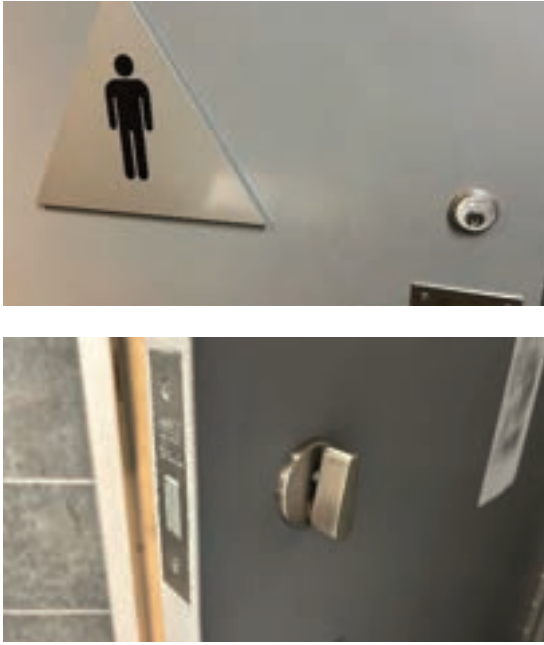
<p>Level one restrooms are equipped with deadbolt throws. The throws are unable to be used to throw the deadbolt from the interior to secure the door, the throw will allow a single retraction of the deadbolt to allow free egress if locked from the exterior. There is no public address system that provides opportunity for local communication if the building has been placed into a lockdown or shelter-in-place state.</p>	<p>Consider installation of public address speakers in all restrooms that can be placed into remote lockdown, to provide communication when this occurs and occupants to shelter-in-place. Use a multimodal communication system (e.g., mass notification, public address, cell phones, pagers, panic buttons, etc.) that notifies all building occupants of threats and provides emergency instructions.</p>	4

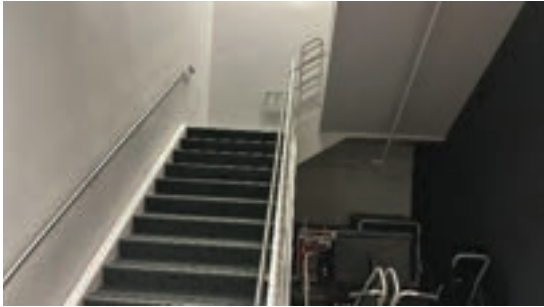
<p>Reference observation #6, this stairwell from level two down to level one allows access into areas behind doors leading from the lobby when closed and locked.</p>	<p>Reference recommendation #6.</p>	4
16

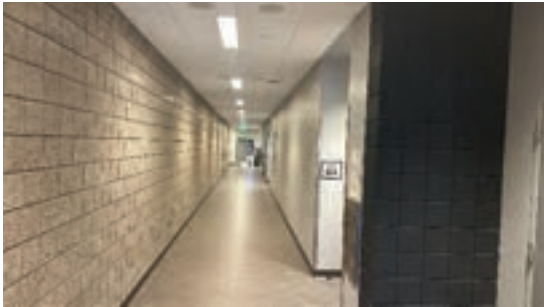
<p>No video surveillance camera in the corridor monitoring activity.</p>	<p>Install video surveillance to provide ability to monitor general activity in public corridor space. Use of multi-sensor or dual head cameras will provide enhanced visibility using the same infrastructure that would be required for a single fixed-dome camera.</p>	3

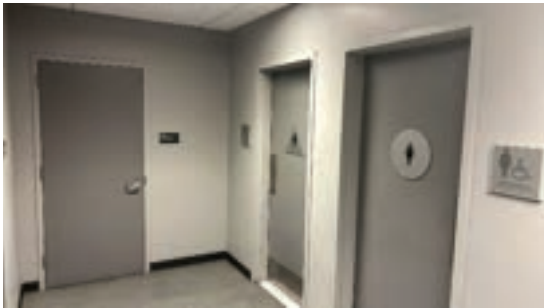
19

<p>Hardware applied to these restrooms on the second level is different to that on the first floor. Hardware is pull trim only and the doors cannot be locked from the public side. There is no video surveillance camera installed monitoring activity in this alcove which is setback from the corridor.</p>	<p>Install video surveillance to monitor activity outside of the restroom area. Internal public address is recommended to provide notification of emergency events such as lockdown to occupants of the restrooms.</p>	3

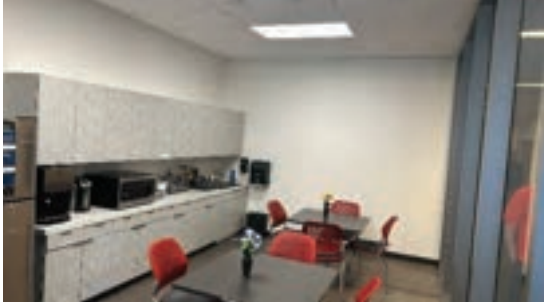
<p>Faculty requested that a monitor be added to the staff break room wall that displays the buildings video surveillance video stream. Intent is not to spend time sitting watching cameras, but to have ability to glance and if something appears out of the ordinary activate a proactive response rather than react to incidents. No Faculty have access to the video surveillance system, and they are uncertain of who has viewing access, length of video retention, and approved use.</p>	<p>Install a wall mount monitor that streams live video surveillance feed from the building system. General activity awarenesses may provide valuable time to respond to something that seems out of the ordinary with appropriate response protocols proactively rather than responding reactively. The monitor is not intended to encourage "sit-and-stare" activity but support wider visibility and ownership of day-to-day security management.</p>	3

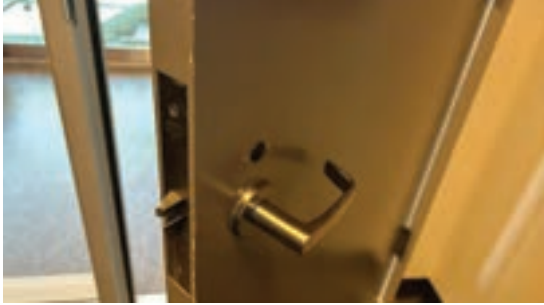
25

<p>Reference observation #8, regarding removal of internal throws to secure the practice room doors on the second level.</p>	<p>Reference recommendation #8.</p>	3
26

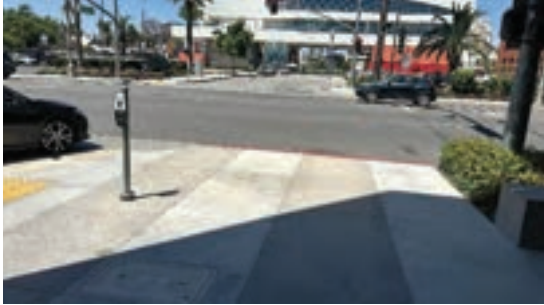
<p>The sidewalk adjacent to the main entry of the building has concrete blocks that serve as bollards to restrict vehicles from potentially traversing up onto the sidewalk. These are well spaced to restrict vehicles from also passing through. There are spaces at each end of the sidewalk that do not have concrete blocks deployed and vehicles could easily enter the sidewalk (there have been</p>	<p>Install additional concrete blocks to eliminate the vulnerability identified. If permanent blocks present accessibility issues for first responders or others, review alternate options including removal bollards. The ability for vehicles to access and park on the sidewalk should be eliminated (unless authorized).</p>	4

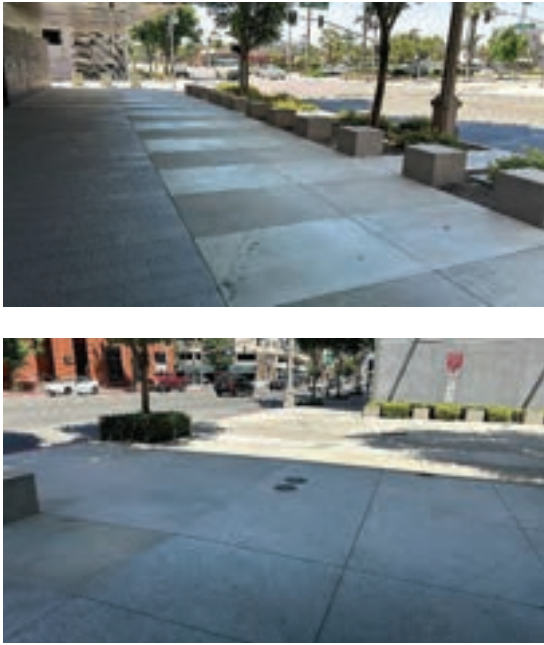
<p>instances of vehicles parking on the sidewalk). The concrete blocks are softened in appearance with low level landscaping within the CPTED recommended ground covering height of below 2' which is excellent.</p>		
27

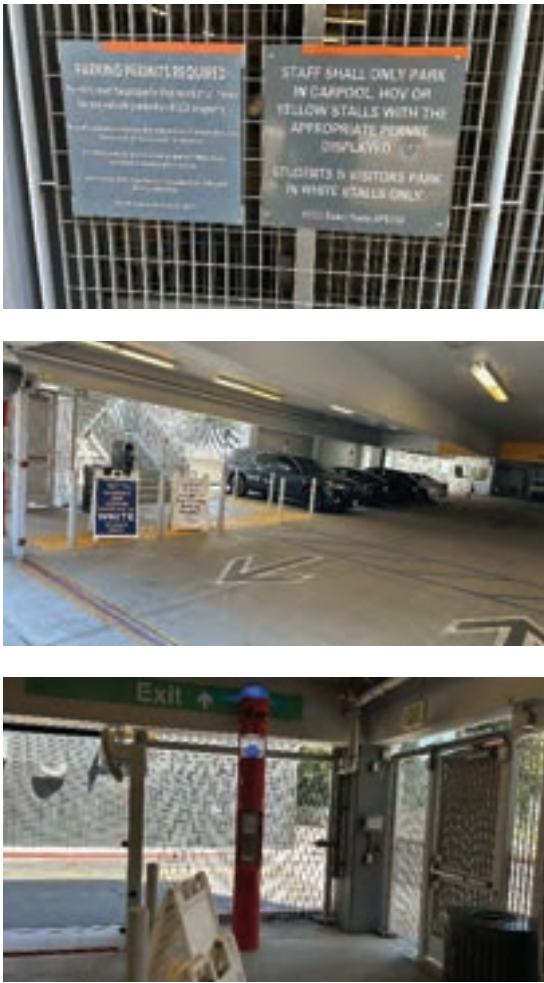
<p>Signage on the exterior of the parking garage provides clear direction regarding parking permits and bays that can be used. The parking garage is locked at 10:00 PM each evening and a metal roller gate closes the main entry; free egress is maintained. Video surveillance is not installed to specifically monitor traffic entering and exiting the structure.</p>	<p>Install video surveillance to monitor incoming and departing vehicles. Use of license plate recognition (LPR) cameras would support identification of vehicles not permitted to park at the facility and or identify vehicle users with other issues that may require intervention by the parking office.</p>	2

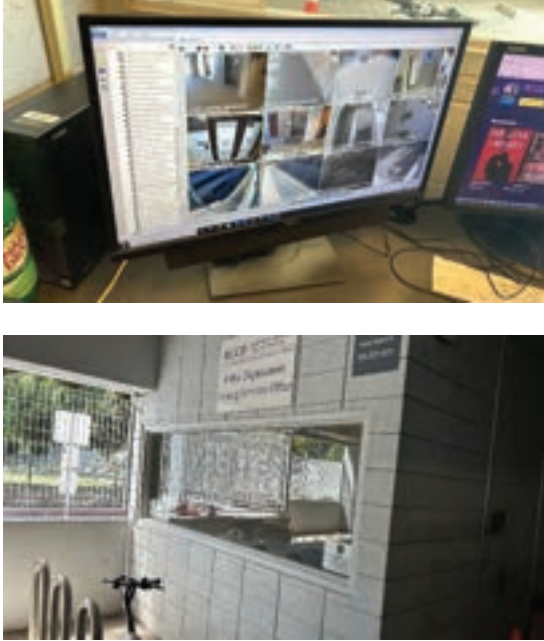
<p>RCCD Police Department Parking Services Office located on level one of the parking garage has a monitor that provides visibility of all video surveillance cameras installed at the District Office, Coil Center, and the Culinary Arts Academy. Camera field of views appeared clear with exception of one camera that requires maintenance review to clean the lens to provide a clear field of view. There appeared to be cameras installed within classroom areas which is not consistent with camera deployment across the RCC campus.</p>	<p>Expand the ability for video surveillance to be monitored beyond this central point. Refer to individual site assessment reports with recommendations of local monitoring to support proactive response to abnormal behaviors observed. Review the cameras that provide visibility of class in session. Review with district legal counsel appropriateness of monitoring students unknowingly who are attending class.</p>	3

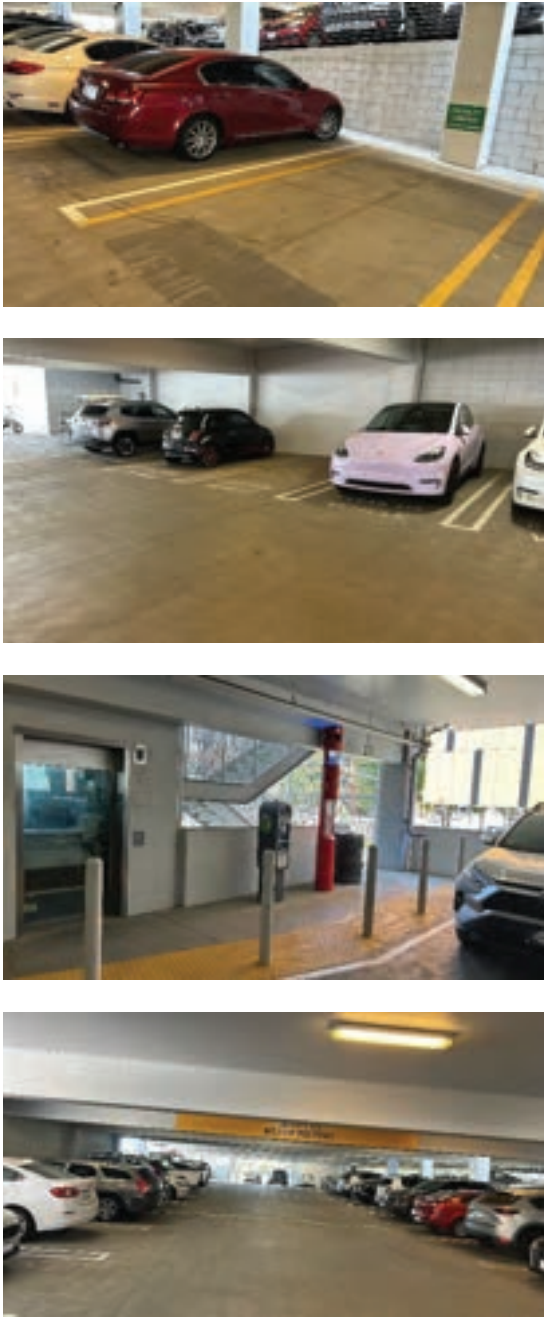
<p>Signage installed on pillars clearly identifies faculty parking spaces defined by yellow bays. As with RCC campus all faculty parking bays are yellow and public/visitors bays white. There is no signage either physical or painted on the tarmac that provides speed limit control. Emergency Phone Code Blue towers are located consistently in the same location on every level. All towers are consistent and use the Code Blue call stations.</p>	<p>Install signage that indicates the approved speed limit within the parking garage. Fixed and tarmac signage is recommended.</p>	2
31

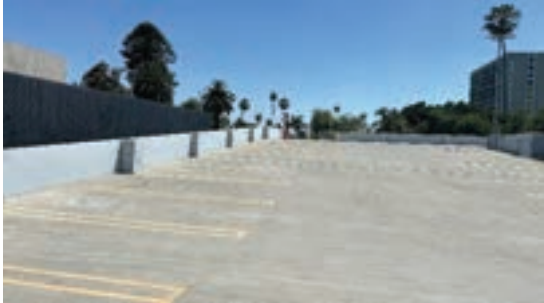
<p>The perimeter wall on the top deck of the parking garage is approx. 4' in height. There have been suicides occur at the RCC parking garage and the top deck measures in place do not provide any potential restrictions to stop suicides by jumping from occurring. The elevator landing sliding door on each level is glass, this is</p>	<p>Replace signage that is sun-bleached with new. Install video surveillance throughout the parking garage providing visibility of activity. Replace the glass elevator landing doors with more robust steel material, if visibility from within the cab is the desired intent consider doors that are a combination of steel (lower) and glass (upper) to reduce damage</p>	3
