Riverside City College Academic Senate

FINAL REPORT

Riverside Community College District (RCCD) has assigned Salas O'Brien Engineers, Inc. and Aanko Technologies (SOBE/Aanko) to conduct a comprehensive physical security program review of all District campuses to establish a baseline status that can be used as a foundation to develop, grow, and strengthen its District-wide physical security program to better protect and serve its communities. This security program review involves site visits, existing documentation evaluation and stakeholder interviews to evaluate physical components including security electronic systems, policies and procedures, socio-environmental conditions, training programs, and security staffing levels. The physical site assessments for all campuses were conducted during their typical hours of operation, before and after hours of typical operation, with the assumption that the security components and electronic systems were in good working order and functioning normally.

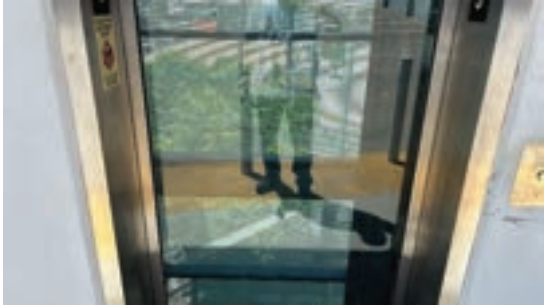
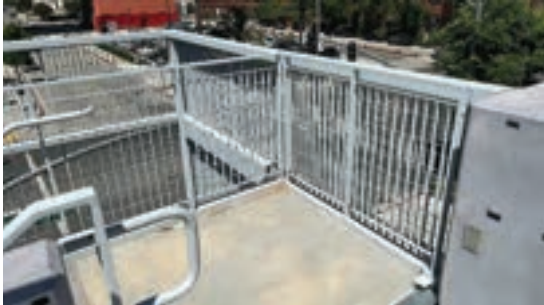
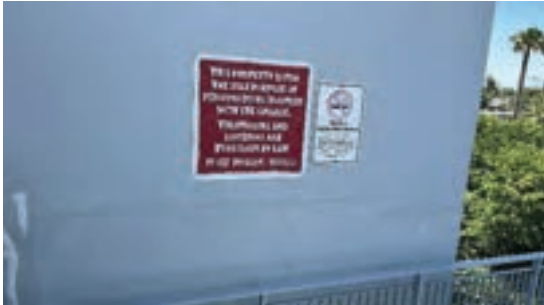
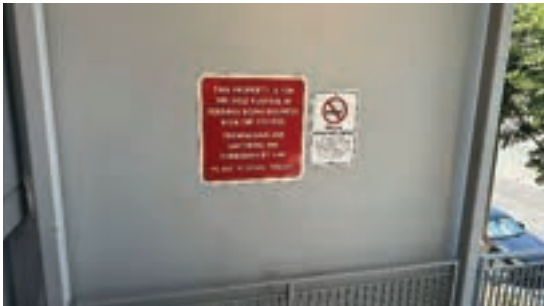
<p>unusual for this type of built environment setting. We were advised that the glass doors have required replacing causing negative operational impact on facility use and also causing expensive repair costs. Signage reference the use of the garage is displayed at each stairwell, signage that is exposed to direct sunlight for extensive periods of the day requires replacement as the text is difficult to read.</p>	<p>impact on operations dysfunction and continual increases in operating costs.</p>	<p style="background-color: yellow;">High</p>

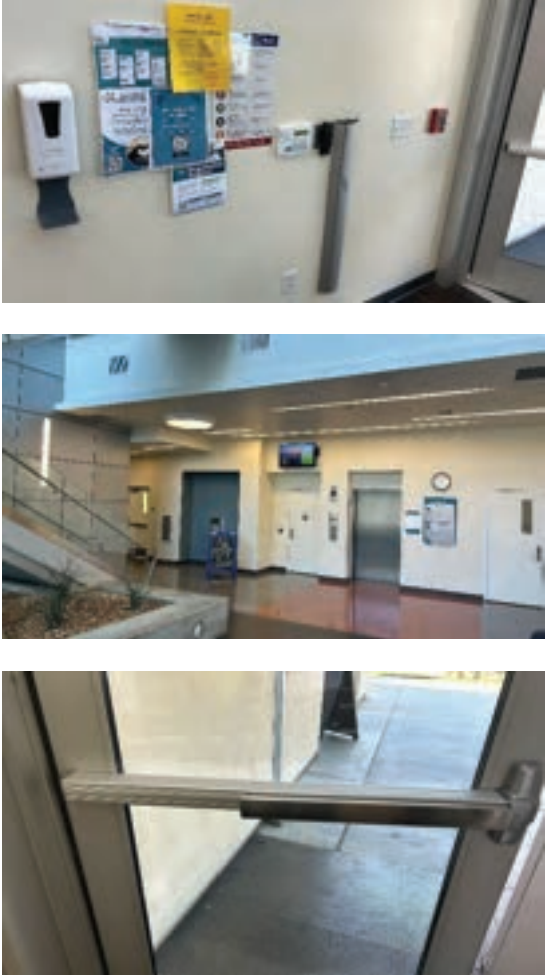
<p>intrusion system uses a security card reader adjacent to the DMP keypad. There is no video surveillance within the internal lobby area. The single main entry door does not fully close and latch upon closure. Review of the automatic door operator should occur. A Knox Box is installed on the exterior of the entrance. An emergency procedure chart is installed in the lobby area, these are installed typical across all classrooms.</p>		
21

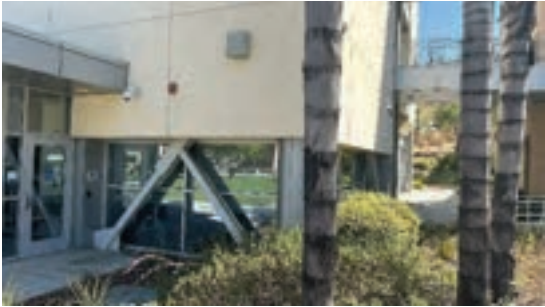
<p>Several fixed field of view video surveillance cameras are installed on the exterior of the south side of the SAS building. Cameras are installed consistently on each exterior level of the bridges leading from the Humanity Building. Replacement of these single field of view cameras with multi-sensor cameras would provide a significant increase of general camera coverage using existing cable and infrastructure.</p>	<p>Recommend replacement of cameras with newer dual head or multi-sensor cameras as part of a refresh program. The cameras currently are sufficed for monitoring of activity.</p>	2

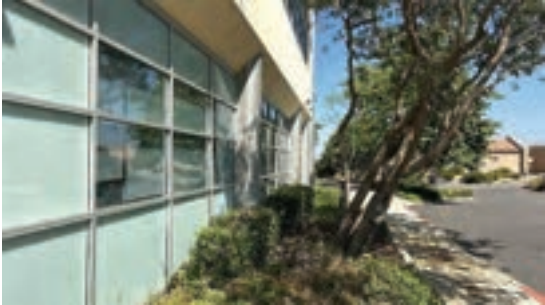
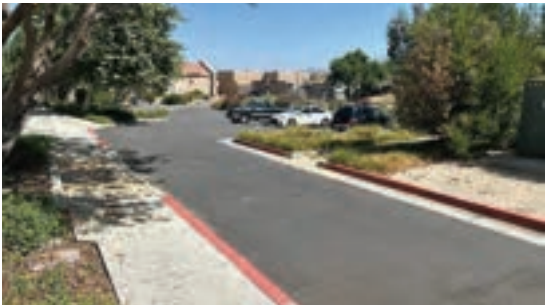
24

<p>Vehicle access to the rear of the SAS building is unrestricted. The emergency call station identification number is weathered, and the unit number cannot be easily identified. There is inconsistency in deployment of maps at call stations to help call users identify their location. Signage above doors is inconsistent in the size and font of text used, it is difficult to read from a distance. Video surveillance lacks consistency in application and edge device type installed.</p>	<p>Reference recommendation #15 regarding installation of vehicle barriers. Review programming and power at all emergency call stations with strobes, strobes should be illuminated at all times to draw attention to their location. This is a best practice approach that should be a district standard. Replace all sun-bleached signage with new, ensure all site signage is durable against human tampering and natural weather events. Apply door numbering that reflects emergency evacuation plans, use text, and finishes on signs that provide clarity and ease of reading.</p>	2

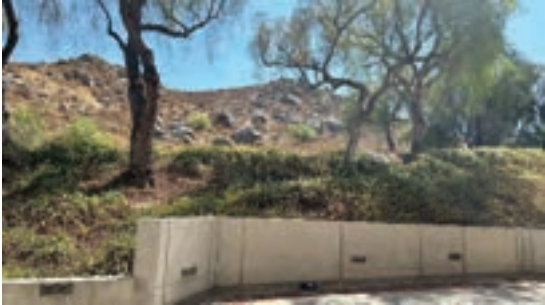
25

<p>The Humanities building is adjacent to an open space area which provides visibility into the building from a vantage point. There is no ballistic film applied to the existing glazing, and concerns were raised by occupants during a recent lockdown that visibility and exposure is concerning. There</p>	<p>Window treatments should be installed to restrict visibility from the public side, consider ballistic film. Glass should be selected and designed in accordance with relevant standards to meet the security requirements of the threat(s), threat locations and vulnerabilities identified in the</p>	3

ID#	PHOTO	OBSERVATION	RECOMMENDATION	RISK
	 	<p>are issues with protocols being followed as experienced in the recent lockdown drill with shelter in place instruction ignored by some participants.</p>	<p>site risk assessment. Create formalized policy and procedure regarding lockdowns and shelter-in-place, distribute and provide training for staff, students, faculty, and other campus users.</p>	
26	 	<p>The main entry into the Humanities building has no access control measures applied to it and there is no video surveillance monitoring general activity. There is no signage that clearly indicates our celebrates that this is the main access point into the building. The landscaping is excellent providing natural territorial reinforcement, with a good setback between pedestrian access space and the building perimeter. Glazing is treated with film reducing glare from the sun. There is no ballistic film applied to any of the glazing.</p>	<p>Reference recommendation #25 regarding glazing treatment. Install video surveillance to monitor general activity. Install signage that clearly defines the building function and drives users to the main entry point.</p>	3

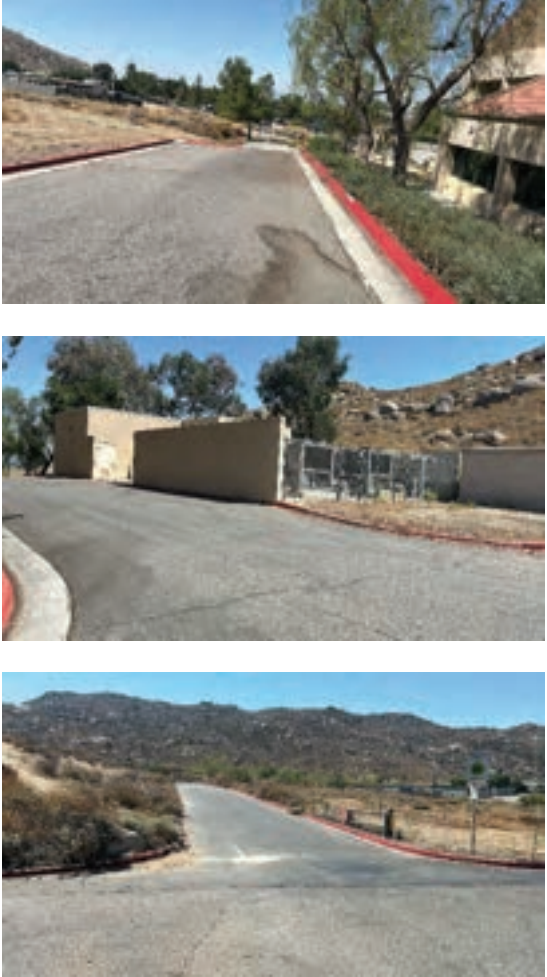
<p>Example of potential unrestricted vehicle access adjacent to the Humanities building. HVAC equipment is secured behind chain-link fencing and gates. There is no video surveillance on the exterior of the Humanities building, providing situational awareness and forensic viewing capability of activity. Video surveillance camera installation across campus is sporadic in its placement with many areas that have zero coverage.</p>	<p>Reference recommendation #15 regarding installation of vehicle barriers. Install video surveillance.</p>	2

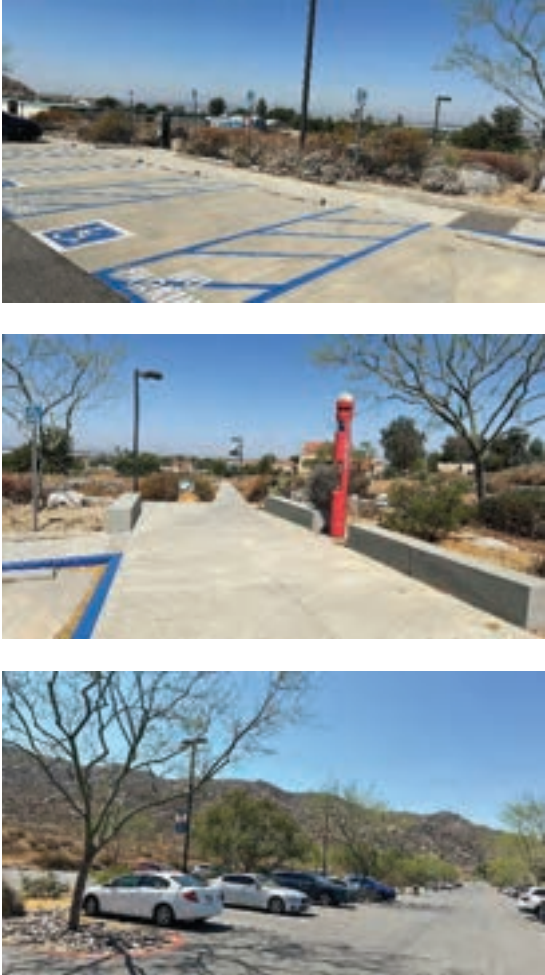
<p>ADA parking spaces at the upper parking lot adjacent to the portable classrooms are marked with paint signage on the tarmac and physical signage. There is an emergency code blue tower and LED cut off lighting adjacent to the ADA access path. There is no video surveillance installed. Lighting luminaires are down cut-off, some luminaires are obstructed by tree canopies that are below them. This may impede the effectiveness of the lighting distribution.</p>	<p>Review programming and power at all emergency call stations with strobes, strobes should be illuminated at all times to draw attention to their location. This is a best practice approach that should be a district standard. Perform periodic landscaping maintenance to trim tree canopy overgrowth and areas of obstruction of lighting. Utilize CPTED best practices.</p>	4
30

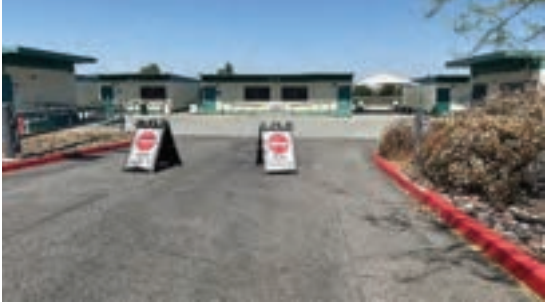
<p>Access into the tarmac area at the portables is unrestricted with A-frame signage indicating that the road is closed. The A-frame signs serve no purpose if a vehicle were to consider entering the space they could easily move them. The swing arm barrier is open, should be closed, and locked to restrict vehicle access if this is intended.</p>	<p>Close and secure the swing arm barrier, A-frame signage can remain as a means of communicating that access is closed.</p>	2

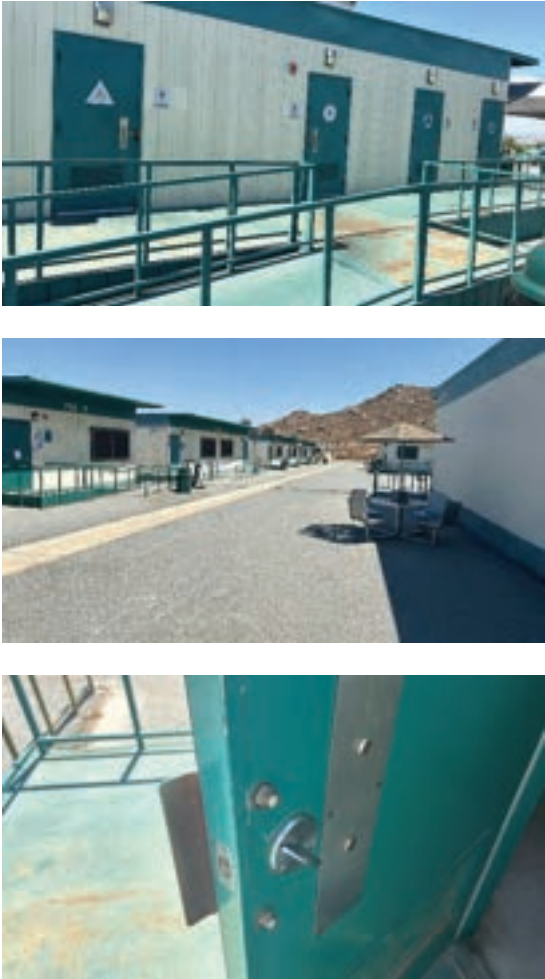
<p>Restrooms at the PSC area are accessible via brass key only with the student and public restrooms unlocked manually on schedule. The internal deadbolt levers have been disabled these should be removed completely. There is no internal or external public address that provides communication if a lockdown has been activated. There is no emergency phone tower located in this area and zero video surveillance.</p>	<p>Consider installation of a Code Blue emergency phone tower at this location which encounters heavy foot-traffic. Use the emergency tower for deployment of a multi-sensor camera providing visibility of activity at the phone and surroundings. Use a multimodal communication system (e.g., mass notification, public address, cell phones, pagers, panic buttons, etc.) that notifies all building occupants of threats and provides emergency instructions. Ability to notify restroom occupants when an emergency event or lockdown has been activated is important. Install a public address system(s) that can verbally advise building occupants of the appropriate action (e.g., evacuate, shelter-in-place) to take in any event.</p>	4

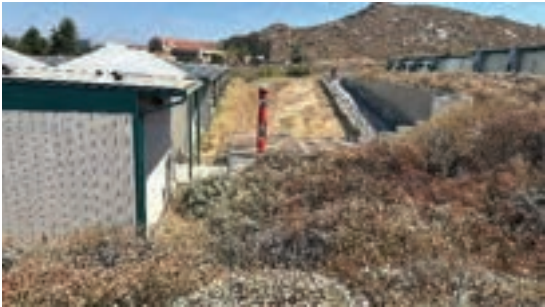
<p>Emergency call phone is located in an obscure location difficult to locate from the upper PSC buildings. There is zero video surveillance monitoring activity of general activity or when a call is placed at the call station.</p>	<p>Provide signage that directs campus users to the emergency phone location if needed. Use text and finishes on signs that provide clarity and ease of reading. Use the emergency tower for deployment of a multi-sensor camera providing visibility of activity at he the phone and surroundings.</p>	2
36

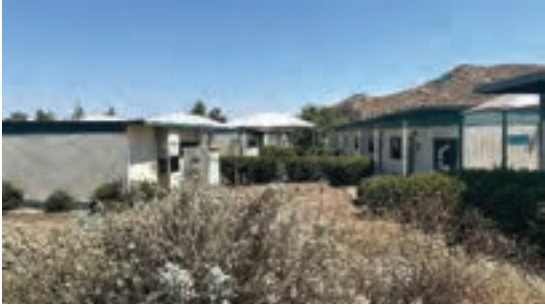
<p>The height of the ground coverings is above CPTED recommendation of 2' and provides an area of concealment for bad actors. Visibility form within the classrooms is minimal.</p>	<p>Perform periodic landscaping maintenance to reduce ground covering overgrowth and areas of concealment. Utilize CPTED best practices.</p>	2

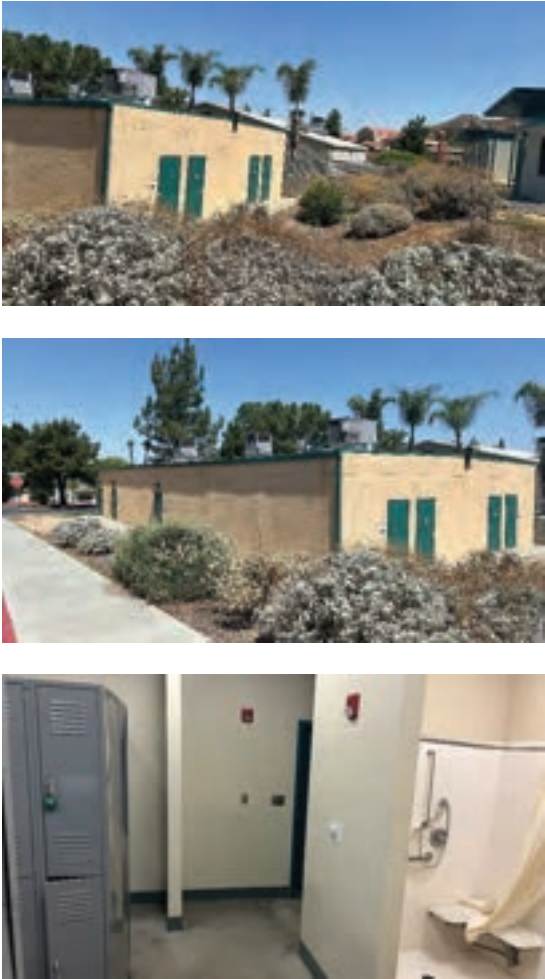
<p>Access to the multiple purpose room (MPR) is using a brass key, there are no access control measures oat the building. It is monitored with intrusion detection. The rest and locker rooms are open for general public. Use, this presents risk as there been instances of homeless persons using these facilities without authorization. The facilities are also open to public use when the sports field are in use. The college allows use of their facilities rather than provide porta-pottys for public convenience. There is no video surveillance in use monitoring general activity. The Facilities Dept. standalone Panasonic VMS does not capture the entry points of the MPR.</p>	<p>Install access control to support remote locking and unlocking of the facility; install video surveillance to the exterior monitoring general activity, and interface with controlled openings for alarm event camera call-up. Review operational needs and consider use of porta-pottys for public use mitigating college risk and liability of unrestricted access for use of facilities by the public.</p>	4

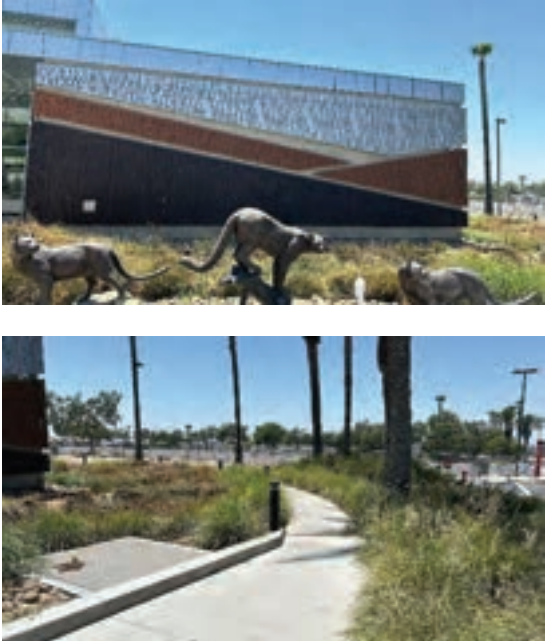
<p>Signage on the Welcome Center (WC) blends into the metal façade making it difficult to identify the building name. The pedestrian sidewalk is well defined and set back from the building with bollard lighting. Ground covering is above the 2' recommended CPTED landscape ground covering height but does not provide support of natural territorial reinforcement and access control.</p>	<p>Review the building identification signage, text size, style, color, and font should be consistent across campus to generate a sense of culture, belonging, and identity. The WC signage is non-descript and should be prominently identifiable by campus users.</p>	3
39

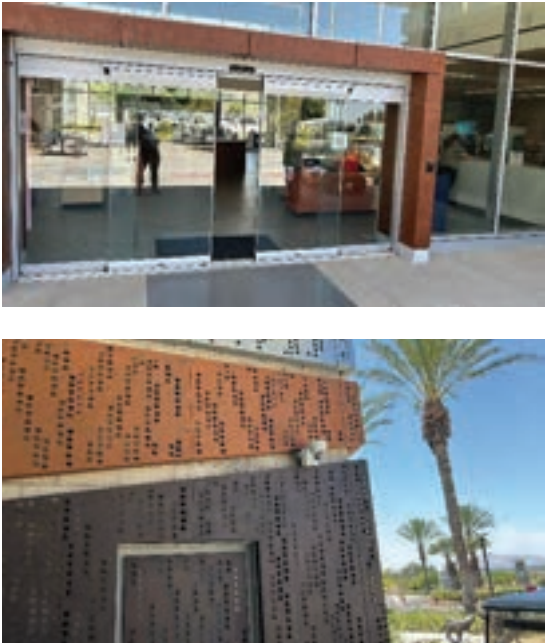
<p>The WC main entry sliding doors are controlled on the access control system with a card reader providing entry via security credential when doors are locked. The video surveillance camera mounted on the exterior of the entry is not focused on the main entry door.</p>	<p>Adjust the existing camera lens to capture activity at the exterior opening to the WC. Replace if needed with a dual-head camera with one lens fixed on the entry.</p>	1

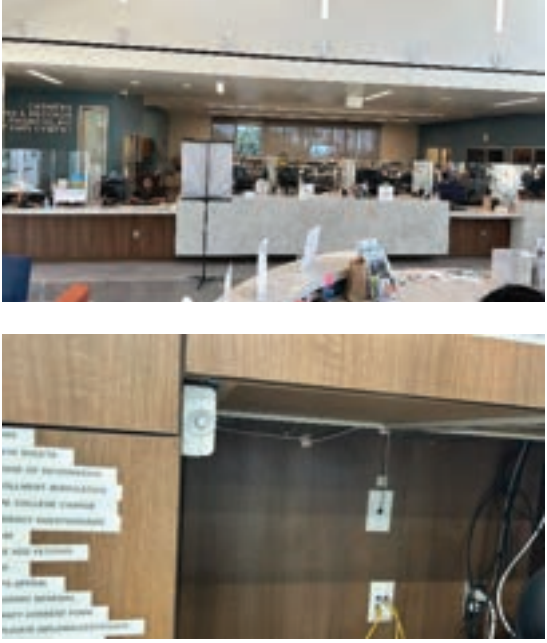
42

<p>Cashiers' office staff and back of house space is accessible via access control only. Video surveillance cameras are monitoring general transaction activity at the counter. There is a plastic screen along the counter that was installed during the pandemic that provides some means of barrier between public and the staff. There is no roller shutter to secure the space after hours. Panic buttons are momentary release installed ad hoc under the transaction desks.</p>	<p>Consider deployment of hardwired panic buttons at all transaction workstations. Recommend replacement of the plastic screen with fixed glazed transaction pass through windows per the cashiers' office. Provide a physical barrier between staff and public. At minimum, a roller grille should be installed to allow compartmentalization of the space and eliminate the open nature currently observed.</p>	3

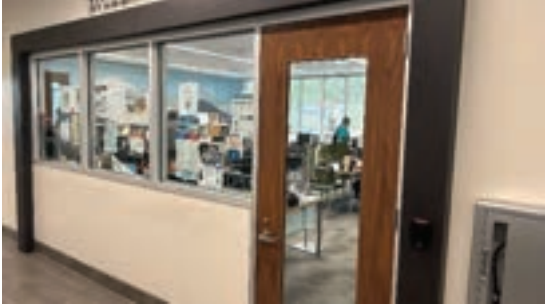
<p>The controlled corridor entry door leading into the student engagement center does not positively latch. There are exterior window treatments installed, but no window treatments on the corridor facing glazing or door. The card reader is installed in a location within the door swing, which is not best practice, as it could potentially result in the door hitting someone on exiting if a person is presenting a credential to access.</p>	<p>Conduct a maintenance review to correct the door operation ensuring that there is flush fit within the frame and positive latching upon closure. Security design standards should provide direction that card readers where possible are not installed within the door swing or on the hinge side. Window treatments should be installed to restrict visibility from the public side, consider ballistic film. Glass should be selected and designed in accordance with relevant standards to meet the security requirements of the threat(s), threat locations and vulnerabilities identified in the site risk assessment.</p>	4

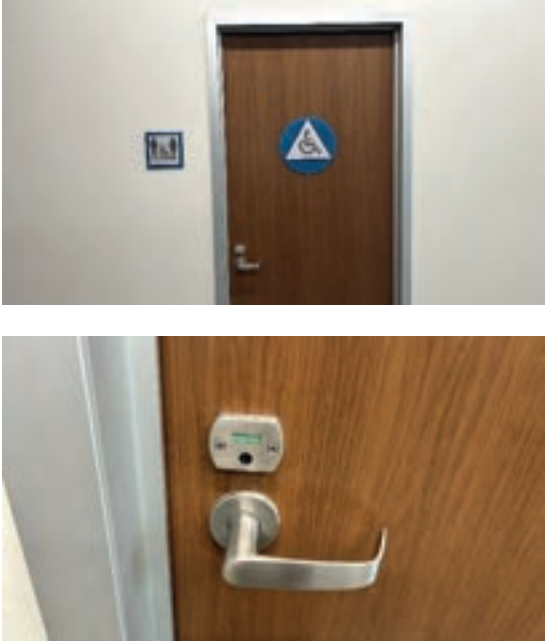
<p>The single stall restroom door hardware allows securing of the door from the interior, there is a privacy indicator notifying that the stall is in use.</p>	<p>General observation, this is a good example of appropriate hardware at this type of room function.</p>	0
49

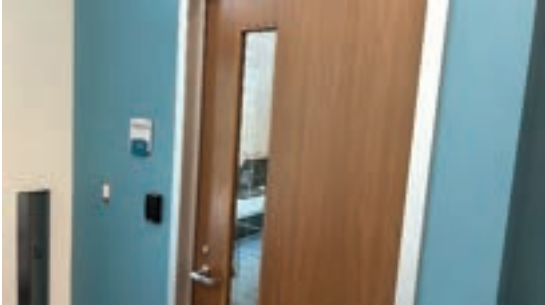
<p>Break Rm. 180 is access controlled. This is a good example of access control application that should be standard at all staff/faculty break rooms. Exterior windows are equipped with window treatments and obscure visibility from the exterior in.</p>	<p>General observation, this is a good example of appropriate security measures at this type of room function.</p>	0
50

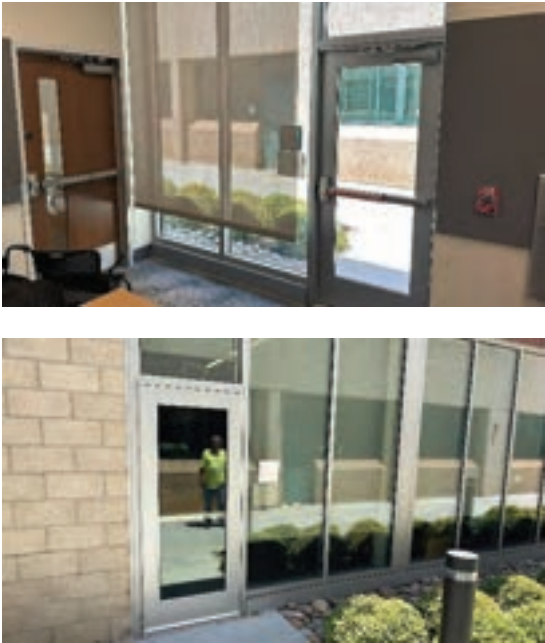
<p>Classroom 171 has an exterior door that appears to have a local door alarm installed within the trim itself. Signage indicates that the alarm will sound upon exit. This door does not appear to be monitored within the access control system and if activated the alarm sounds locally only. There is no signage identifying the door number on either side of the door, the opening is egress only with no trim or key cylinder installed on the exterior.</p>	<p>Replace all battery (assumed) local alarms with hard wired, eliminate potential lack of power monitoring and battery replacement issues that standalone and wireless devices present. Apply door numbering that reflects emergency evacuation plans, use text, and finishes on signs that provide clarity and ease of reading. Remove signage that is incorrectly describing action that does not occur when the door is opened.</p>	3

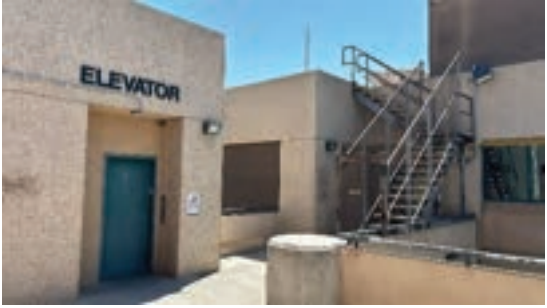
<p>Exterior roof access stairs are accessible behind a padlocked gate leading up to the Science building rooftop. The stairwell gate can easily be scaled. The elevator remains unlocked 24/7 with locking/unlocking on schedule mechanically or remotely available. Video surveillance is lacking in this area to provide visibility and serve as a deterrent to people who may be considering bad behaviors.</p>	<p>Install a multi-sensor camera to provide visibility of activity with a single device housing four lens. Use analytics to identify activity at the stairwell providing camera call-up on motion. Consider interfacing the elevator controls with the access control system to allow remote locking and unlocking of elevator access on schedule. Unrestricted 24/7 access provides unmonitored areas of concealment for bad actors.</p>	3
60

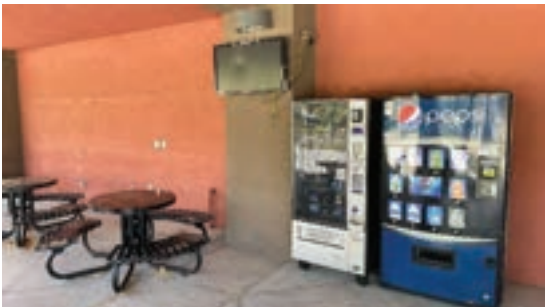
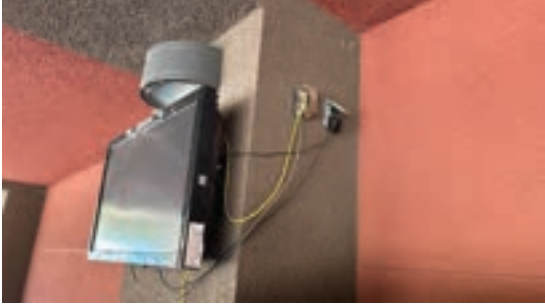
<p>The seating area outside of the Cafeteria has two wall mount monitors that are non-operational, network and power cables are easily accessible. The seating area provides opportunity for eyes on activity and natural surveillance. The vending machines have been vandalized with no recourse as</p>	<p>Remove or reinstate the monitors to an operating state that supports Rave Alert notifications to be displayed when made. If the monitors are deemed no longer needed, remove all associated cable, and close the network data port to avoid potential cyber penetration attempts by direct</p>	4

<p>there is no exterior video surveillance monitoring activity that can be used forensically. Potential risk to the district network could occur as there is unsecured access to data ports available on the public side of the building, it is assumed that the data ports are not active.</p>	<p>network cable connectivity. Vending machines should be monitored by video surveillance in case of theft or vandalism forensic review needs.</p>	
61

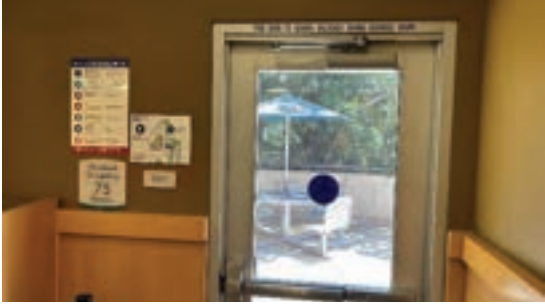
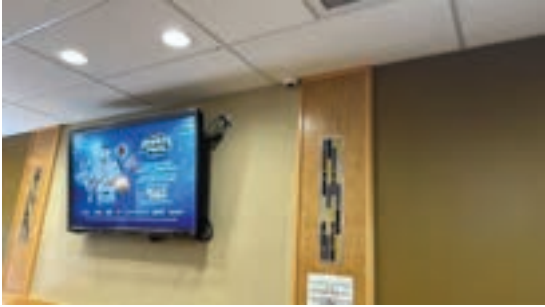
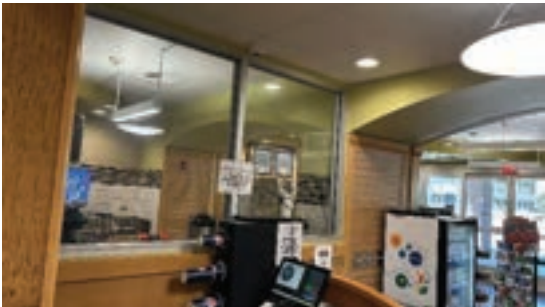
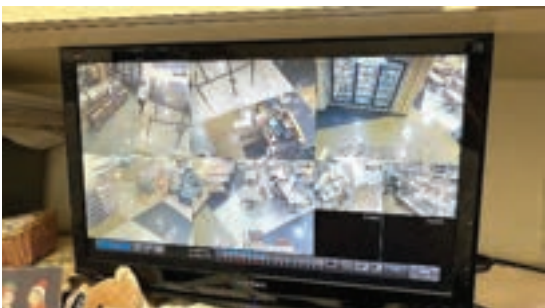
<p>Exit doors at the cafeteria have signage on them indicating that these doors are to remain unlocked during business hours. Free egress is always maintained. Panasonic video surveillance cameras are installed within the cafeteria primarily observing the point-of-sale transactions. The camera system is local to the café only and video can be observed in the food services manager office. The Panasonic video system is storing approximately 10-days video.</p>	<p>Recommend that all video surveillance cameras in use across campus be district provided, eliminate standalone local departmental systems that have not been approved by district for use. Potential privacy and liability issues that should be owned by the district i.e., storage parameters. Recommend that video storage be centralized and not local.</p>	3

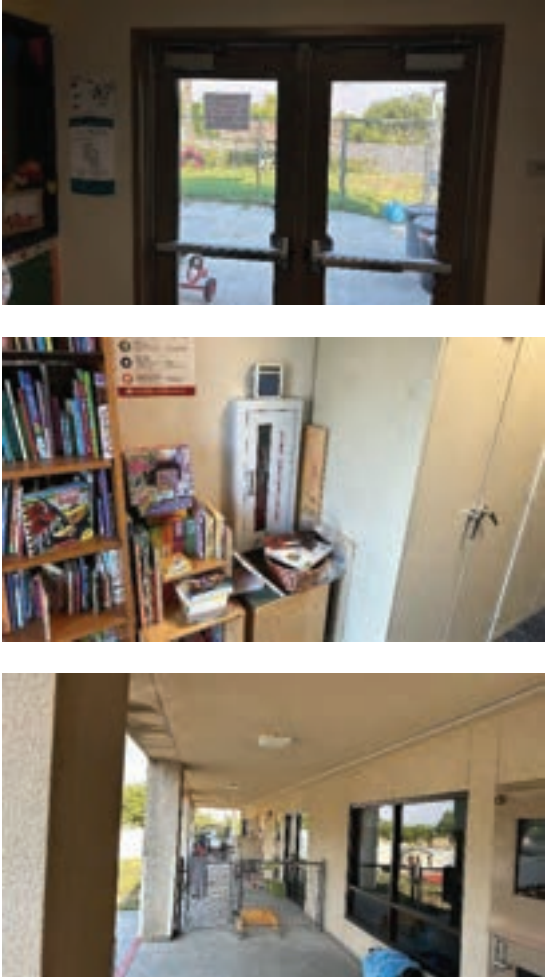
<p>Exit doors are monitored after hours when armed by the intrusion detection system. The doors can be dogged from the interior. The fire alarm extinguisher was obstructed by storage units restricting ease of access, this is not compliant with code. The playground overhang area provides cover for the homeless to occupy, staff confirmed issues with trespass and finding trash and other paraphernalia frequently. There are no trespass or regulatory signs installed. Members of the public have been observed looking into the playground from the exterior vantage points.</p>	<p>Remove the dogging feature of exterior facing doors. Remove storage items that obstruct the accessibility of the fire extinguisher. Install exterior fixed signage that clearly defines playground usage, apply regulatory bylaws and penal code that support prosecution of trespass and unlawful activity. Use text and finishes on signs that provide clarity and ease of reading.</p>	3

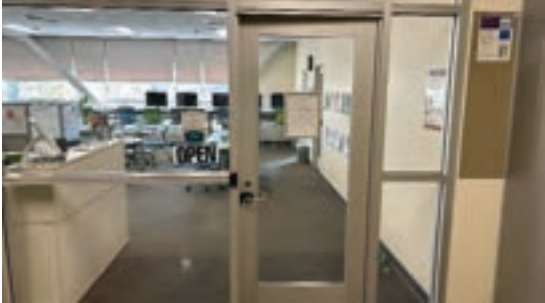
<p>Room 206 is equipped with access control measures; the door was held open using a lock blok band. There is no internal corridor window treatments applied to the interior side. There are window treatments on the exterior glazing.</p>	<p>Remove the lock blok band and replace with a lock blok. Bands should not be used as they require opening of the door to remove, a step that is not required when using the lock blok. Consider installation of window film on all door window vision and side panels to restrict visibility in from the public side, frosted film would minimize impact on natural light and does not require to fill glazing from bottom to top.</p>	2

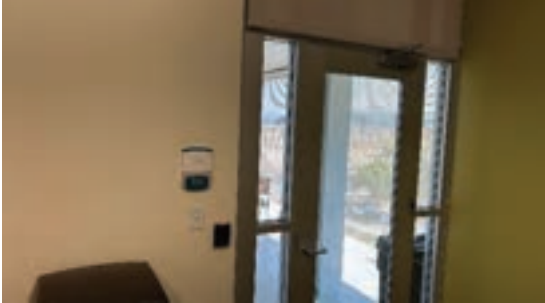
73

<p>Facilities department lounge on level 3 is accessible by access control credential. There is a controlled entry providing access to the patio, free egress is maintained at all times, no video surveillance is present. Exterior card readers are redundant and should be removed. There is no exit sign above either of the patio egress doors. All office doors are access controlled with no visibility with video surveillance of corridor activity available. The IDF houses the Software House access control system server, a</p>	<p>Install video surveillance at the patio to provide situational awareness monitoring. Observation of the office corridor is also recommended. Review AHJ needs to identify egress openings and apply 'Exit' signage if required.</p>	1

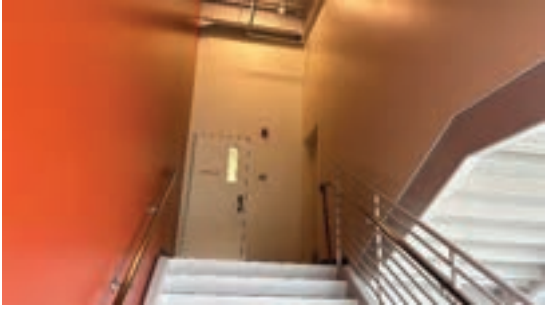
ID#	PHOTO	OBSERVATION	RECOMMENDATION	RISK
74

<p>Stairwell entry provides exit on the first floor only. There is no signage providing instruction to exit at the first level. Signage on the door does indicate that no reentry is possible. Access to the roof space is access controlled. There is no video surveillance monitoring activity within the stairwell.</p>	<p>Install signage reinforcing the operational intent of egress at the first floor only upon entering the stairwell. Video surveillance is recommended in all stairwells where concealment by bad actors could occur.</p>	2
75

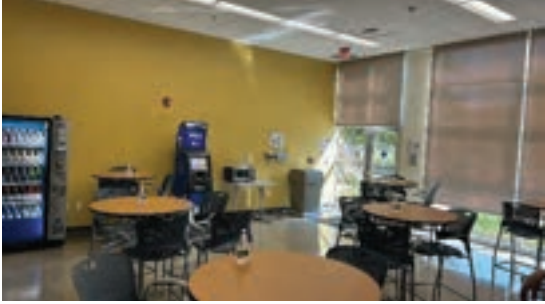
<p>An ATM in the SAS cafeteria area is visible from the public side at night. There is no video surveillance monitoring either ATM transaction activity or general exterior activity.</p>	<p>Consider installation of window film on all door window vision and side panels to restrict visibility in from the public side, frosted film would minimize impact on natural light and does not require to fill glazing from bottom to top. Frosted film also restricts visibility at night when lights reverse the reflective capabilities of other films. A video surveillance camera should monitor ATM activity.</p>	2

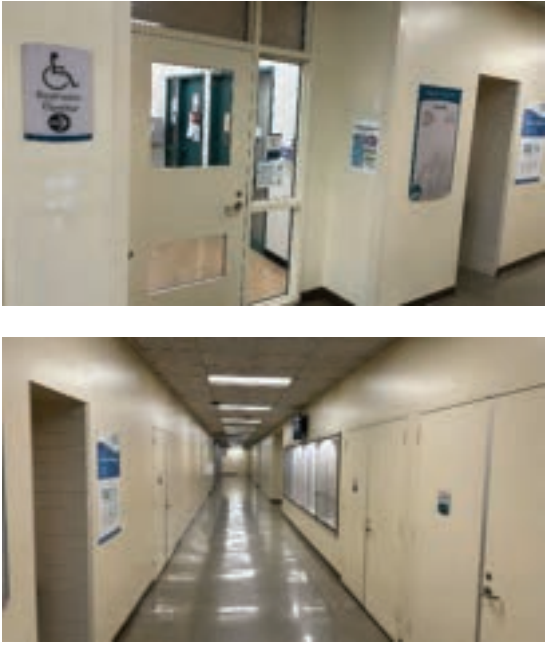
76

<p>The faculty offices at the Humanities building are not controlled with access control. Brass key is required to access each individual faculty office. Window treatments are installed covering the office door window vision panels, the main entry glass has no window treatments applied. Internal video surveillance is not present.</p>	<p>Install spyholes in office doors to allow verification visually of person(s) in the office lobby area. Video surveillance camera installation would provide situational awareness and forensic review capability.</p>	2

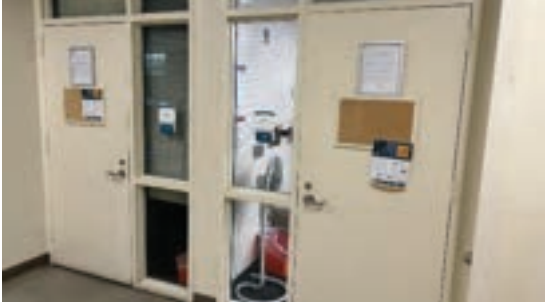
77

<p>Inconsistency in the application of window treatments is illustrated at classrooms 108 and 110. One room has visibility restricted and the other not (108). At the time of assessment room 108 was occupied with a class, the door was not fully closed and secured, and the door was resting on the lock blok. This is not the operational expectation of door position during class at the campus.</p>	<p>Formalize operational status of door positions and communicate and train staff to reinforce positively the intent of expectation from a safety and security perspective. Review door window vision panels and consider a standard application of district provided visibility considerations. Currently there are individual staff/faculty measures in place that do not present a controlled and consistent approach to security.</p>	4
78

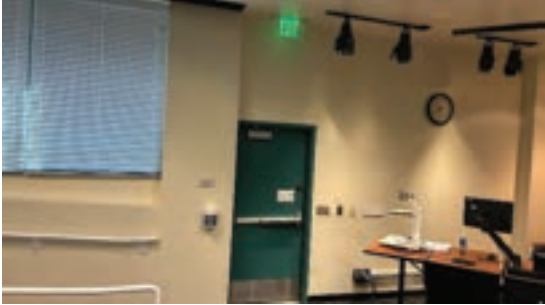
<p>The egress opening at lecture room 109 is equipped with a lock blok. There is no need for a lock blok to be installed on egress only doors as they can incorrectly be propped open providing vulnerability to the space.</p>	<p>Remove the lock blok, egress only doors should not have lock blocks installed.</p>	3

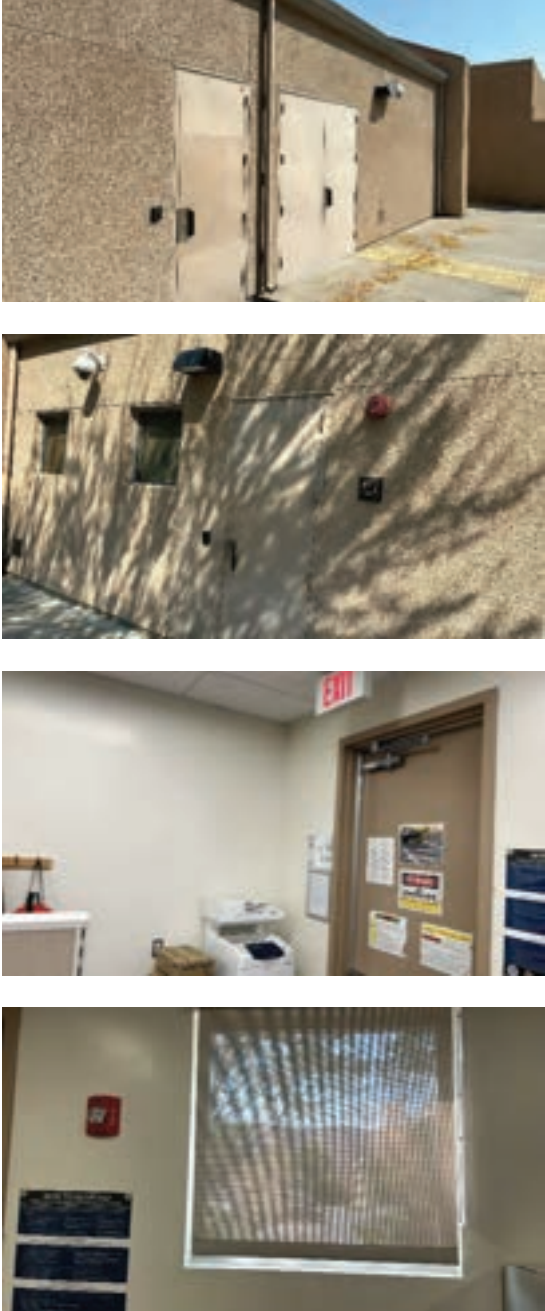
<p>The Network Operations Center (NOC) is discrete in appearance and access is controlled through restricted permissions. Access control card readers provide authorized entry at two openings, PTZ video surveillance cameras monitor general activity. There is uncertainty of who has video viewing access, and split opinion on if the cameras are operational or not. One camera is mounted adjacent to a wall mount enclosure and field of view obscured. There is no viewing monitor installed on the secured side, and no spy hole in the door to allow visibility of persons attempting/requesting entry. Windows do have window treatments applied. The building is monitored on an intrusion detection system that can be armed and disarmed at several locations within the building.</p>	<p>Review the existing video surveillance cameras and confirm if operational or not, replace if non-operational. Provide internal viewing capability. The non-discrete appearance of the building is appropriate and does not draw attention to itself.</p>	2

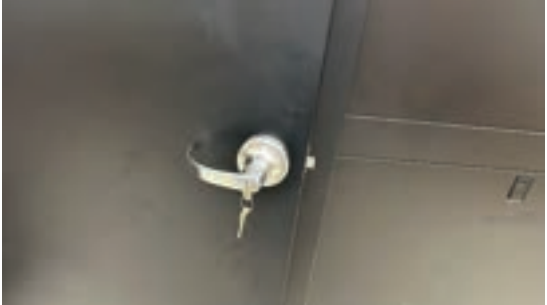
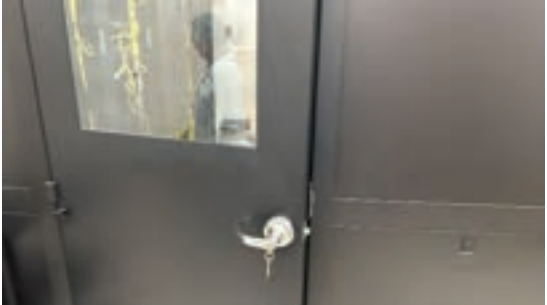
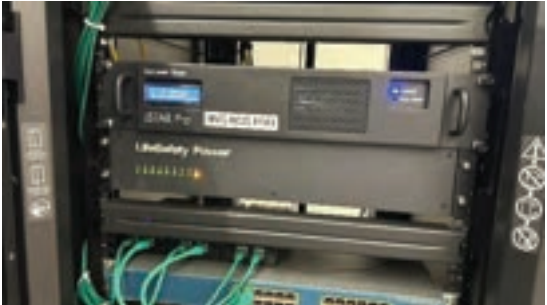
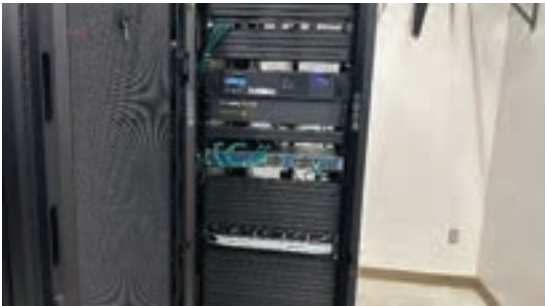
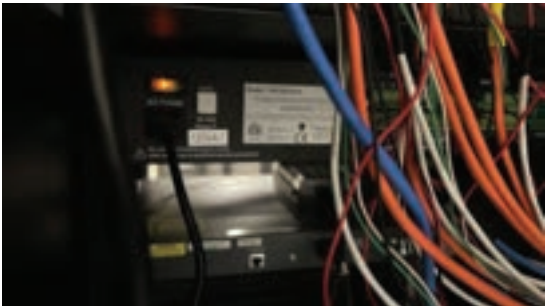
ID#	PHOTO	OBSERVATION	RECOMMENDATION	RISK
82	 	<p>Access into the network equipment control room is restricted permissions. Within the space there are several video surveillance cameras. Equipment racks were not secured and observed with keys in the cylinders and some racks unlocked and unmonitored. Security head-end servers are installed within the space.</p>	<p>Racks and enclosures should remain closed and locked, access to these should be restricted key issuance. Recommend installation of a lock box inside the secured space with code required to access keys. Keys should not be available for use by unauthorized persons if they breached the access control measures.</p>	1

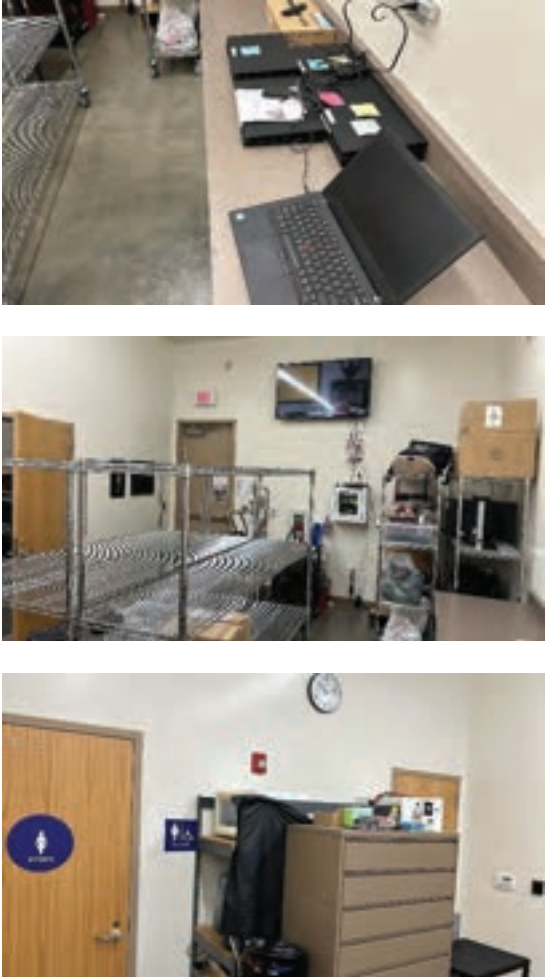
<p>The Emergency Operations Center (EOC) is in its infancy and currently equipment and space layout is under development. Laptops with role specific information are under profile creation, the space is equipped with restrooms, HVAC, generator back-up and is able to support a prolonged emergency response scenario. Television access to news channel feed and a white board for incident management are available.</p>	<p>Consider display of the proposed physical EOC layout via a wall map/sign similar to evacuation plans, supporting efficiency in setting up a physical workspace when required.</p>	2
84

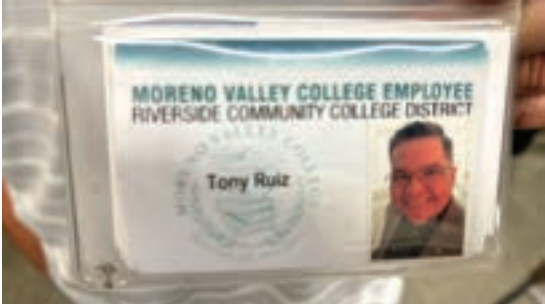
<p>Identification badges are not mandated to be worn and displayed by staff and faculty. ID badges are not issued with a photograph, the example provided has been created by the provider to display his photo image.</p>	<p>Review policy and protocol regarding issuance and display of staff/faculty identification badges. Lack of identity badge policy and display makes it challenging to identify persons who belong on campus in positions of authority etc. There is no standard process in place across RCCD that provides a common expectation and ease of identification of college/district/campus staff and faculty. ID badges can create a sense of belonging, community, and encourage approach by students in need of identifying college personnel who they need to engage when</p>	3

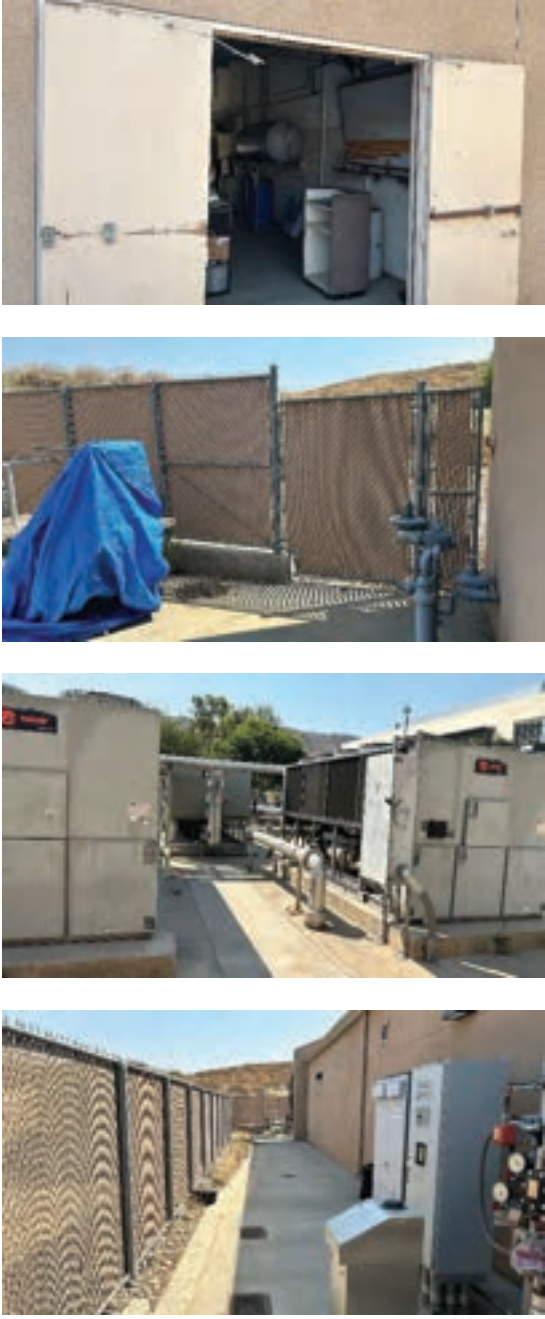
<p>The first photo shows an open white storage door leading to an interior area with various equipment. The second photo shows a chain-link fence gate with a blue tarp in the foreground. The third photo shows an outdoor area with power generator units and associated piping. The fourth photo shows a fenced-in utility area with electrical equipment.</p>	<p>Access to the power generator area is easily achieved by scaling the perimeter chain link fence. Storage areas are unlocked and remain in this state 24/7. There is no video surveillance coverage of the general area which has experienced equipment theft including a golf cart.</p>	<p>Install video surveillance to provide deterrent and monitoring capability. Secure open storage areas to restrict ease of unauthorized access, consider monitoring the access gate for position with a position monitoring contact connected to the access control and intrusion detection systems.</p>	2

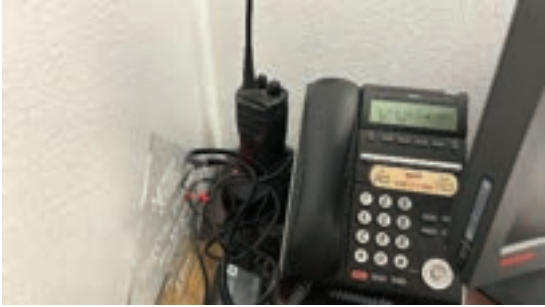
86

<p>NEC telephone handsets are available in faculty and staff offices only, they are not provided typical within classrooms. The phones do not support intercom capability and are near end-of-life. The district NEC PBX is to become unsupported by NEC at the Fall period, this may impact communication performance significantly.</p>	<p>Consider provision of VoIP telephones in all classrooms and learning areas. Reliance upon personal cell phones for communication purposes has risk if there is a cell coverage issue. Consider a Cisco or similar solution with new handsets that support wide area broadcast with intercom capability.</p>	4

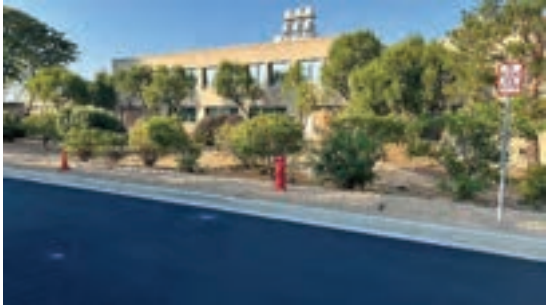
<p>Rodeo Road was recently resurfaced, the blue tarmac reflector indicate the location of the fire hydrant. Signage indicates that this is a fire access road and parking is not permitted, this is a single sign along the roadway.</p>	<p>Recommend that the curbstone be painted red to indicate a fire lane and no parking permitted. This may not be a requirement as the campus is private property, but consistency with other areas of campus is encouraged.</p>	1
2

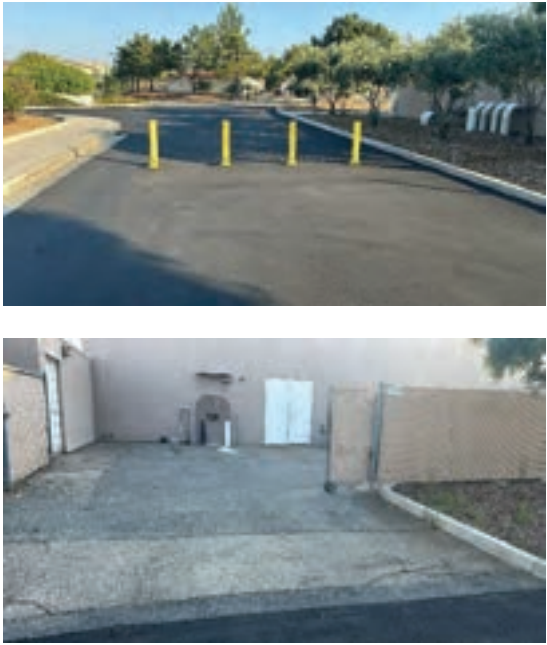
<p>Removable bollards are secured with padlocks and keys to the bollards are located within the wall mount Knox box. The roller gate at F1 building is chain-link and approximately 6' in height. There is a gap underneath that provides ease of access via crawling underneath, there is no video surveillance monitoring activity that would allow for use of analytics to identify unusual activity.</p>	<p>Consider future chain-link fencing and gate heights to be a minimum 8' with ability to crawl underneath eliminated. The removable bollards and Knox box are excellent measures restricting unobstructed vehicle access around campus. Install video surveillance for situational awareness and forensic viewing capability.</p>	2

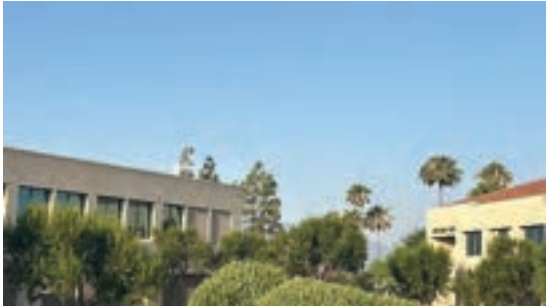
3

<p>A siren system is installed on top of the Science and Technology (ST) building. This is the predominant exterior means of communication in an emergency situation with canned messaging programmed for annunciation. There is ability to annunciate verbal communication manually from the control location in the Operations Center (OC). This system is tested quarterly.</p>	<p>The availability of mass communication is excellent, this is restricted to the exterior only. Consider use of a multimodal communication system (e.g., mass notification, public address, cell phones, pagers, panic buttons, etc.) that notifies all building occupants of threats and provides emergency instructions. Telephones are installed internally across campus although the intercom feature is not supported by the current system set-up. Consider use of new handsets that support intercom functionality</p>	0

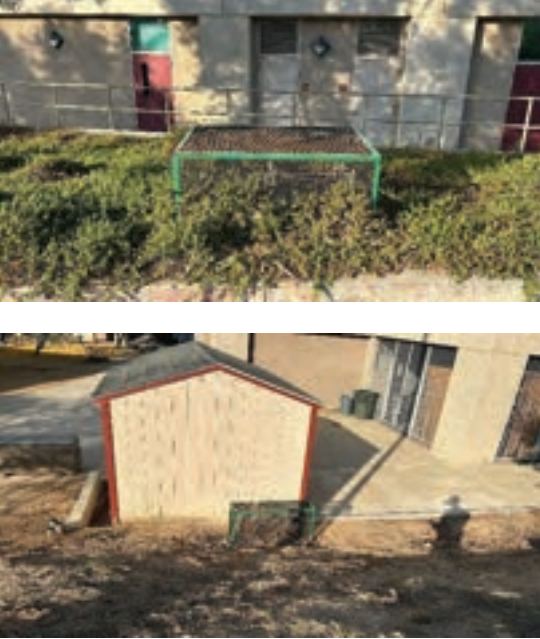
The water main is protected with a metal cage. This cage is difficult to remove to perform maintenance work as the ground covering has grown through and within it making movement of the cage challenging.	Consider securing access to the mains with a breakaway lock on the protective cage cover. Refer to local AHJ for access compliance issues. Perform periodic landscaping maintenance to reduce ground covering overgrowth to below 2', perform immediate action to clear the overgrowth impacting the existing cage. Utilize CPTED best practices.	1
