Riverside City College Academic Senate

FINAL REPORT

Riverside Community College District (RCCD) has assigned Salas O'Brien Engineers, Inc. and Aanko Technologies (SOBE/Aanko) to conduct a comprehensive physical security program review of all District campuses to establish a baseline status that can be used as a foundation to develop, grow, and strengthen its District-wide physical security program to better protect and serve its communities. This security program review involves site visits, existing documentation evaluation and stakeholder interviews to evaluate physical components including security electronic systems, policies and procedures, socio-environmental conditions, training programs, and security staffing levels. The physical site assessments for all campuses were conducted during their typical hours of operation, before and after hours of typical operation, with the assumption that the security components and electronic systems were in good working order and functioning normally.

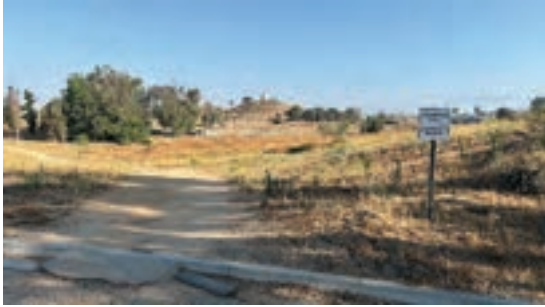
The campus backs up to the Naval Base which is separated by perimeter fencing. There is understood to be an MOU agreement with the Navy that allows emergency access onto base in the event of an emergency. This access requires County Sheriff engagement to accompany the access onto the base if needed.	Review and ensure that an MOU is still in place. If not engage appropriate stakeholders, review, revise, and implement to ensure that the evacuation route and protocol is agreed and understood by all parties.	4
10

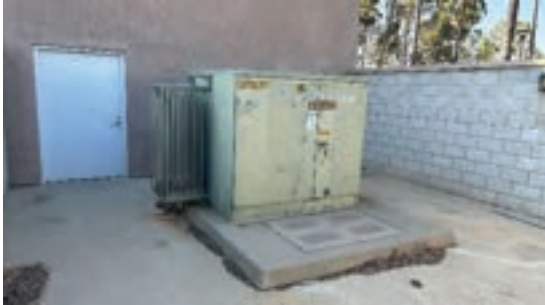
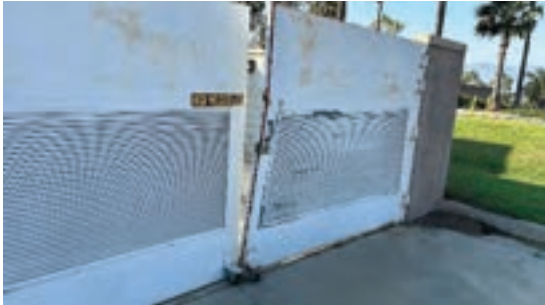
The high voltage electrical transformer is accessible as the enclosure gates are damaged and appear not to close fully and securely. As observed at the chiller there is no video surveillance.	Perform corrective action to ensure that the gates close and can be secured, eliminate the risk of danger of unauthorized entry. A single multi-head camera corner wall mounted would support visibility of several areas within and adjacent to the enclosure. Install signage on the exterior of the enclosure indicating danger.	3

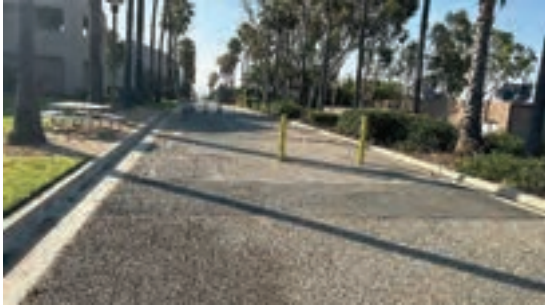
11

The removable bollard is removed for ease of access around campus by the facilities and maintenance teams. The bollards serve as a secondary means of vehicle restriction as the new bollards identified in observation #2 are the primary vehicle controls.	Reinstall the bollard when facilities and maintenance access is not required. Permanent removal suggest lack of responsibility and ownership of security measures. An inadvertent presentation of security posture vulnerability may suggest there are others to potential bad actors.	1

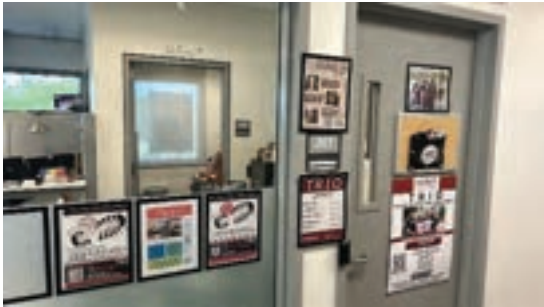
<p>Student Support Services office #207 door was unlocked and can be placed into this state by presenting a security credential with permissions to unlock and lock using the two-time presentation approach. There is no internal corridor facing window treatment installed with unrestricted visibility from the corridor into the space. There is a video surveillance camera in the corridor that provides monitoring of general corridor activity, there is assumption that many of the campus cameras are non-operational.</p>	<p>Window treatments should be installed to restrict visibility from the public side, consider ballistic film. Glass should be selected and designed in accordance with relevant standards to meet the security requirements of the threat(s), threat locations and vulnerabilities identified in the site risk assessment.</p>	2

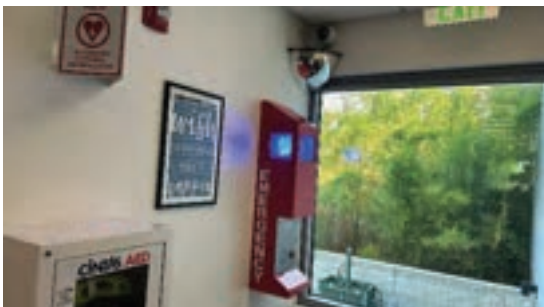
22

<p>An external emergency call box installed internally appears to present challenges for ADA access. The ability for a wheelchair user to access the call box without obstruction is challenging. Video surveillance cameras are installed monitoring corridor activity, see observation #21 reference operational state assumptions. Office doors are equipped with access control measures but appear to function in an</p>	<p>Reference recommendation #16 regarding mounting implications of emergency call stations on interior walls. Recommend that access-controlled offices remain closed and locked at all times, the application of access control presupposes that the intent is for the space to be secure and not accessible to the public. Create district signage standards that present a familiar feel across all RCCD campuses.</p>	3

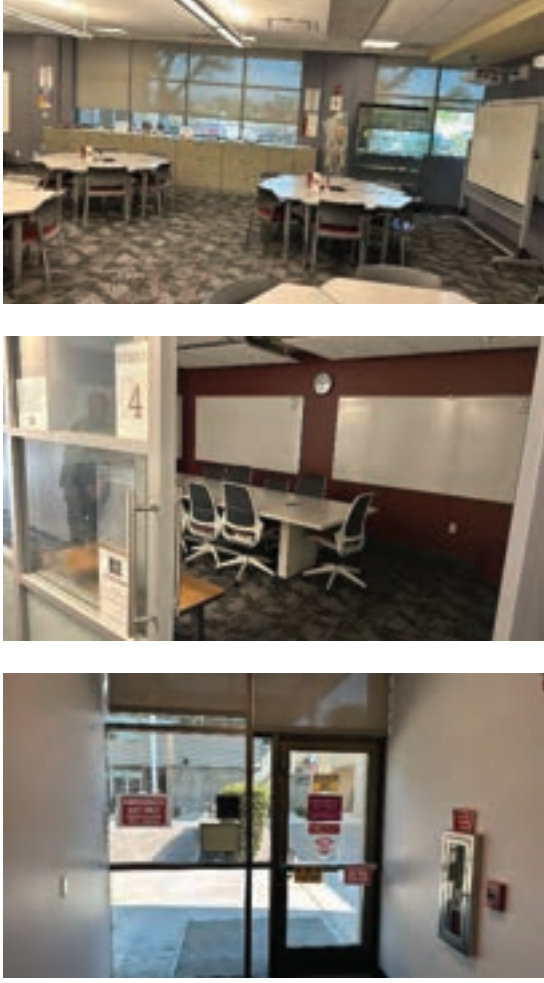
<p>The LIBR Learning Resource Center level one access into the space is through doors that are propped open but remain in a locked state. The LIBR building has obvious high risk issues regarding lockdown as the lack of electronic hardware eliminates remote lockdown capability. There are minimal areas to shelter-in-place as many rooms are built up with storefront walls with no obscuring of visibility. The emergency exit door has several signs on it indicating that the local door alarm will sound. The alarm appears to have no power as the LED light was not flashing, as with other battery powered local door alarms on campus, non are monitored on the access control or intrusion detection systems. Window treatments are installed on the exterior facing windows restricting visibility when lowered during daylight hours from the public side.</p>	<p>Create protocol for shelter-in-place and lockdown specific to the library building. The ad hoc creation of rooms and learning spaces presents significant challenges to securing the building in a lockdown. Ability to secure the building perimeter is key maintaining, if possible, threats on the exterior of the building. Replace all battery local alarms with hard wired, eliminate potential lack of power monitoring and battery replacement issues that standalone and wireless devices present.</p>	4

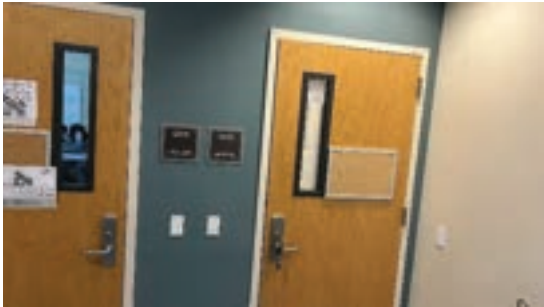
28

<p>Lecture Rm. 109 door is equipped with a lock blok with door hardware that cannot be dogged from the secured side. The door window vision panel has been covered with a makeshift covering, eliminating visibility into the room from the corridor. The VoIP telephone that has recently been installed</p>	<p>Operationally review the current practice of window vision panel coverings, consider protocol that restricts coverings to 75% or AHJ recommendation that provides privacy but ability for first responders to view in. Ensure that all equipment i.e., telephones are recorded in an inventory asset management</p>	3

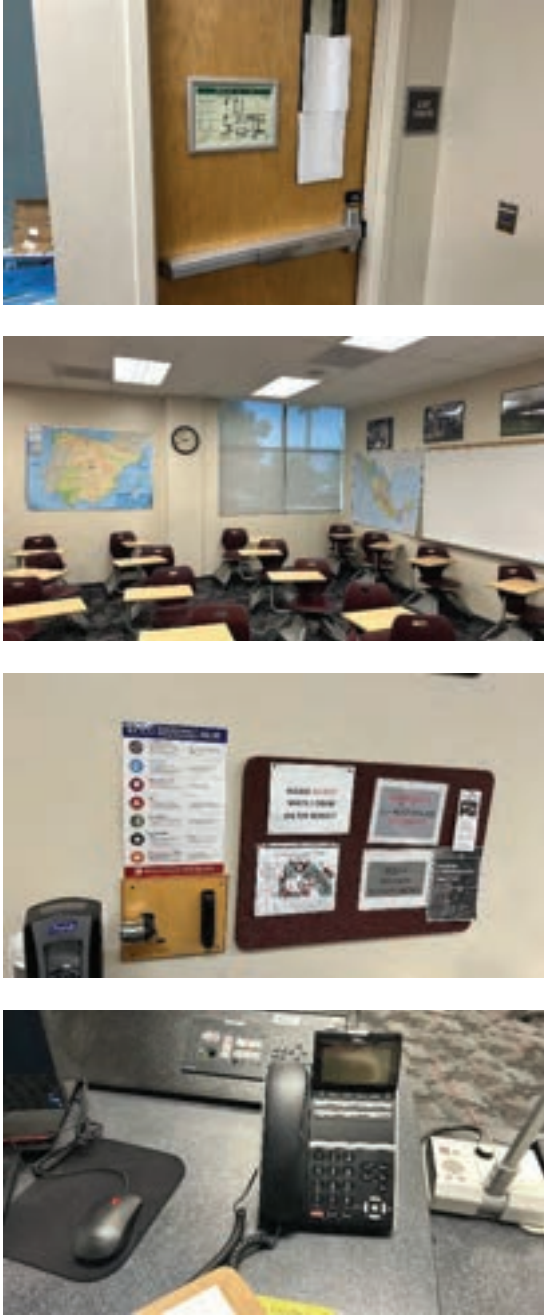
<p>into the space had been removed, this was a common issue across campus. Window treatments are installed on exterior windows and Emergency Procedures and Evacuation Plans are installed in all classrooms; this is excellent. Note: the missing VoIP telephone handset was located within a storage cabinet. There is no ability to communicate over the phone using an intercom function.</p>	<p>system, provision, and removal of communication tools such as telephones should carry consequence for removal.</p>	
29

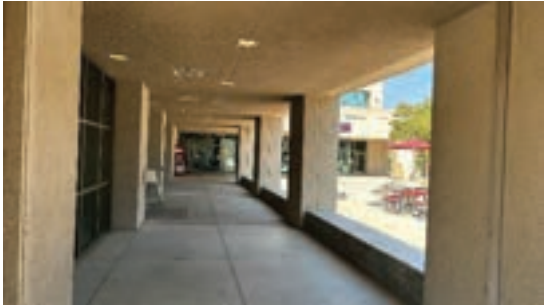
<p>The courtyard and covered walkway areas have no video surveillance monitoring available. Internally installed emergency phone stations would provide more impact and potential benefit of installed within the exterior space, there is a lack of emergency call station installation at this area. Wayfinding and general</p>	<p>Install video surveillance to provide situational awareness and forensic viewing of the covered walkways. Install new emergency call stations strategically within the walkways providing maximum visibility to campus users for identification if needed. Install wayfinding signage that clearly identifies the direction of</p>	3

ID#	PHOTO	OBSERVATION	RECOMMENDATION	RISK
	 	<p>instruction/guidance signage across campus is lacking. Direction to buildings etc. is difficult to establish due to the lack of deployment of updated campus wayfinding maps.</p>	<p>campus buildings and facilities. Use wayfinding to maintain a sense of wellbeing and security for campus users as well promoting a positive campus user experience.</p>	
30	 	<p>Signage to the Student Health Services Department is provided with two physical signs. These are not easily readable from a distance and are anomalies regarding wayfinding and directional signage in use on campus. There is no signage that indicates the department location from parking lots, signage is localized.</p>	<p>Reference recommendation #29 regards wayfinding, additionally consider use of digital signs and QR codes that allow campus users to use personal cell phones to self-navigate campus if digital/interactive maps are provided upon scanning of a QR code. Perform frequent landscaping maintenance to cutback growth that may obstruct signs and lights etc.</p>	3

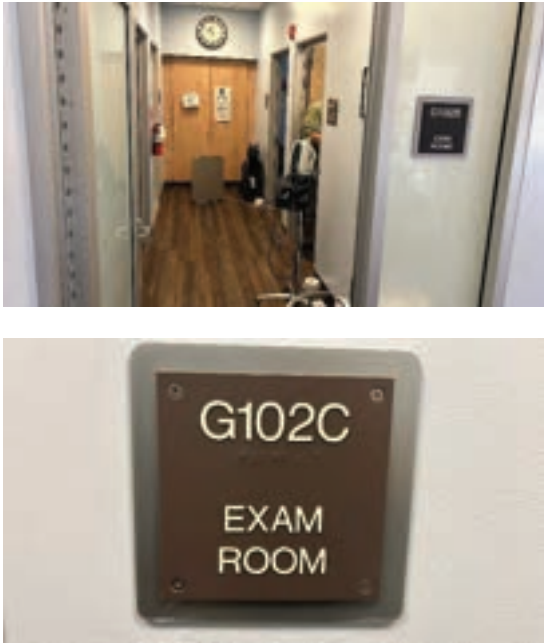
31	 	<p>Accessibility into the student health services is unrestricted with no access control, intrusion detection or video surveillance installed. A door chime annunciates when the door is opened providing notification person(s) entering to staff. There is no ability for staff to observe activity on the public side approach of the space. This area often receives students with mental health issues which can easily escalate. There are no access control measures on the consultation room as observed at other locations, and no panic buttons provided. Signage on rooms does not reflect the current functionality of the</p>	<p>Discussion with staff determined that controlled entry into the space throughout the day would impede services. Visibility of the exterior approach however was a request as often agitated individuals enter the space and early awareness would be beneficial. Consider installation of exterior video surveillance with live video stream to a wall mount monitor providing the reception desk with visibility of exterior activity. Ability to automatically lockdown doors from the interior should be available along with panic buttons installed in both the main entry and the consultation room. Review and update</p>	4

<p>space. This is a high traffic area receiving between 20 and 50 patients a day. Staff in this location are vulnerable due to lack of security measures applied.</p>	<p>signage to reflect current room functionality as observed.</p>	
32

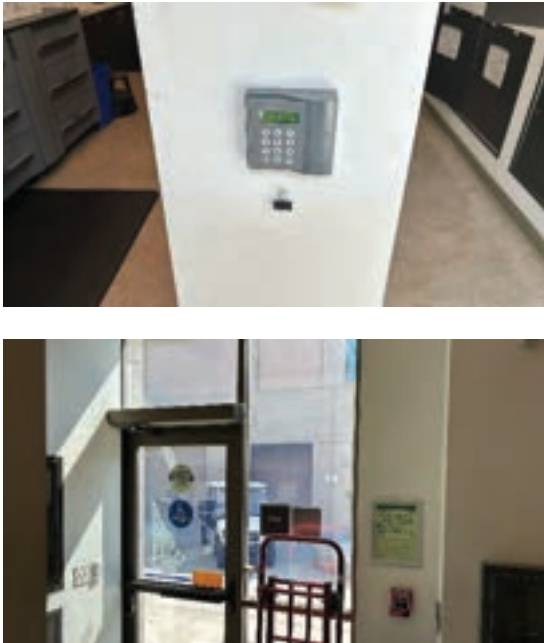
<p>The College Safety and Police Resource Center has a Software House intrusion arming station installed within it. The intrusion code for the space is unique and places this space into an armed state. A separate code can be used to implement lockdown of the building. The lockdown capability currently across campus is that input of a lockdown code will only lockdown the immediate building and not the entire campus. The same code is used for lockdown across all arming stations.</p>	<p>General observation.</p>	0
33

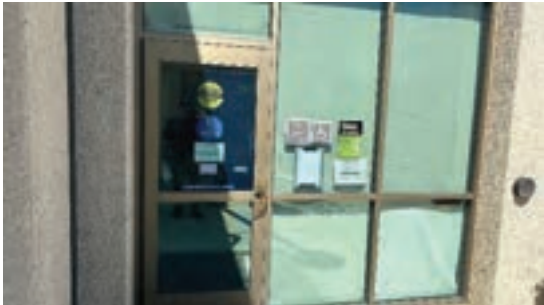
<p>The Police Department entrance door is on its own keyway with restricted access to Police Department Officers and staff. The Police Department has no access to the security electronics systems that are in use on campus. There is no live stream of video surveillance cameras onto monitors</p>	<p>Recommend that coordination and collaboration occur with the district police department to establish an MOU that encompasses the use of existing and future security electronics to support campus policing and incident response. The lack of visibility or use of cameras and other technologies available</p>	4

ID#	PHOTO	OBSERVATION	RECOMMENDATION	RISK
		<p>providing situational awareness viewing capability, and no use of remote mobile access to support incident response.</p>	<p>diminishes the investment made and ability for technology to serve as a force multiplier to existing stretched police resource levels.</p>	
34	  <p>The first photo shows a red door and a glass elevator. The second photo shows a red door with a lock block and a glass door. The third photo shows a dark doorway. The fourth photo shows a card reader and a lock on a wall.</p>	<p>The exterior elevator at the Student Services Building (SSV) cannot be locked down remotely as there is no access control system interface. This presents a significant vulnerability in a lockdown as internal access to the second level can be achieved using this elevator. The stairwell egress opening SSV 111 is equipped with a lock blok. This egress only opening should remain closed and locked at all times from the public side and used for emergency egress only. There is no video surveillance installed and the main entry doors on level one do not have access control measures applied. There is signage that indicates that no student access is allowed, this cannot be enforced as the doors remain unlocked. These doors should be controlled with access control if access is to be restricted to certain campus users. A DMP intrusion system arming station is armed by presentation of security credential at the card reader. It is understood that discussions regarding use of wireless access control measures is under consideration for the entry doors.</p>	<p>Interface the elevator with the access control system allowing for remote lock/unlock and lockdown. Accessibility from the exterior directly into the interior when all other openings are locked is a major vulnerability. A video surveillance camera should monitor activity at the elevator call buttons and the entry into SSV level one administration area. SSV 111 lock blok should be removed and the door closed and secure at all times, as an egress only door, free ingress should not be provided. The entry doors into the SSV administration space should be access controlled with hardwired options only.</p>	5

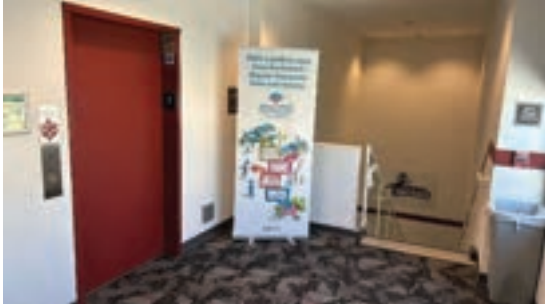
<p>The second level exterior landing provides free ingress to the counseling area via access from the exterior (see observation #34). In a lockdown the trash can is used to block the ability for the elevator to return to level one, there is no written protocol regarding elevator security in a lockdown.</p>	<p>Reference recommendation #34 regarding elevator security proposals. Install video surveillance to monitor elevator landing and stairwell activity.</p>	5
41

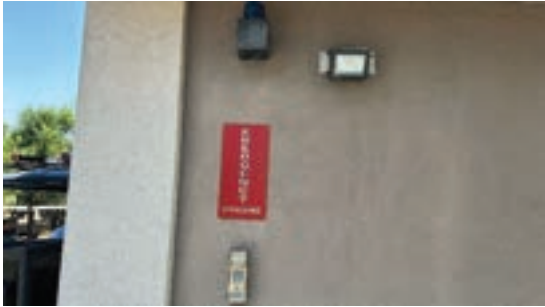
<p>The Trigon emergency call station located at the Bookstore is end-of-life and no longer supported by the manufacturer. The independent strobe is not illuminated providing visual identification of the call stations location. A sign indicates the emergency phone location, but text is small, and the sign is a secondary notification measure. There is inconsistency in the application across campus reference the type of devices and form factor used for emergency call stations. There is no video surveillance integrated with the call stations providing camera call up capability.</p>	<p>Consider use of a standard Code Blue all-in-one call station with blue strobe unit in the future. Use the Code Blue towers to support video surveillance cameras, solar back-up, and other devices as appropriate. Interface the Code Blue call stations with other security electronics systems providing camera call-up and notification when a call is activated. A district standard should be created, out of service stations should be covered/removed and 'Out of Order' signage installed. Non-operational units present liability risk to the college and district that should be avoided.</p>	4

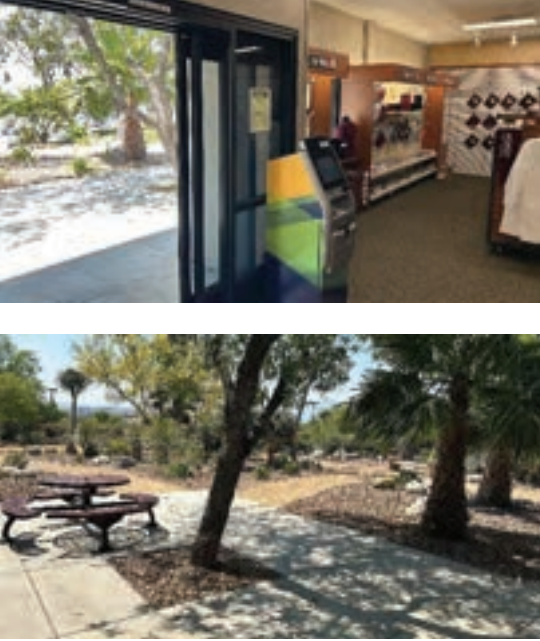
<p>The Bookstore is a district owned building rented out to Barnes & Noble. Barnes & Noble utilize their own security system i.e., intrusion detection to monitor security status, the district have no access to this. There is an ATM machine located within the Bookstore with no video surveillance installed to monitor transaction</p>	<p>Install video surveillance externally to provide general activity monitoring.</p>	2

<p>activity. Video surveillance is also not installed on the exterior of the building providing ability to review forensically activity if an incident were to occur. The seating area provides excellent ability to get eyes on activity and enhance natural surveillance.</p>		
43

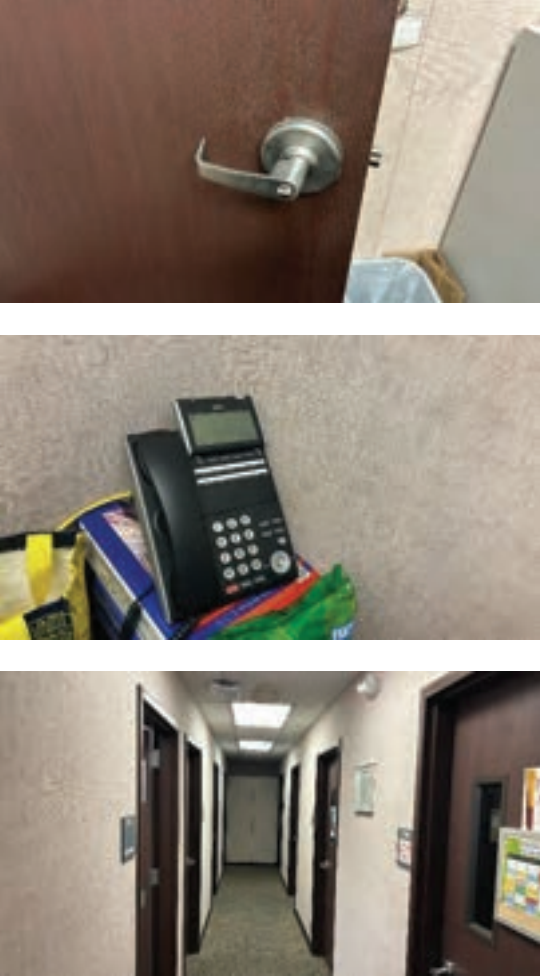
<p>Portables A and B (Faculty Offices) are used by college faculty. Access is via brass key only with no access control measures installed. The door remains locked at all times and the space is monitored on the DMP intrusion detection system. The intrusion system is armed and disarmed by card reader suggesting that building users must have security credentials and brass keys to use access the space. Individual office doors can be secured from the inside using a push button and all have VoIP telephone phones.</p>	<p>The existing measures are adequate, recommend that future security standards determine if all faculty offices should be access controlled. Apply a standard approach to all faculty offices across campus and the district.</p>	0

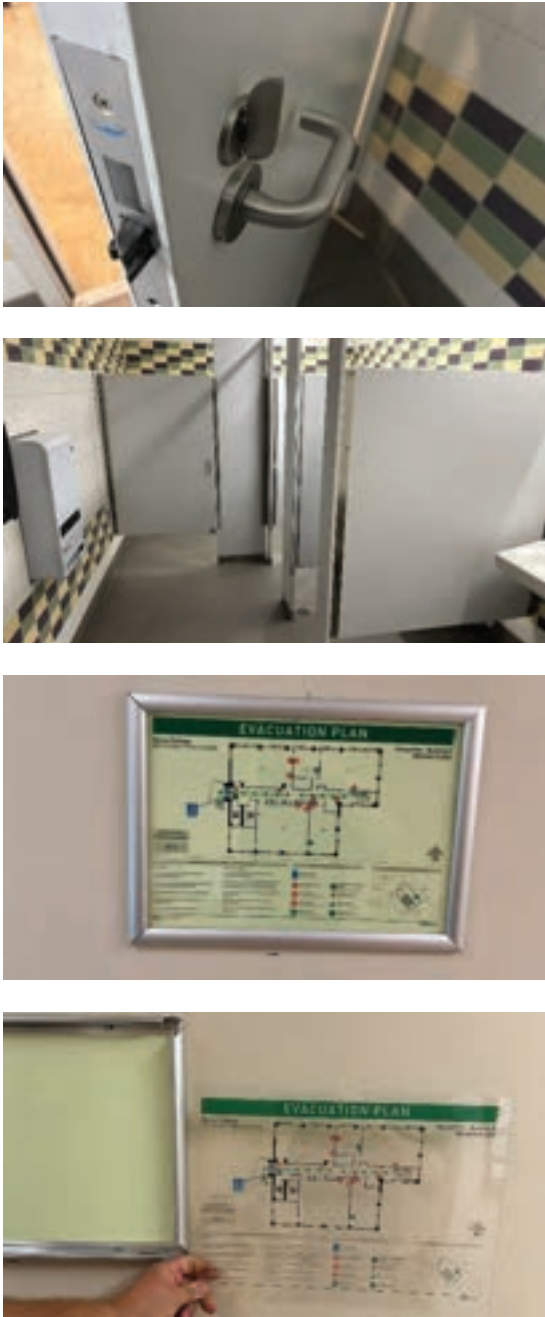
<p>Gender neutral restrooms have several stalls within them, and the entry door can be locked from the interior. There is potential risk/vulnerability associated with the locking capability still present. A bad actor could lock a person(s) inside against their will. There is no video surveillance monitoring the approach to the restrooms.</p>	<p>Gender neutral restrooms with internal locking available is a high-risk situation. Recommend review of the current operation and approved use. Mixed gender restrooms with multiple stalls presents heightened risk of assaults, harassment and other nefarious activity occurring. Install video surveillance on the public side to</p>	4

<p>Evacuation Plans are removable with the frame fixed providing opportunity for refresh and replacement as needed of the map itself.</p>	<p>provide forensic viewing of person(s) ingress and egressing should an incident occur. Review alternate options for single stall all gender use.</p>	
49

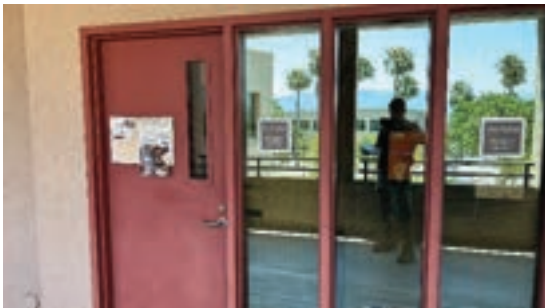
<p>Faculty Office 206 accessible by brass key. Window treatments are installed and can be lowered to restrict visibility in. All office doors at this area can be locked from the interior using brass key only.</p>	<p>General observation.</p>	0

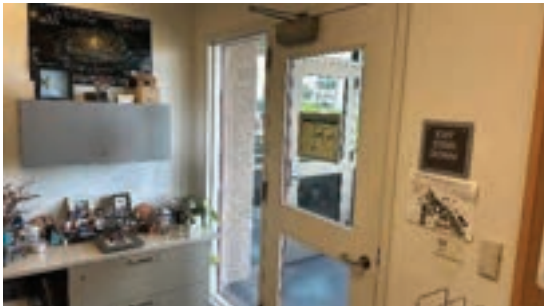
<p>ST Faculty Offices on the second floor are accessible by brass key only with no electronic access control measures. There is no window treatment on the entry door window and side vision panel. Different faculty members have applied their own window treatments to their individual office spaces, there is no consistency in approach or mandate that window treatments be applied.</p>	<p>Review security measure expectations at faculty offices and create a single district standard. There is clear inconsistency across campus at different building faculty offices which is influenced by the time period of build. Frosted glass and internal locking hardware at these offices is proposed, installed by the college and not by individual faculty members.</p>	3

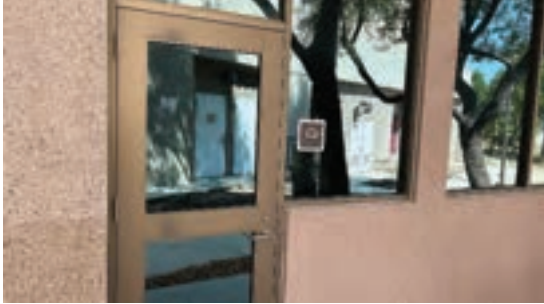
<p>The Music Practice Rooms exterior door is unlocked and provides direct and free ingress to the three internally accessible practice rooms. Each practice room cannot be locked from the interior. There is no video surveillance on the exterior of the space or within the internal lobby area. A single VoIP telephone is available in the vestibule and tinted window film is applied to both the exterior and interior facing glazing. A drop-down blind above the exterior door is challenging to reach for anyone below 6' in height.</p>	<p>Consider controlling access with a card reader, distribute departmental credentials or issue students with credentials to restrict and control access into the practice rooms. Video surveillance should be installed on both the exterior and within the internal vestibule. Replace the blind above the door with frosted film or a blind on the entry door internal side for ease of accessibility.</p>	2

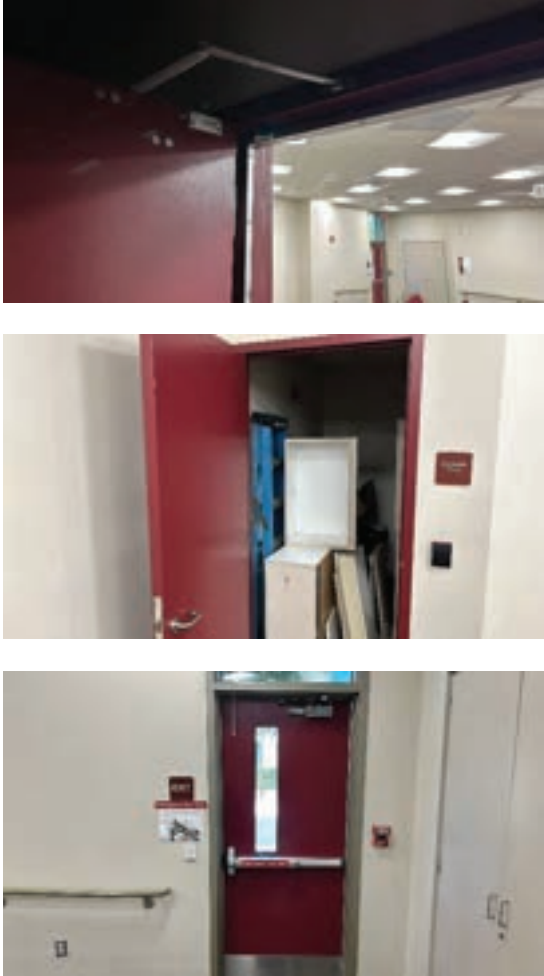
<p>Industrial Technology Building (IT) storage rooms 117A and 117B illustrate an inconsistency in the application of door closers. All access-controlled openings should be equipped with door closers as a standard feature. Door position monitoring contacts are installed at internal access-controlled openings, which is excellent. This provides ability to understand door positions and maximize security technology to support existing security staffing measures. The exit door does not have a window vision panel cover restricting visibility from the public side. The IT space has no intrusion detection system in use.</p>	<p>Install door closers on all access control openings to ensure positive latching upon closure. Develop security standards that provide consistency in security technologies used across the district. Intrusion detection at a minimum should be in use.</p>	<p>3</p>

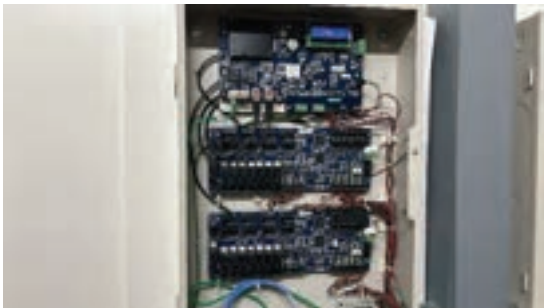
<p>Room 117C houses the Software House iStar equipment, enclosure covers had been removed and not reinstalled. There is no video surveillance monitoring activity, again illustrating inconsistency in approach to monitoring critical infrastructure spaces. The thermostat for the HVAC system appears to have no power to it, the HVAC system is non-operational. Entry requires presentation of a security</p>	<p>Security headend equipment should be secured with enclosure doors reinstated and the enclosure status monitored by a tamper switch. Video surveillance should monitor activity within the space at minimum with exterior video surveillance interfaced with access control providing camera call-up on alarm event trigger. Engage facilities and maintenance to review the HVAC system and restore to operating state.</p>	<p>2</p>

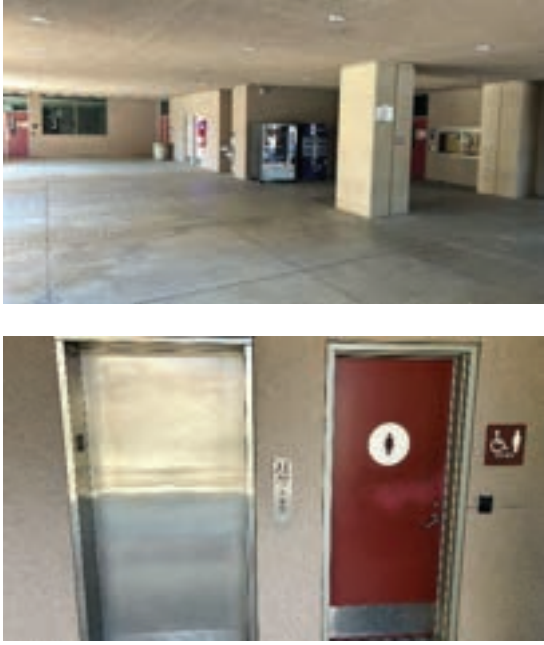
<p>Several Sony video surveillance cameras provide general situational awareness viewing capability and approach and activity at the vending machines. A single multisensor camera would provide significantly enhanced viewing capability using existing cable if installed. The external elevators remain unlocked at all times with no interface with the access control system to support scheduled lock and unlock. Restrooms are locked and unlocked on schedule via the access control system. There is no signage indicating the hours of availability.</p>	<p>Recommend that elevators be controlled by the access control system with ability to remotely lock and unlock on schedule. Card reader at the first-floor hall call buttons would provide authorized use when in a locked state. Display signage that clearly displays the hours of operation at the restrooms. Consider an internal public address system that provides notification to restroom occupants in the event of a restroom so that they can shelter-in-place when doors are remotely locked. Video surveillance should monitor all elevator landing and restroom entrances.</p>	2

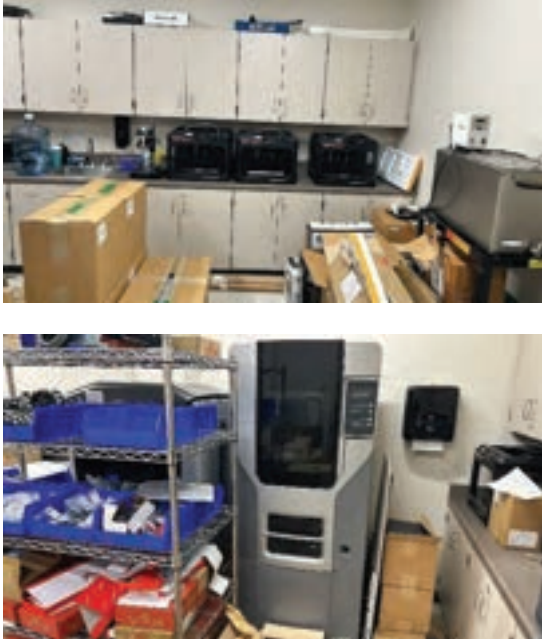
<p>Expensive 3-D printers at the IT are stored within an access-controlled storage room, which is excellent. However, there is no video surveillance installed that monitors the space contents or supports ability to interface with access control and /or video surveillance to provide camera call-up on alarm event.</p>	<p>Develop security standards and develop a phased upgrade and implementation program applying baseline minimum security electronics to all buildings. Propose that video surveillance be installed in high value equipment storage rooms.</p>	3
62

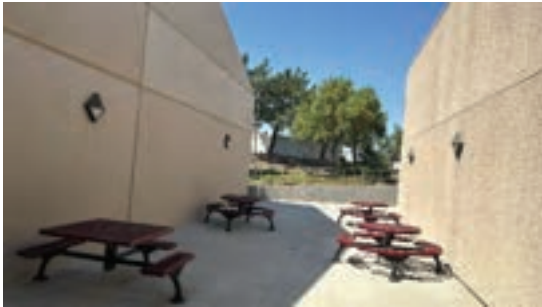
<p>A single video surveillance camera monitors activity at the seating area. A multi-sensor camera would provide enhanced visibility using existing infrastructure.</p>	<p>Consider swap out of the existing fixed field of view camera for a multi-sensor, repurpose existing cable if CAT 6, if required pull new cable.</p>	1

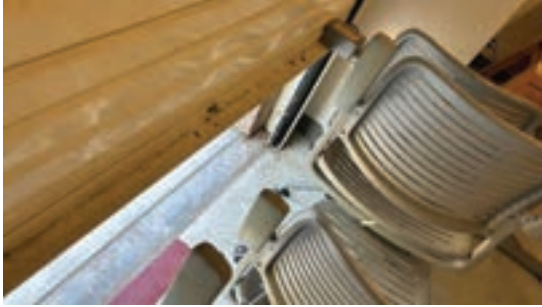
<p>The roller door in the IT building is not monitored with a door position monitoring contact. This presents a vulnerability in the building envelope security posture, and a place for potential undetected unauthorized entry. The roller door appears not to be used frequently.</p>	<p>Install surface mount door position monitoring contacts and terminate on the intrusion detection system.</p>	3
64

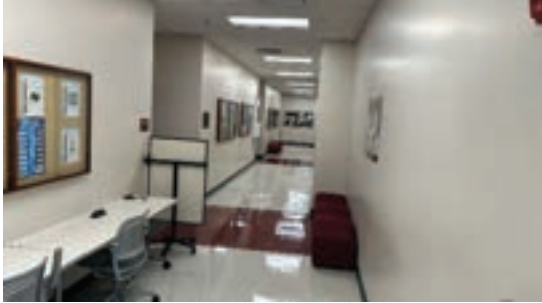
<p>Access control measures at the Q (IT) building appear excellent with all exterior envelope doors monitored on the intrusion detection system. There is no video surveillance within the corridor providing visibility of general activity.</p>	<p>Install video surveillance to provide situational awareness viewing capability.</p>	2

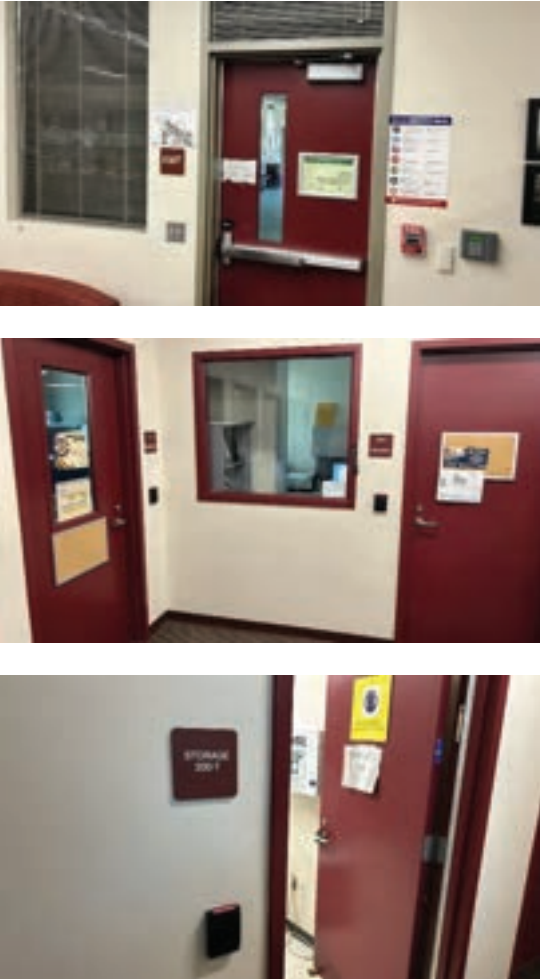
<p>Suite 200 at building Q (IT) is faculty offices with access control on each and every door within the space. The main entry door into the suite is unlocked on schedule and a lock blok applied with the door in a locked state all times to provide immediate latching on closure. The exit door remains locked and closed at all times, the lock blok should not be engaged. A door wedge in use at Storage Room 200–T with a lock blok strap retracting the latch indicates that the door is never fully closed and secured. The Software House keypad arms and disarms the entire buildings intrusion detection system. Lockdown can be activated by input of a code that will lock down the building only, a separate code is available that will lockdown the entire campus.</p>	<p>Remove the exterior door lock blok, the egress only door should not be propped at any time. Remove the lock blok strap and door wedge at Rm. 200-T and close and lock the door, if free ingress is required at all times remove the access measures.</p>	4

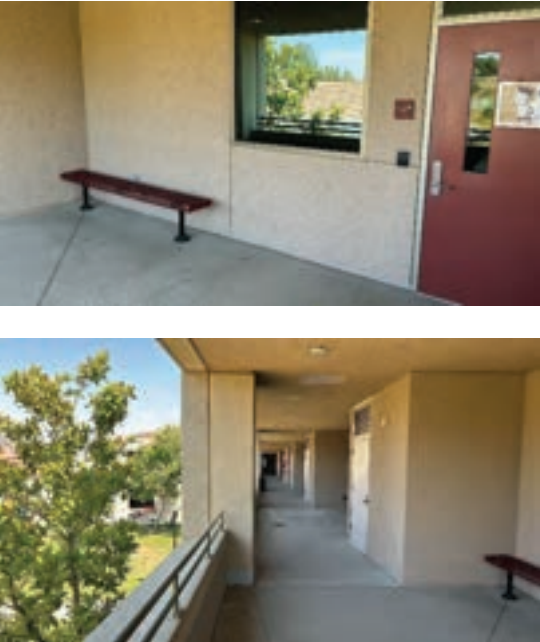
<p>The setback seating areas on the second floor provide potential area for homeless to sleep undetected for a sustained period. The bench provided does not include CPTED recommended seating that restricts ability for persons to lay down and sleep on furniture, deterring social nuisance.</p>	<p>Review CPTED best practices regarding external furniture an consider for future installations, limit opportunity for sleeping on benches. Install video surveillance to monitor exterior walkways.</p>	1

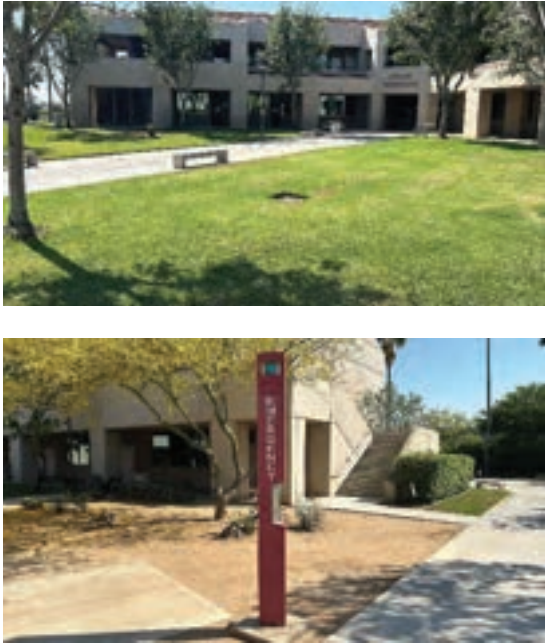
68

<p>Natural surveillance and territorial reinforcement is supported by excellent maintenance and landscaping at the ATEC building. The emergency phone unit is manufactured by Trigon and no longer available. The call station instructional signage is damaged and no longer legible. The blue strobe is not illuminated, and the base is not complying with ADA requirements allowing for unobstructed or impeded wheelchair access. There is no video surveillance installed at the exterior for the ATEC building.</p>	<p>Blue strobes should be illuminated at all times for ease of identification of call stations. Future installation consider use of Code Blue towers to support video surveillance cameras, solar back-up, and other devices as appropriate. Interface the Code Blue call stations with other security electronics systems providing camera call-up and notification when a call is activated. A district standard should be created, out of service stations should be covered/removed and 'Out of Order' signage installed. Non-operational units present liability risk to the college and district that should be avoided. Review ADA accessibility needs and perform corrective actions, as necessary.</p>	4

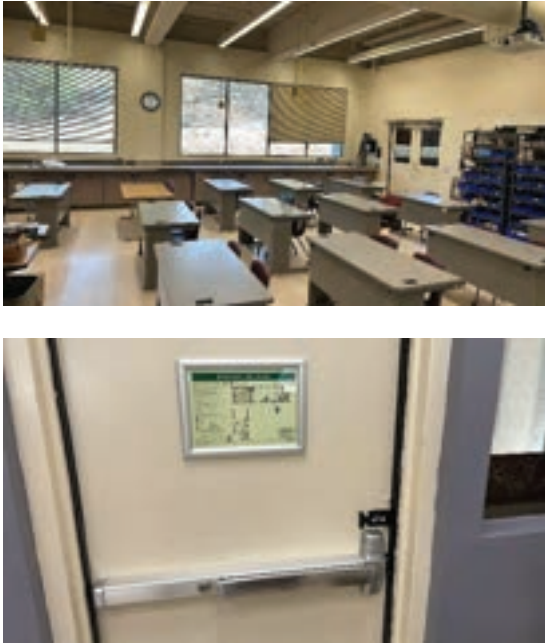
<p>ATEC Classroom 119 door latch can be retracted using the key cylinder on the interior panic bar, dogging of doors should not occur. A lock blok on the interior supports a locked door at all times. Window treatments (blinds) restrict visibility from the public side when lowered.</p>	<p>Review hardware with internal dogging capability and remove key cylinders and dogging access, replace with blank plates.</p>	2

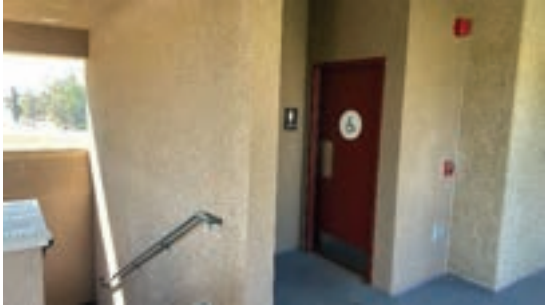
ATEC second floor women's restroom is setback without video surveillance of activity. The restroom is unlocked and locked physically by Campus Police. The fire alarm pull station is accessible for misuse and tampering with and the stairwell is a blind spot for persons entering and exiting the restroom.	Install a multi-sensor video surveillance camera to monitor restroom entrance, stairwell and second floor walkway activity. Develop security standards that provide a consistent level of security measures at restrooms, current conditions lack any standardized approach.	2
72

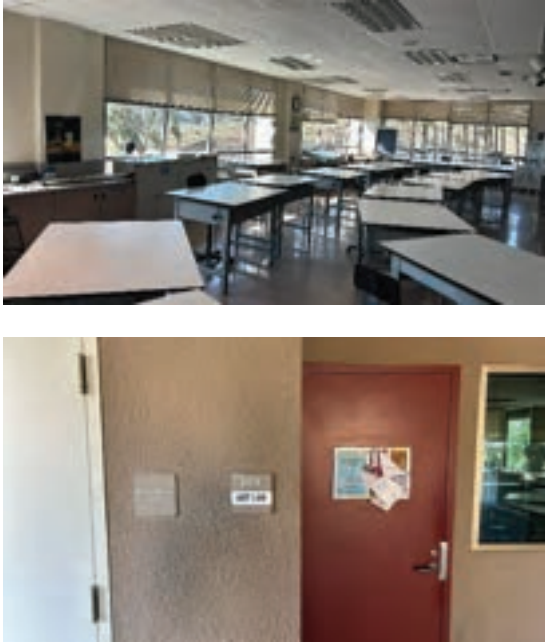
73

Rm. 209 is an Art Lab; reflective window film is applied to the exterior glazing eliminating visibility during hours of daylight from the public side in. The intent of the film at install was simply to serve as a means to reduce sunlight into the Lab, it now serves a positive impact on building security. Additional window blinds can be lowered to restrict visibility further in the evening when lights are turned on, thus eliminating the film reflective capability.	General observation, develop security standards that provide consideration of use of ballistic film on future building refresh or new construction projects.	0

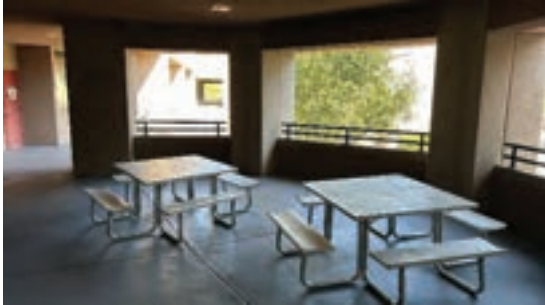
The ATEC second floor seating area outside of the Art Lab. provides an area for eyes on activity as well as an area for unobserved loitering. There is no video surveillance providing situational awareness of any activity at the exterior of the ATEC building.	Install video surveillance to monitor activity in this area which is currently an unmonitored blind spot.	2

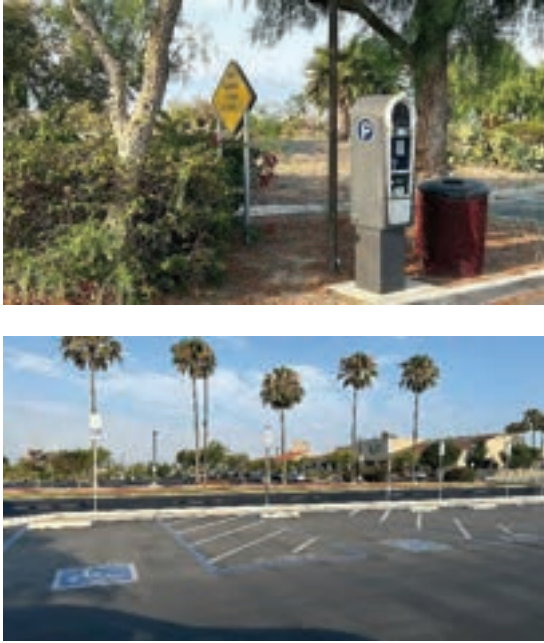
79	 	<p>A single sign indicating that yellow parking bays are for staff parking only needs repair, as it is leaning over; the sign is difficult to read from a distance. The yellow markings on the tarmac require a refresh of new paint to clearly define parking bays. The parking permit dispenser is located at the furthest point away from the college with no video surveillance monitoring activity. ADA parking spaces are identified with signage on the tarmac and physical signage at</p>	<p>Perform maintenance repair and refresh of signs as identified. Install video surveillance across all parking lots providing visibility of activity and to serve as a potential deterrent to bad actors. Strategic placement of multi-sensor cameras would provide significant coverage. Use of wireless point-to-point data transmission would reduce data and power needs as potential battery; solar and step-down transformers could</p>	3

<p>each bay. The physical signage needs a refresh as it is weathered/sun bleached and no longer clearly displaying the message intent.</p>	<p>utilize power available at lamp posts to support the cameras.</p>	
80

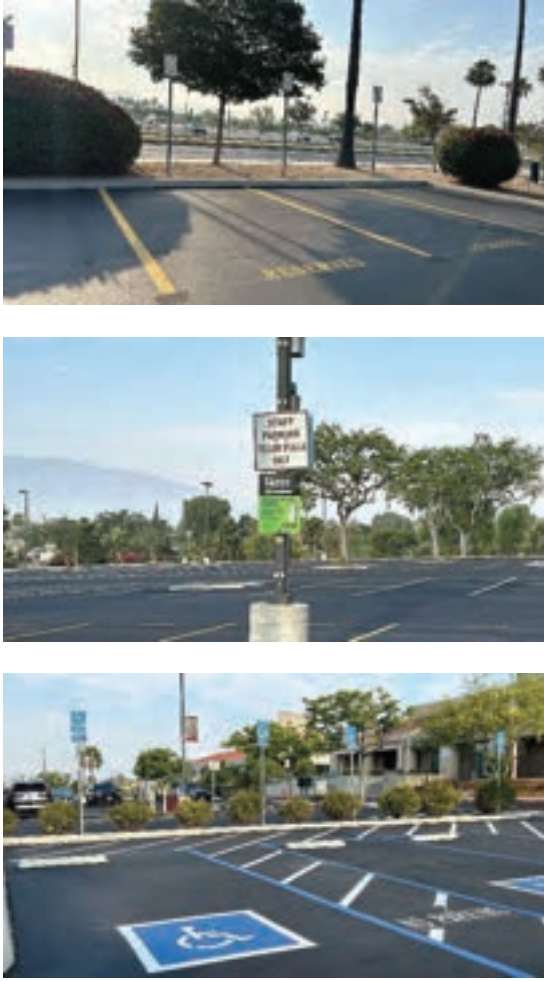
<p>Parking Lot A, parking spaces and general signage within this lot are significantly stronger than those observed in Parking Lot B. There appears to have been a recent refresh of the asphalt and parking bay markings. This is excellent and presents a welcoming environment to students, visitors, and faculty etc. There are emergency call stations installed in the lot, the call stations appear to have been overlooked in the parking lot refresh. The blue strobes were illuminated during the hours of darkness for ease of identification, they do not appear illuminated in the daylight. There is no video surveillance installed in the parking lot.</p>	<p>Reference recommendations #78 and #79 for emergency call station and video surveillance considerations. The presentation of the parking lot should be rolled out across campus as it represents pride and care of the facility, which is welcoming. Wayfinding should be provided to support ease of building identification to parking lot users.</p>	3

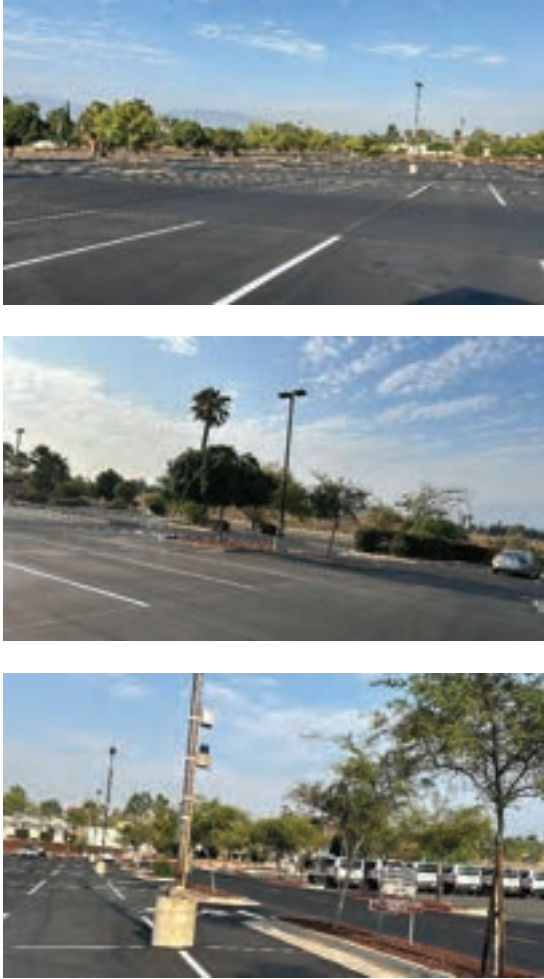
<p>Parking Lot C is dedicated for student parking only. There is a single emergency telephone installed in the parking lot, which is insufficient for the size of the area. There is no consistency in the type of emergency call stations used across campus. The unit in use in this parking lot is a Trigon call station. The parking bay markings and tarmac are exceptionally well maintained. There are no speed control measures in place, including a lack of speed bumps, vehicle barriers and speed control signage. There have been instances of vehicle vandalism occurring within the parking lot areas, but no video surveillance installed to support forensic review.</p>	<p>Reference recommendations #78 and #79 for emergency call station and video surveillance considerations. Speed limit signage should be displayed consistently within parking lots and consider strategic positioning of speed bumps and cushions to support speed restrictions. Parking lots could be compartmentalized from an access perspective with installation of swing-arm barriers. Enforce use of official parking permits on vehicles using segregated parking areas (e.g., student, employee lots). Remove non-registered or illegally parked vehicles.</p>	4

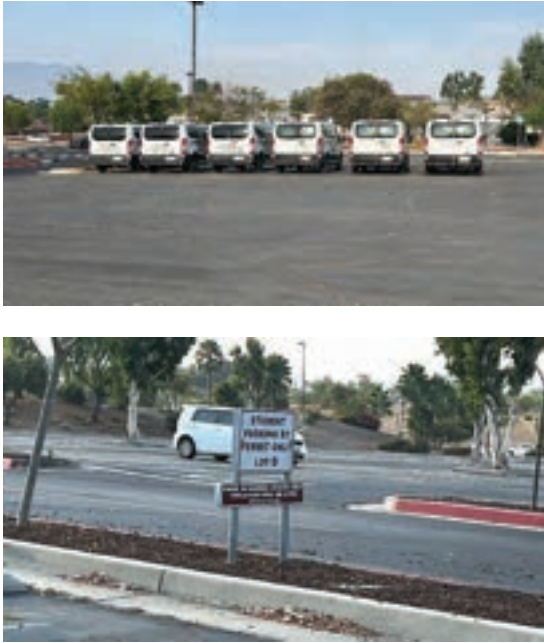
<p>Parking Lot D has poorly defined parking bays and needs a maintenance refresh. Dedicated motorcycle parking is not clearly identifiable from a distance, and there is no wayfinding signage providing any direction to this location from the Third Street point of entry to campus. Student parking is permitted with use of a permit only. College vehicles are parked and stored within this parking lot, there is no restriction to exit campus with a vehicle if unauthorized access to one occurs. As with all other parking lots there is no video surveillance. All parking lots have a lack of speed restriction measures in place, all parking</p>	<p>Reference recommendations #78 and #79 for emergency call station and video surveillance considerations. Speed limit signage should be displayed consistently within parking lots and consider strategic positioning of speed bumps and cushions to support speed restrictions. Parking lots could be compartmentalized from an access perspective with installation of swing-arm barriers. Enforce use of official parking permits on vehicles using segregated parking areas (e.g., student, employee lots). Remove non-registered or illegally parked vehicles. Provide signage that indicates the</p>	3

<p>lots could be compartmentalized with use of vehicle barriers to restrict vehicle access into parking lots outside of authorized usage times. A single sign at Parking Lot D does provide some direction to campus buildings.</p>	<p>location of motorcycle parking bays from Third Street.</p>	
83

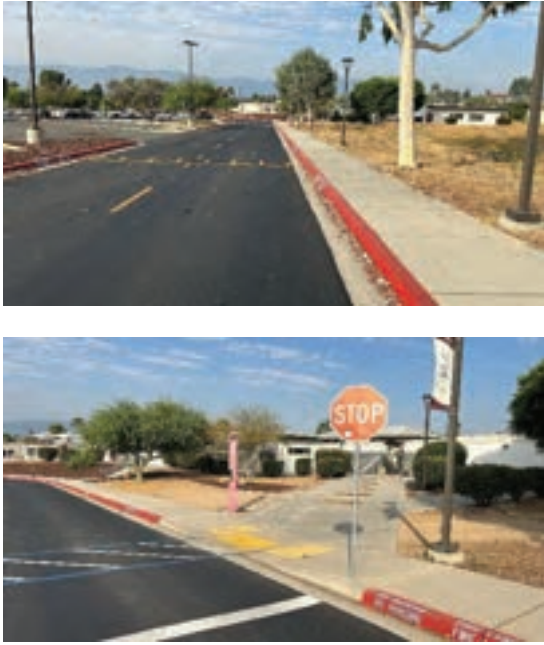
<p>The West End Drive tarmac has recently been resurfaced and paint markings are clearly defined. There are speed bumps present however, there is no vehicle speed restriction signage installed. The emergency phone is another example of inconsistency in standardization of type, the red tower is easier to identify than post mounted units. There is no video surveillance.</p>	<p>Reinforce speed limit control with physical signage.</p>	3
