Riverside City College Academic Senate

FINAL REPORT

Riverside Community College District (RCCD) has assigned Salas O'Brien Engineers, Inc. and Aanko Technologies (SOBE/Aanko) to conduct a comprehensive physical security program review of all District campuses to establish a baseline status that can be used as a foundation to develop, grow, and strengthen its District-wide physical security program to better protect and serve its communities. This security program review involves site visits, existing documentation evaluation and stakeholder interviews to evaluate physical components including security electronic systems, policies and procedures, socio-environmental conditions, training programs, and security staffing levels. The physical site assessments for all campuses were conducted during their typical hours of operation, before and after hours of typical operation, with the assumption that the security components and electronic systems were in good working order and functioning normally.

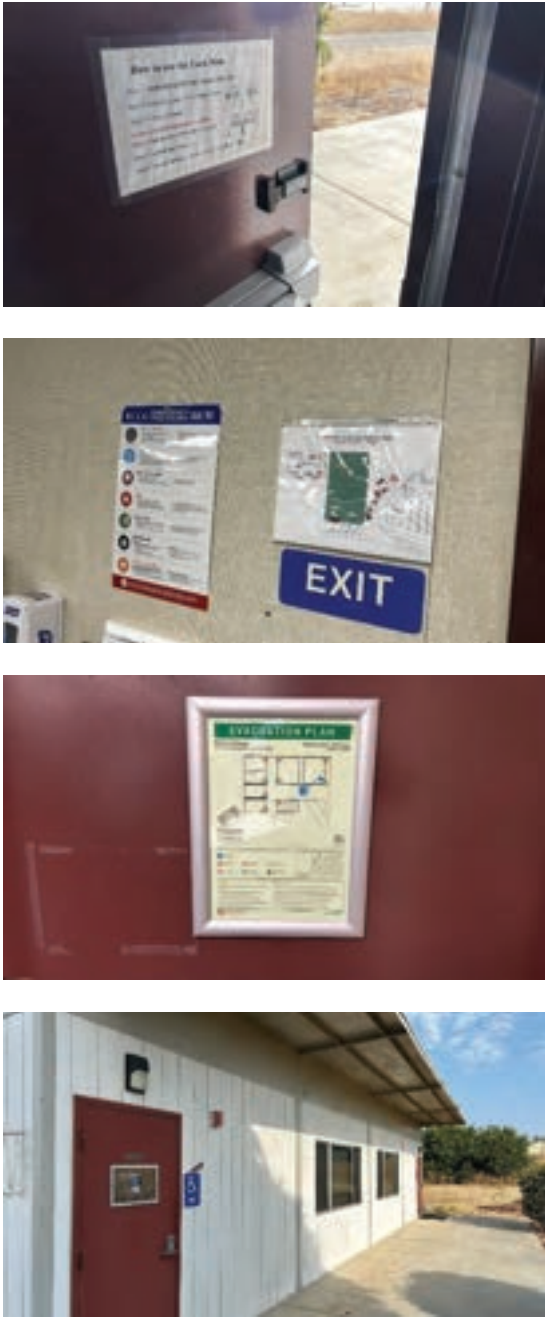
<p>WEQ Rm. W8 portable is a fitness room with entry by brass key only. There were no security electronic access control measures deployed across the portables. Room usage signage is small with minimal text not easily identifiable from a distance. Window treatments are installed and can be lowered when needed. Lock Bloks, Emergency Evacuation Plans and Procedures were installed and displayed as typical.</p>	<p>Recommend that all buildings at a minimum be monitored with an intrusion detection system. Review signage across campus and consider implementation of consistent signage style, fonts, text size that provides a standardized approach. Ensure all site signage is durable against human tampering and natural weather events. Signage can support the culture, sense of community, and be welcoming when deployed correctly. Consider signage that is consistent in appearance across the district rather than just this campus.</p>	4

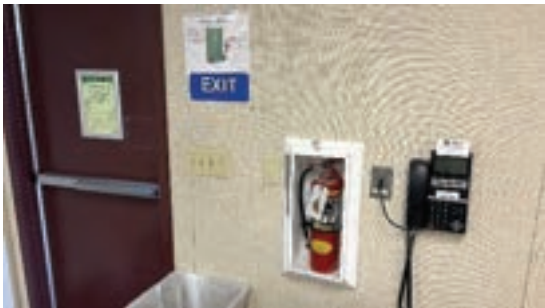
<p>Classroom W7 is accessible by brass key, typical measures were observed including a wall mounted VoIP telephone. There are challenges across campus due to network port locations which restrict placement of telephones on the wall, which is the preferred mounting location. The Medeco brass keys</p>	<p>Consider installation of data network ports at consistent locations within new build and existing building upgrade projects. Consider a consistent location to support preferred wall mounted VoIP telephone placement. The use of the Medeco restricted keyway is excellent and should be rolled out to all openings on campus, a</p>	2

ID#	PHOTO	OBSERVATION	RECOMMENDATION	RISK
	 	<p>and key cylinders are in use at these portables.</p>	<p>district standardization on keyway should be considered for ease of management, distribution, and retrieval supported by an electronic key management system.</p>	
86	 	<p>Gates between portables intended to restrict access to the utilities were unlocked. Even when locked the heights of the gates does not function as sufficient deterrent to scaling.</p>	<p>Gates should be secured with padlocks and video surveillance installed to provide situational awareness and forensic viewing capability. Replacing the gates with new taller gates is not recommended due to cost consideration and minimal additional deterrent provided.</p>	1
87	 	<p>The Activity Center is easily identifiable with its building signage. The space provides public services and there are men's and women's locker rooms. There are no access control measures or video surveillance in use. An emergency call box is mounted on the wall with signage. This is an old Trigon unit no longer supported by the manufacturer, the blue strobe was illuminated at night. The W-2 classroom is used for martial arts and dance classes, there have been instances of vandalism occurring within this room.</p>	<p>Consider installation of security electronics including both video surveillance and access control. Ability to secure this facility remotely is encouraged as it is a known area of vulnerability and concern. Internal communication capability within the restrooms visually and audibly should be considered if the rest and locker rooms are able to be remotely locked down.</p>	4

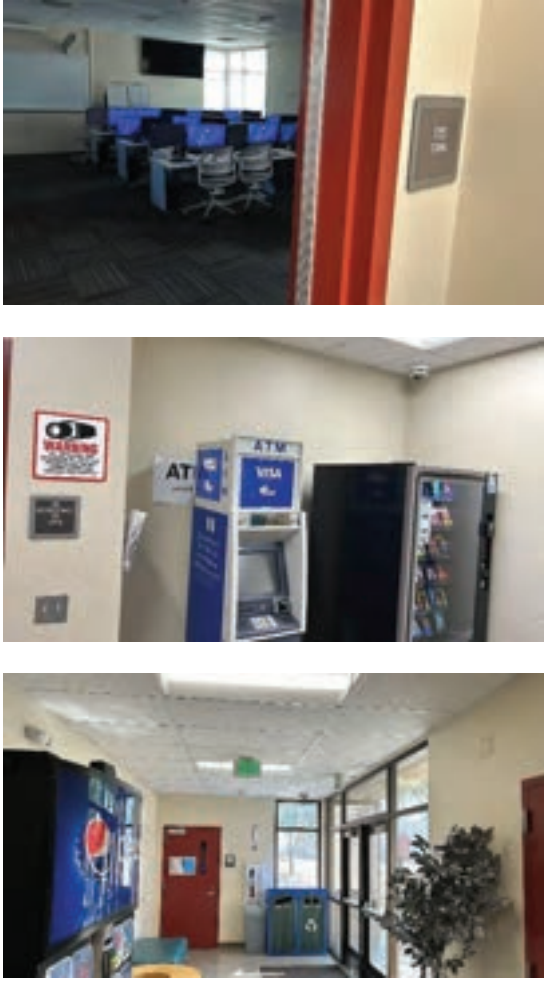
<p>STEM Center Rm. 115 is a classroom that houses expensive equipment. The door is not locked from the exterior side providing free ingress to all building users. The door appears not to be in the path of egress and has no exit sign installed above it. The ATM and vending machine have a Vivotek video surveillance camera installed monitoring activity, there is signage also indicating that there is video surveillance monitoring all activity. The cameras are believed to be non-operational with no onsite visibility of video available.</p>	<p>Rm. 115 should be secured, and general access restricted to controlled entry by card reader or brass key. Replacement and/or removal of the video surveillance cameras is recommended if non-operational. There is potential liability impact if cameras and signage are installed but the system non-operational or monitored as indicated. A standardized approach to video solution used, edge devices installed, and system administration is recommended.</p>	3

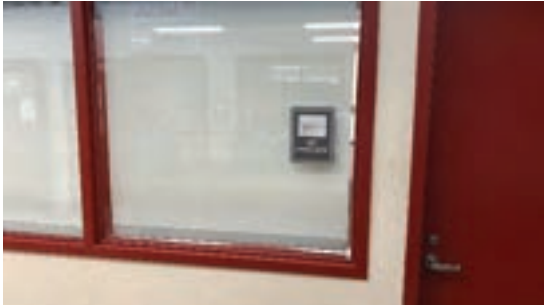
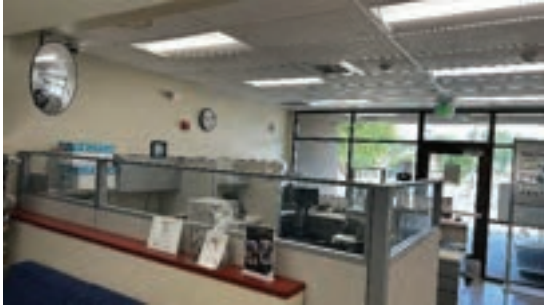
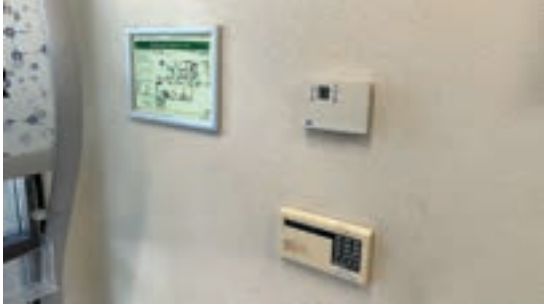
<p>The STEM Building has an intrusion system with Bosch arming station located within the main entry lobby. Video surveillance cameras are well deployed across the entire space however it is assumed that many of them are not operational. As with observation #102 signage indicates that there is video surveillance monitoring all activity. This is incorrect information if the video surveillance system is not operational.</p>	<p>Reference recommendation #102.</p>	3
104

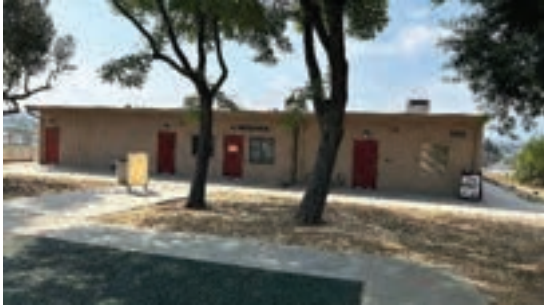
<p>STEM Buildings 200 and 300 were former early childhood learning center space and have 6' chain-link fencing providing delineation of the perimeter on two sides. Classroom 302 is accessible by brass key only. There is no access control or video surveillance in use. Windows have blinds installed</p>	<p>Existing security measures are appropriate, implement future security measures upgrade subject to any future security standards that may be created to provided minimum baseline conditions across all district campuses.</p>	2

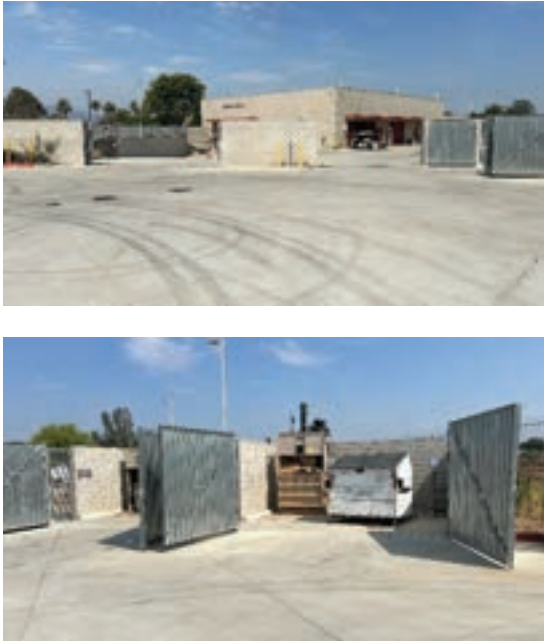
<p>The Operations Center (OC) is unlocked and freely accessible during normal hours of business. After-hours the yard and office are secured, there is continual presence of staff in the area providing eyes on activity throughout the day. Access controlled spaces are opened during the day to provide efficiency of access as needed and to support air flow as no HVAC within the work bays. Trash dumpsters are positioned within dedicated gated spaces.</p>	<p>General observation, the significant amount of activity that occurs during the normal hours of operation provides extensive eyes-on-activity. Maintaining closed and secured work bays at all times is impractical and would impede operations. People activity and ownership of the security program is key to maintaining a safe environment at the OC. Video surveillance does support situational awareness and forensic viewing.</p>	<p>0</p>

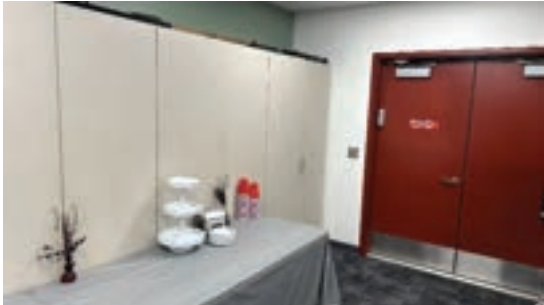
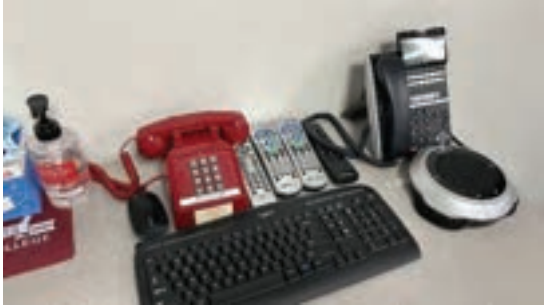
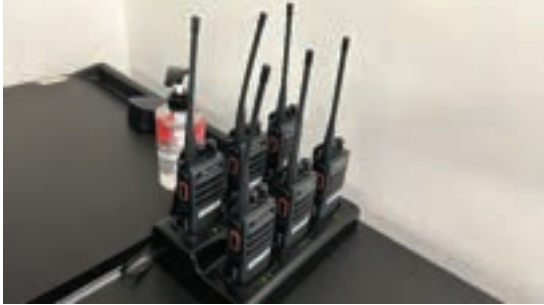
<p>A POTS landline is located in the designated EOC space. Every campus has a POTS line; however, this is the first campus where we have physically observed the red handset. The number displayed was tested and is still operational. Radios and emergency EOC equipment is stored within the cabinets. Role specific laptops are set-up ready for use if needed.</p>	<p>Measures in place are excellent, the district should conduct a frequent testing and validation of emergency POTS lines at all campus locations.</p>	0

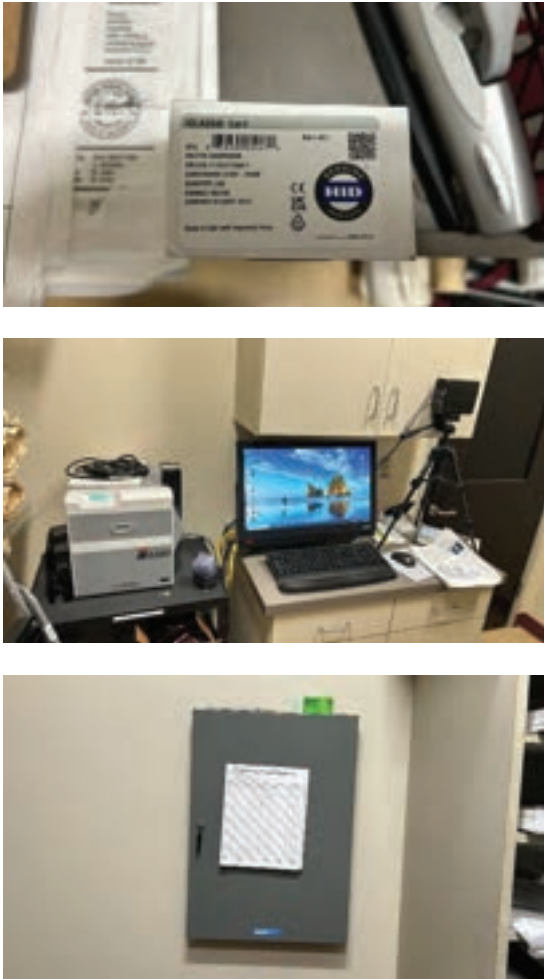
<p>The first photo shows a white HID iClass security card with a QR code and text. The second photo shows a workstation with a monitor, keyboard, mouse, and a camera on a tripod. The third photo shows a grey security panel with a white label.</p>	<p>The college is using HID iClass security card credentials, these are 13.56 MHz contactless cards, user photo image can be applied to the cards on issue. The workstation provides visibility of the Software House access control and video surveillance systems, network connection appeared slow.</p>	<p>Use of higher frequency encrypted security credentials is excellent and should be used across all district facilities, 125 kHz frequency should not be used. Reference recommendation #108 regarding security electronics systems management and administration. Security credentials across the district should contain photo imaging of the credential holder, there is inconsistency in this approach across the district.</p>	3

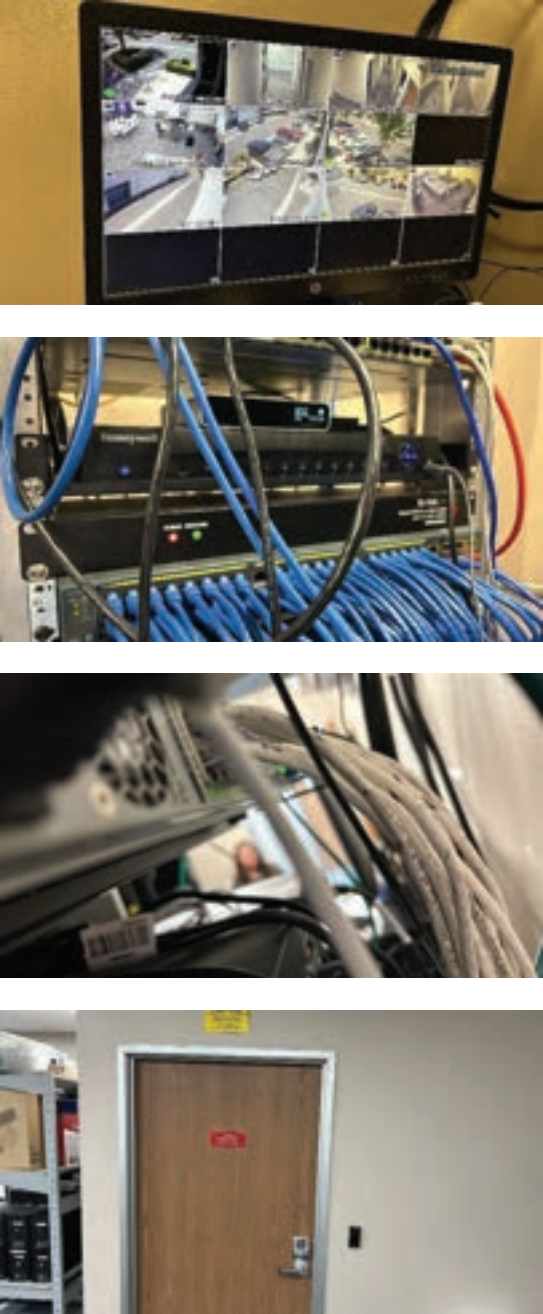
<p>All security access control devices and video surveillance cameras are Honeywell product and system. This is a legacy existing tenant system who were previously the owners of the building. Access to the access control application is provided to the district allowing for activation and deactivation of security credentials. District cannot view video surveillance cameras locally; it is assumed that district police can monitor cameras. The tenant holding control over a security system that includes shell devices is unusual.</p>	<p>Replace the existing security electronics systems with district owned and managed systems. The tenant should not have visibility of cameras outside of their leased space without written authorization from the district and confirmation by legal counsel that there is no liability impact on providing access. The assumption that district police can view video surveillance cameras appears incorrect. Verify if district police can or cannot view video cameras and confirm if they do require viewing rights. Security electronics system standards should be created, and systems interfaced.</p>	4

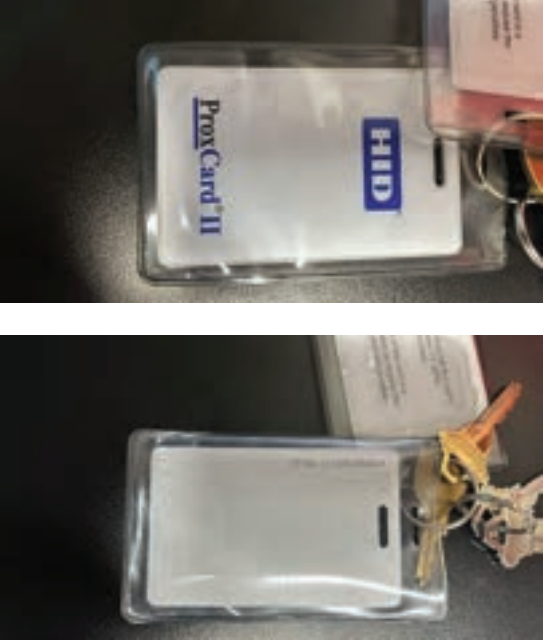
<p>HID ProxCard II are issued to both district and tenant employees. The tenant informs the district administrator when an employee left employment so that credentials are deactivated. The district staff are unsure of how many brass keys are in circulation providing entry to the building. The tenant has not shared any key issuance records with the district.</p>	<p>Perform a review of the building keying status, consider rekeying the exterior locks with new key cylinders and controlled brass key distribution. Distribution of keys should be minimal with access control credentials the primary access tool. The district should migrate away from Prox cards that can easily be copied.</p>	4

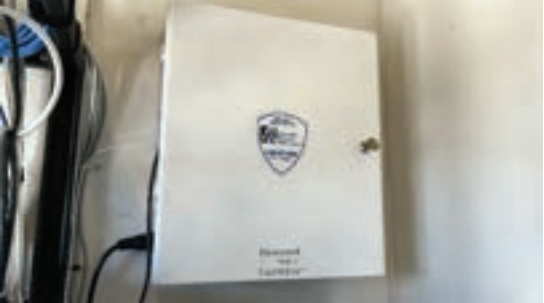
<p>Exterior accessible access control and intrusion detection equipment is located within the electrical room. The electrical room is accessible by brass key only. There is no video surveillance camera monitoring the equipment or drip tray installed under the HVAC unit. Battery back-up should be</p>	<p>The electrical room should be controlled with card reader providing an audit trail of approved access or unapproved entry attempts. A video surveillance camera should be installed internal to the space providing deterrent and visibility of activity. Best practice is to remove keys from the security</p>	3

<p>replaced with new as existing is approximately 3-years old. Keys to security enclosures should be removed.</p>	<p>enclosures to prevent potential tampering by unauthorized persons, batteries should be replaced on schedule every 2 to 3 years. If the HVAC system is not plumbed, install a drip tray. Security electronics system standards should be created, and systems interfaced.</p>	
5

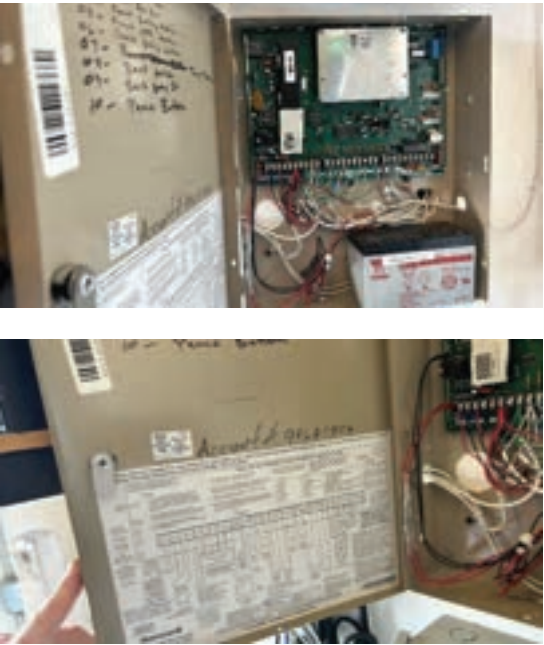
<p>The intrusion detection system also utilizes Honeywell product. There is no integration between any of the security electronics which are all Honeywell products. Security electronics is not providing operational benefit to building safety and security. Power supplies are powered by cable plugged into a receptacle.</p>	<p>Security electronics system standards should be created, and systems interfaced. Recommended migrating to the DMP intrusion system used consistently across district facilities. Best practice security electronics installation is to hard wire security power or house power transformers within security junction boxes/enclosures.</p>	2

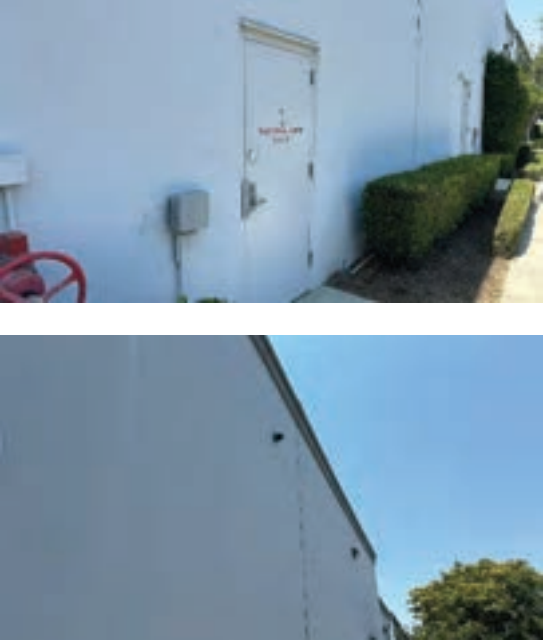
6

<p>An exterior video surveillance camera monitors general activity in the vicinity of the electrical room. Access into the electrical room requires a brass key, there is no access control applied to restrict unauthorized access into this space.</p>	<p>Reference recommendation #4, the video surveillance camera if lowered to approx. 10' AFF would provide visual coverage of the electrical room point of entry. Interface with the access control and intrusion detection systems.</p>	3
7

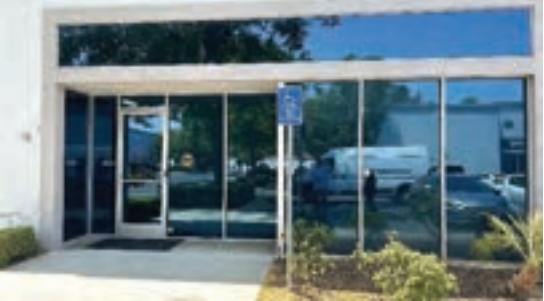
<p>Glazing has reflective measures applied to it, reducing visibility from the exterior side during the hours of daylight. There are no ballistic treatments applied to the glazing. There is a single video surveillance camera located on the ceiling, providing situational awareness of activity at the main point of entry. There</p>	<p>Consider a video intercom at the main entry providing ability to communicate with persons requesting entry visually and audibly if the building. This eliminates the risk associated with having to open the door to verify why someone is requesting entry if not an authorized security credential</p>	3

ID#	PHOTO	OBSERVATION	RECOMMENDATION	RISK
	 	<p>is no video intercom installed allowing for two-way audible and visual communication with persons seeking entry prior to granting it.</p>	<p>holder. Consider use of industry standard ballistic level protection rating at exterior doors and windows that may require ballistic-level protection.</p>	
8

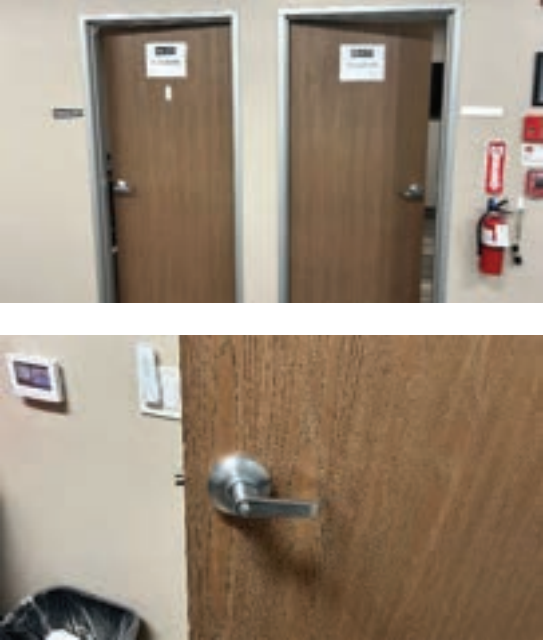
<p>The district office spaces are accessible by brass key only, there are no electronic access control measures. Both doors can be locked from the interior using a thumb turn, door closers are not installed, and neither were lock bloks.</p>	<p>Install lock bloks and door closers to support positive latching upon closure. Doors should always function in a locked state. Installation of access control at these offices should be considered as the district staff do not occupy them each day and the tenant has access to the space directly outside the offices. Install a multi-sensor camera in the reception area monitoring general activity.</p>	3

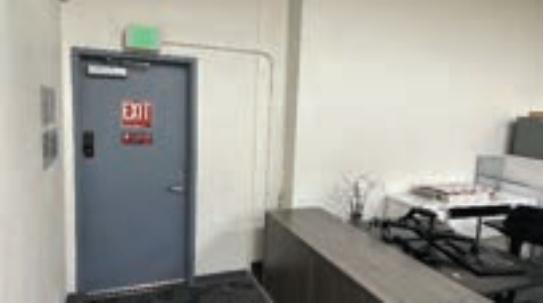
10

<p>Exit opening has a local door alarm installed and has a spy hole providing visibility of exterior activity. The door has an internal locking lever. The external roller shutter door has been framed in.</p>	<p>Replace all battery local alarms with hard wired, eliminate potential lack of power monitoring and battery replacement issues that standalone and wireless devices present.</p>	2
11

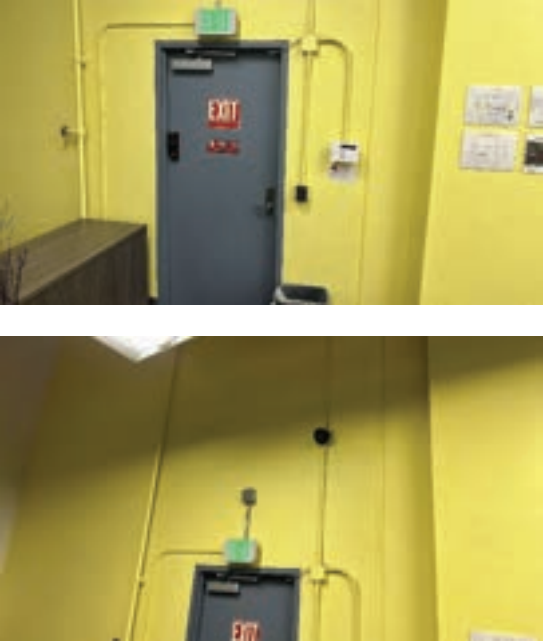
<p>The local door alarm is non-operational, an intrusion detection arming station is located on the wall. Unique arming/disarming codes are issued to district staff and to the tenant, there is uncertainty regarding the tenant management of codes. There are two video surveillance cameras in this conference room, and the interior card reader was a leftover from the tenant when owner who used the interior card reader to monitor their staff presence.</p>	<p>Remove legacy internal card readers previously installed for prior building owners' management of people attendance. Repurpose or install new card reader that is used to arm and disarm the intrusion detection system, eliminate use of arming station codes that can be shared. Replace all battery local alarms with hard wired, eliminate potential lack of power monitoring and battery replacement issues that standalone and wireless devices present.</p>	2

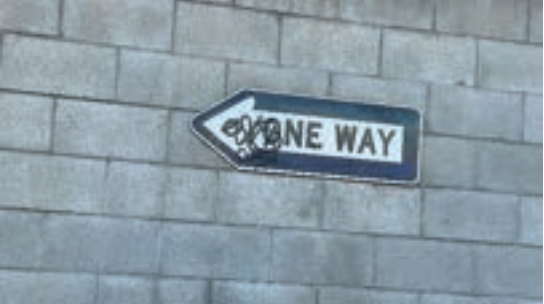
10

<p>Tagging on campus is a frequent occurrence and had been applied to the one-way sign at the perimeter road adjacent to the swimming pool.</p>	<p>Prioritize maintenance and repair that could affect the perception of safety and security of facilities such as removal of graffiti/tagging from signage.</p>	2
11	 	<p>Swimming pool perimeter fence line is easily scalable. There is no video surveillance monitoring any of the activity at the swimming pool area which presents potential liability issues if an incident were to occur. Ease of access into the swimming pool is concerning. A Code Blue emergency telephone was</p>	<p>Develop security standards including review of fencing heights and material. Consider future use of decorative fencing that does not have flat top rail to support ease of scaling. Unauthorized activity at the aquatic center carries significant risk and liability to the college that should be mitigated. Video</p>	4

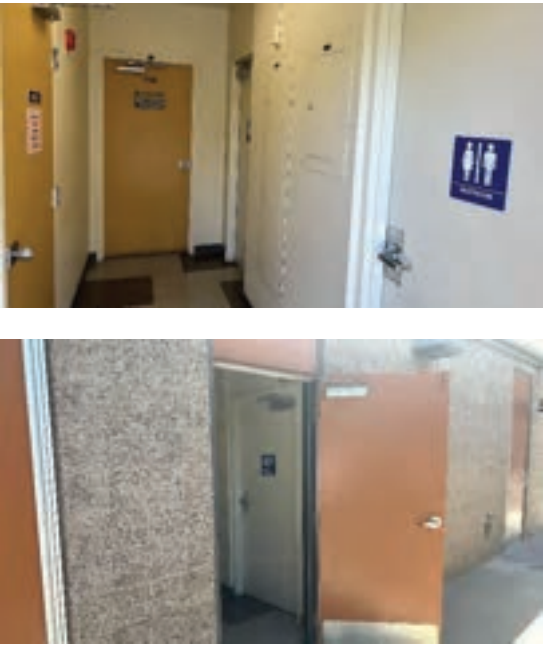
<p>Exterior restrooms are completely unlocked and provide opportunity for any person to loiter inside with intent to cause harm. Again, the lack of video surveillance does not allow for situational awareness visibility of activity within the restroom vestibule area, or ability to monitor activity on the immediate exterior of the building both in real-time and forensically.</p>	<p>Install electronic surveillance that provides a view of the immediate area, specifically activity at primary exits and entrances. Consider using cameras with intelligent video surveillance capability that can automatically identify suspicious activity, abandoned items, unexpected movements, etc. Use video surveillance equipment that adjusts for environmental conditions (e.g., lighting, distance, vibrations, etc.). Consider locking and unlocking the restrooms on schedule or provide staff key access to restrict unauthorized use and access.</p>	3

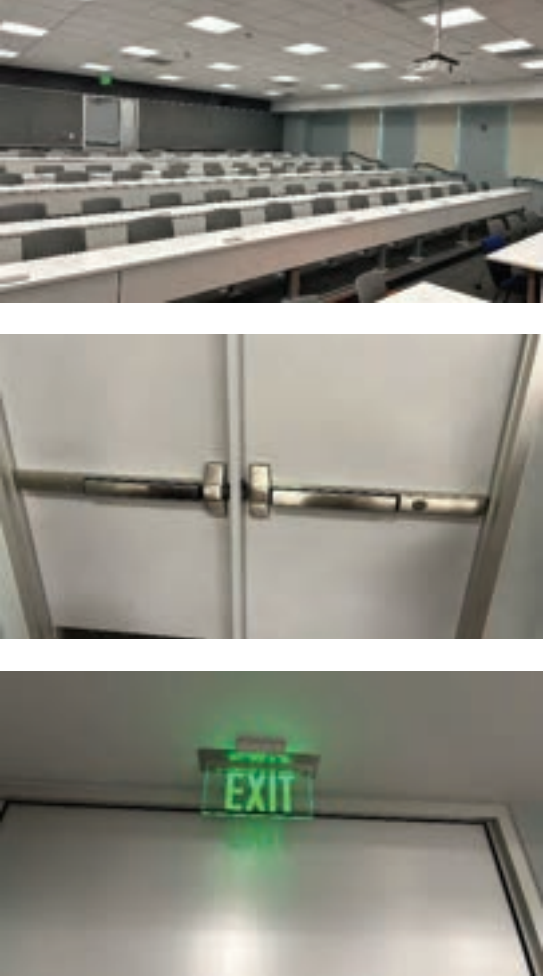
<p>system arming stations are allocated per building and not on a per classroom basis. Corbin Russwin panic hardware is installed and requires 1 AMP inrush per the college locksmith. Request to exit motion sensors are mounted on the ceiling rather than integrated within the hardware. The single door at the rear of the classroom is not equipped with a door position monitoring contact and relies upon the ceiling mount motion detector to identify any movement within the space if access is made through this opening.</p>		
31

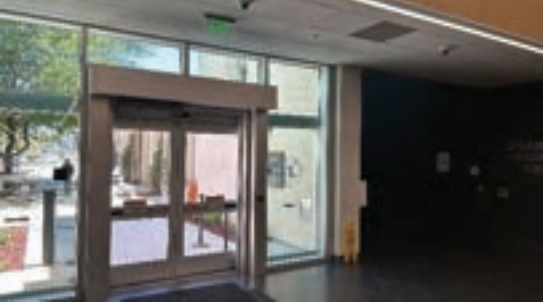
<p>The main entry doors into the CAK building are electrified sliders with access control, and an ADA push plate (actuator) mounted on the exterior side providing access when the building is closed. There are concerns shared that in a lockdown the door sensor automatically opens the doors when activated. An operational review of technology use and how it currently performs is required. A ceiling mount request to exit motion sensor shunts the door position contacts on activation. Video surveillance cameras installed in the lobby area are believed to be non-operational. The lack of operational cameras presents</p>	<p>Review the current operational state of the opening from the interior during a lockdown. Consider installation of an internal ADA push plate that provides free egress, removing the constant opening of the doors when the internal motion sensor is activated. Review code and AHJ requirements. Conduct a review of all video surveillance cameras and perform corrective action or replaced with new, any cameras that are non-operational.</p>	4

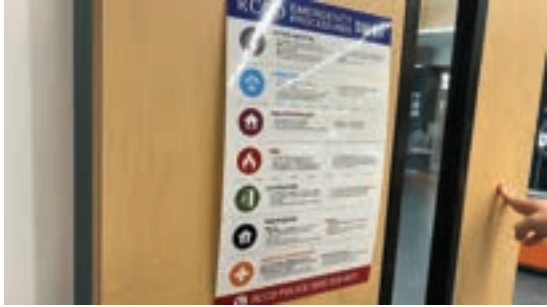
Emergency procedures are distributed across campus in most buildings and are deployed by safety staff in classrooms. There distribution is excellent, and they serve as a quick reference guide for incidents including lockdown, fire, earthquake etc.	General observation.	0
33

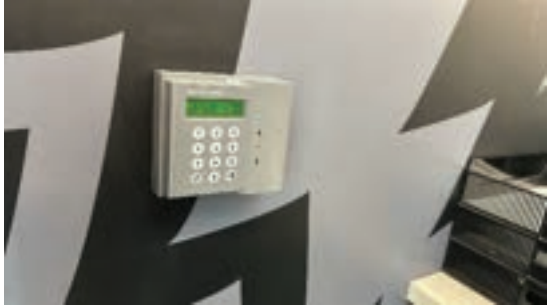
Software House intrusion detection alarm arming stations are located in all buildings that have access control and intrusion devices installed. All non-access control buildings with intrusion devices, DMP keypad arming stations are installed. The Software House keypads are used for initiating a lockdown by input of a 4-digit code that is known by select authorized individuals.	Develop security standards that provide direction regarding minimum security requirements at each building. Review the process and protocol for activating a lockdown using the 4-digit code. Review operational considerations and alternate protocols that may reduce risk of inability to activate a lockdown if the authorized individuals are not present, determine a workaround.	3

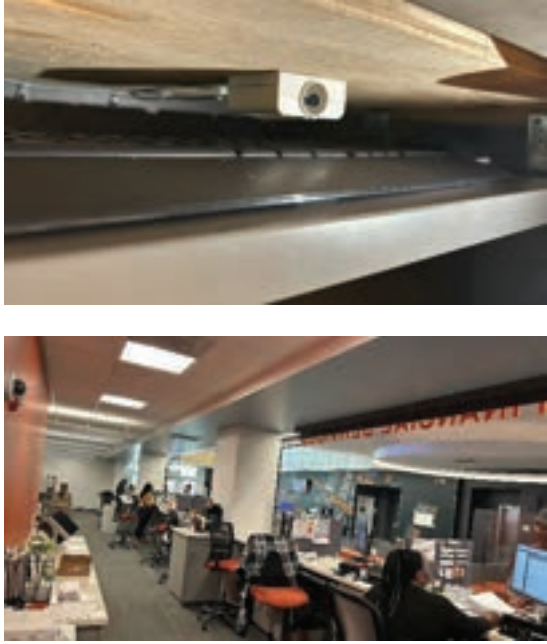
34

Wireless panic buttons are installed under the Financial Aid transaction counter that communicate out through the access control system to the intrusion detection system monitoring station. The offsite monitoring station then alert the Riverside Sheriffs Dispatch who then notify campus police. Wireless panic buttons are reliant upon maintaining power through batteries to function as intended, the power status is not monitored on the access control system. Panic buttons are not located at every workstation which places inefficiency to activate if assistance is required at a workstation without a panic button installed. There is no physical barrier above the counter between the public and staff, the counter remains open at all times with no roller grill	Develop security design standards that provide consistency and governance to installation of devices such as panic buttons. Consider use of hardwired devices rather than wireless, wireless communication can often be impacted by the built environment; and continual review of battery life often required. Standardization of approach eliminate risk and vulnerability that ad hoc placement of devices presents. Consider installation of further video surveillance to provide monitoring of the transaction counter.	3

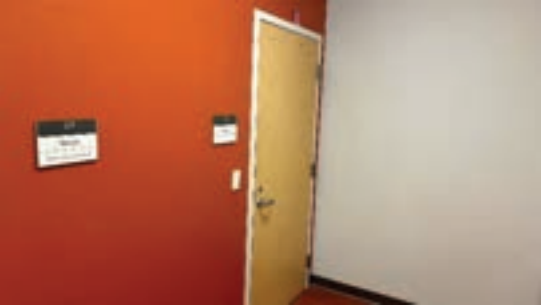
<p>Break Rm. 112 is accessible to staff via brass key only. There is no ability to monitor which staff members enter into the room. The use of keys to access the space presents risk if an employee later is released from employment and they retain their keys. There is no formal retrieval process in operation that guarantees that staff return keys upon end of employment. Use of access control credentials would allow for immediate removal of access through systems programming.</p>	<p>Consider application of an access control card reader at this location to provide an audit trail and restricted access to the staff lounge. Develop security standards that would identify staff lounges as requiring access control measures.</p>	2
36

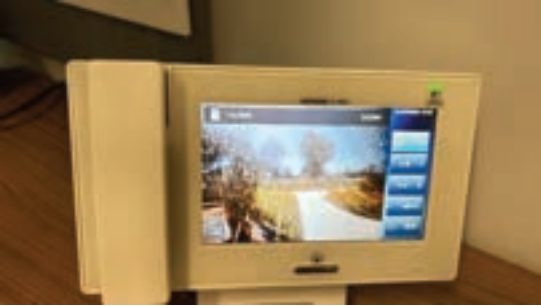
37

<p>Cashier's Office rear entry door access is provided via remote release from an Aiphone video master station. The visibility on the camera lens at the master station does not provide a clear facial recognition of any person requesting entry. The video door station requires review and repair. Verkada video surveillance cameras are installed, but no staff members</p>	<p>Perform a maintenance review of the exterior camera to ensure that a clear field of view is provided on the internal video master station. Provide communication to the department staff regarding who can view the video surveillance cameras, and how long video is retained. Develop policy and protocol regarding video usage and retention. Security standards</p>	2

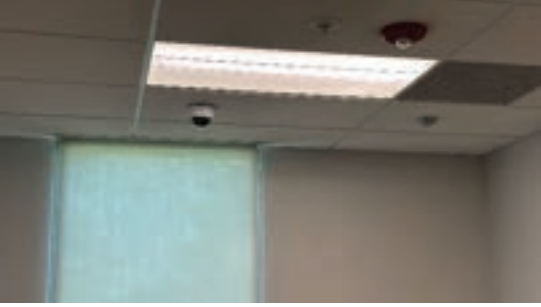
<p>have any idea who monitors activity or what usage rights that persons with viewing capability may have. This is concerning from a privacy perspective that there is a lack of policy available regarding video retention and use.</p>	<p>should clearly define where video surveillance cameras will and will not be installed.</p>	
38

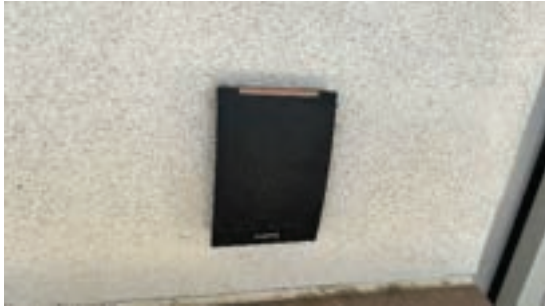
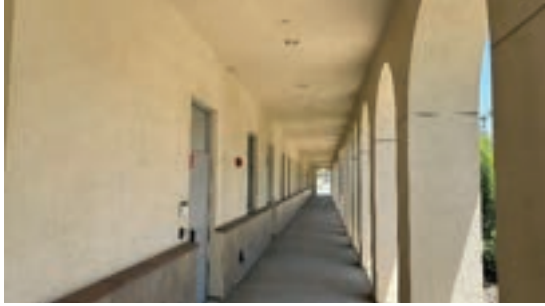
41

<p>Controlled entry doors with zero video surveillance coverage of activity no ability to interface access control and video surveillance currently. Interfaced systems would allow for camera call-up on alarm event programming within the access control system. Real time situational awareness and forensic viewing capability is not available.</p>	<p>Monitor all exterior covered walkways and access control points providing visibility for situational awareness and forensic viewing capability. Video surveillance cameras should be programmed to provide immediate camera call up upon activation of a door forced or door held alarm event.</p>	3
42

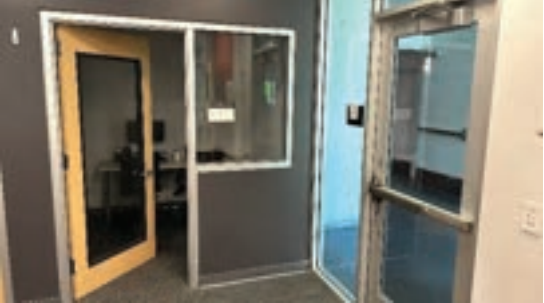
43	 	<p>Second floor motion detector serves no purpose as access to this floor is highly unlikely from the exterior. The glazing is inaccessible from exterior scaling of the building. Intrusion detection is typically deployed on level one of buildings and on upper floors only where direct entry into building spaces can be achieved i.e., stairwells. Public restrooms are setback from the corridor with no video surveillance monitoring of activity in the corridor or the setback area.</p>	<p>Develop security standards that provide clear direction on where security devices shall and shall not be installed. Consider installing a video surveillance camera monitoring activity on the exterior of the setback restrooms.</p>	3
44

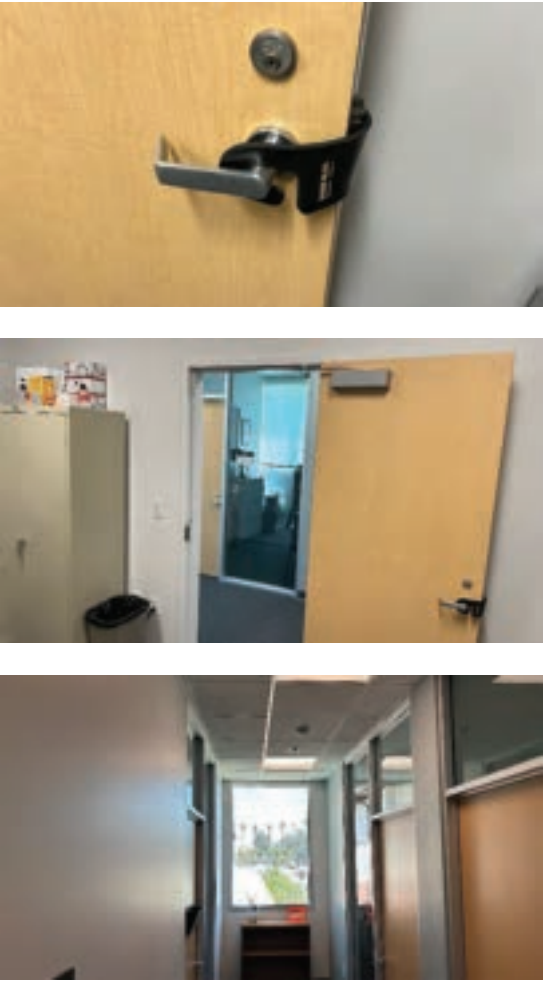
<p>Storage Rm. 204T is identified for shelter place use in the event of an active shooter. The door hardware is equipped with a door lock strap that covers the latch allowing for immediate closure and latching of the door when removed (the door needs to stay in a locked state to support securing of the entry upon closure without having to lock with a key). There is no means for occupants to communicate out from this space if sheltering within, other than by using personal cell phones. There is no network phone installed although data wall jacks are available to support such equipment. communication from within the space. Additionally, no emergency supplies pack was observed and there is no video surveillance installed on the exterior of the room in the corridor providing situational awareness.</p>	<p>Remove the latch retraction strap and replace with a lock block on the door frame. The door should not be propped open. Install a network phone within this space providing ability for communication in the event of a lockdown or shelter in place. Consider installation of emergency supplies for use in the event of long-term shelter in place. Install video surveillance in the corridor adjacent to the opening.</p>	4

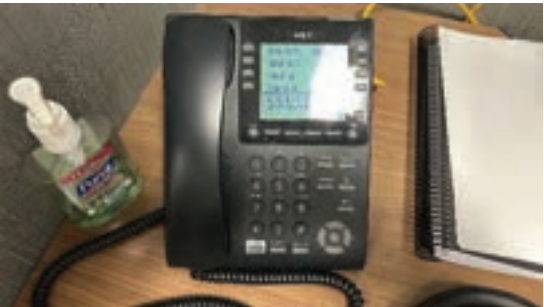
46

<p>All office spaces have network telephones located at the work desk. The phones cannot be used for all call communications and are "old" technology NEC handsets. The deployment of telephones is restricted to office staff and telephones are not deployed within classrooms. There is a reliance upon the cell phone as the primary tool used for mass communication via push SMS messaging and the RAVE application that is an opt-in service.</p>	<p>Review the use of telephones across the campus, the pending termination of the NEC PBX service will impact further communication capability. The telephone system requires an upgrade to modern technology, and it is recommended that telephones be provided in all student learning areas i.e., classrooms.</p>	3

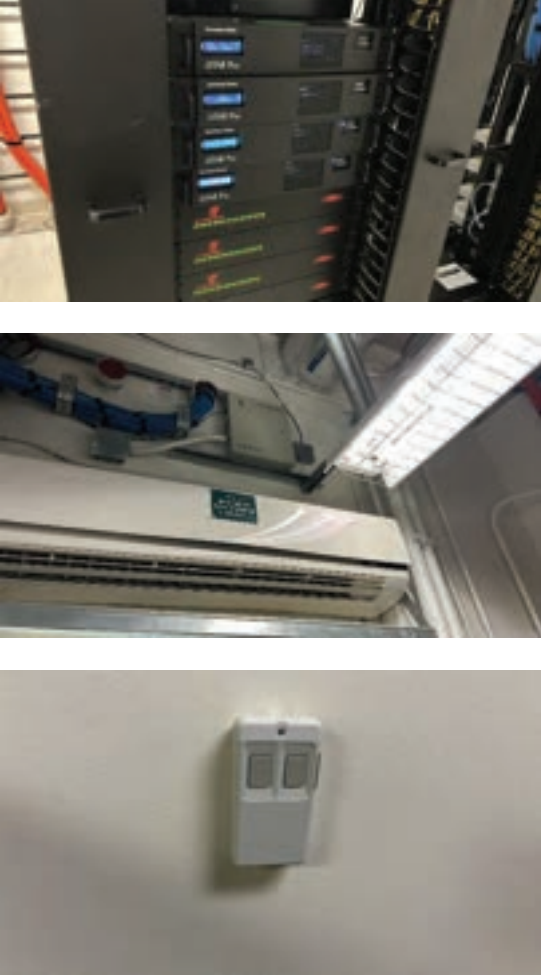
<p>Data Rm. 215 is a generic example of data equipment rooms located on each level. Rooms are climate controlled with HVAC units and access control headend panels are rack mounted. The iStar Software House panels are no longer manufactured. Door control panels are located above each door and cable then ran back to the iStar panel. Wireless lockdown buttons are currently being deployed across select campus buildings, activation of the button will lock all doors programmed within the system to automatically lock. No signage indicating button purpose are currently installed, and they are easily tampered with as no covers installed. Additionally, no protocol to interface with camera call-up has been considered.</p>	<p>Install protective covers over the wireless lockdown buttons to avoid potential tampering and misuse. Apply signage adjacent or above each lockdown button providing clear identification of what the buttons operational intent is. Recommend that future lockdown buttons be hardwired and mushroom form factor with protective casing. All locked down buttons should be monitored with video surveillance to provide forensic review if activated.</p>	3

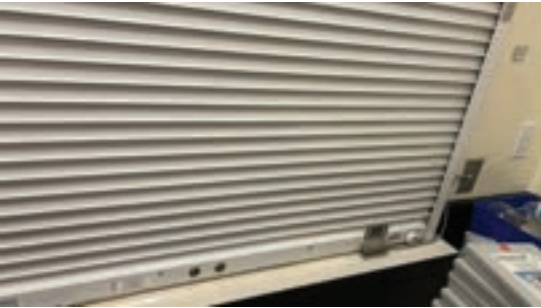
53

<p>The pass-through window for distribution of chemicals and other controlled science items is secured when the space is unoccupied and monitored with a surface mount contact. The department main entry card reader is mounted to the wall within the door swing. This location is poorly designed and does not meet best practice design, locating within the door swing presents ADA access challenges and potential harm to persons presenting their security credential if a person is egressing eth door at the same time. The</p>	<p>All card readers should not be installed within the swing of the immediate door. There is potential for injury to occur to persons presenting security credentials at the card reader if an occupant of the space egresses at the same time. Remove the lockdown button and relocate within the interior of the department. Refer to recommendation #52 regarding future lockdown button considerations.</p>	1

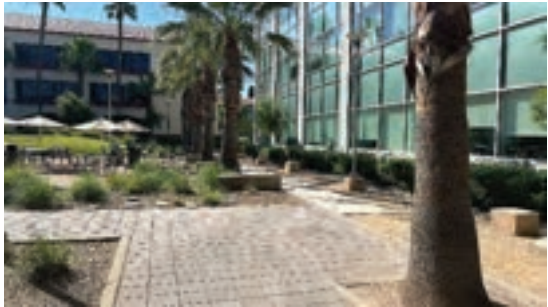
<p>pedestrian walkways between the Nursing and Math's Buildings. The blue strobe on the tower is not illuminated at all times, there is inconsistency across campus on blue strobe illumination.</p>		
56

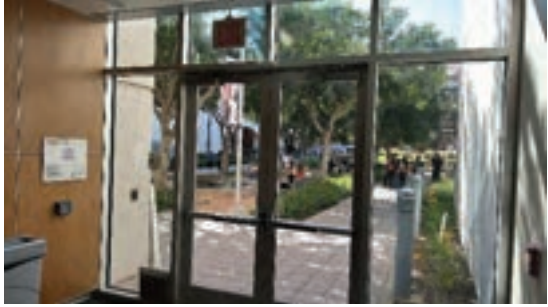
<p>The Nursing Building main entry door is controlled with an access control card reader providing after-hours access. A Software House arming station is installed to arm and disarm the intrusion system. There appears to be no dedicated ADA accessibility into this building. Video surveillance cameras are installed however they are believed to be non-operational. The area outside of the building provides seating for students which provides excellent natural visibility of activity, natural access control is also applied with paved walkways that clearly define pedestrian path of travel.</p>	<p>Review the main entry from an ADA perspective and make corrective measures if required. Conduct a review of all video surveillance cameras and perform corrective action or replaced with new, any cameras that are non-operational.</p>	3

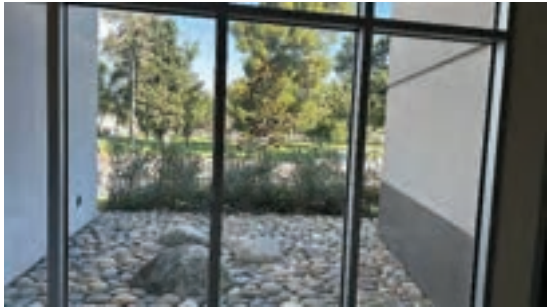
57

<p>Glazing provides unrestricted visibility into an out of the building. There is no protective film applied to this glazing, nor is there any film applied that would reduce visibility from the exterior in. Glazing is double paned as typical for all "newer" building on campus.</p>	<p>Consider application of one-way film eliminating ability for visibility from the public side in.</p>	2
58

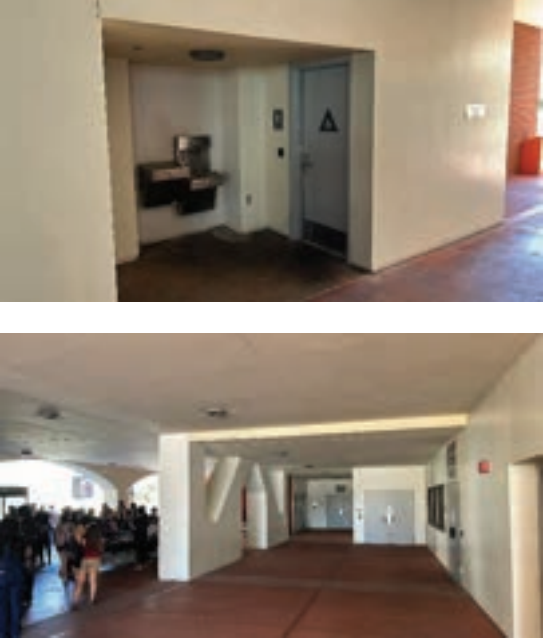
<p>The outdoor area adjacent to the Digital Library and the Auditorium is heavily controlled with access control applied to exterior doors including restrooms, which are locked and unlocked on schedule. There is no public address system installed that provides notification audibly if card readers are put into a locked state and building access restricted. Elevators are also controlled on a schedule; however, they are not connected to the access control system for automated locking/unlocking or monitoring. An emergency wall mounted call station calls out directly to 911 dispatch. There is no video surveillance monitoring</p>	<p>Use a multimodal communication system (e.g., mass notification, public address, cell phones, pagers, panic buttons, etc.) that notifies all building occupants of threats and provides emergency instructions. The lack of communication availability to occupants within the restroom in the event of a lockdown is a liability that requires mitigating. Improve communications across campus from an information perspective providing education on the different means of receiving mass notification communications. There is misunderstanding amongst campus users, with many only aware of the RAVE mobile</p>	4

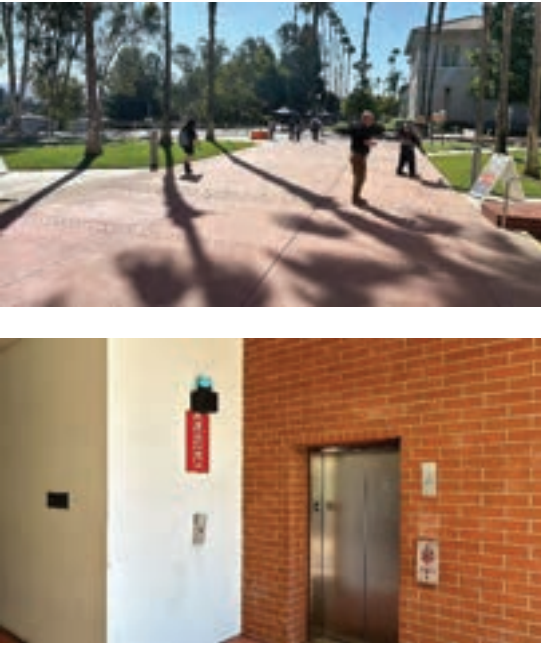
<p>the area which experiences heavy foot traffic and frequent student congregation. There is good natural visibility across the area with student presence serving as eyes and ears on the ground, well-maintained landscaping supports natural surveillance, access control, and territorial reinforcement.</p>	<p>application communication and nothing else. Consider connecting the elevator controls to the access control system to allow remote locking and unlocking and schedule. Install video surveillance providing ability to monitor situational awareness activity and perform forensic review.</p>	
62

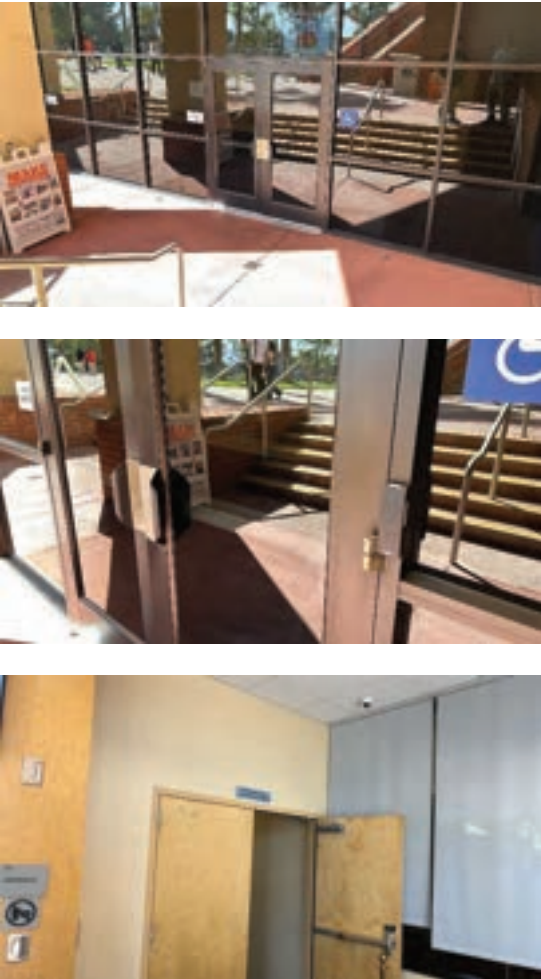
<p>Access to the Auditorium Rm. DL 121 is access controlled with a mullion mount access control card reader installed. At the time of assessment, the right leaf at the opening was not fully closed and latched. This is a vulnerability if the door is not fully secured when doors are locked on schedule. Film is applied to the glazing restricting visibility from the exterior inwards. The interior doors leading into the auditorium space were propped with a lock blok installed. Video surveillance cameras within the vestibule appear to be older technology and believed to be non-operational.</p>	<p>Perform maintenance review at the opening to ensure that positive latching occurs upon closure.</p>	4

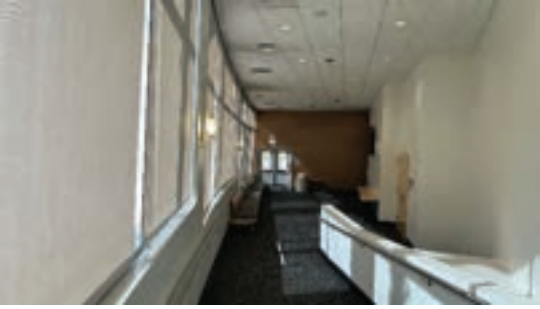
<p>The ADA access ramp is not visible from the exterior with blinds applied to the exterior glazing lowered. Egress from the main auditorium is through the side exit doors that lead out directly to the exterior exit doors. There is no video surveillance of activity within this space, or audible or visual public address in use.</p>	<p>Consider installation of video surveillance.</p>	2
64

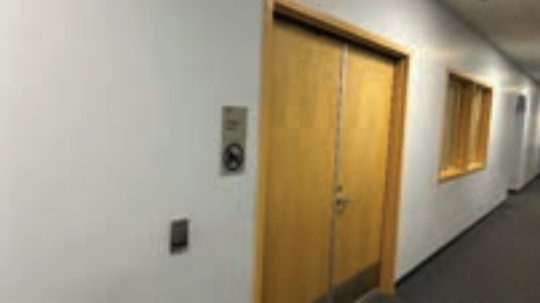
65

<p>Keypads are installed within the interior space of the ISS department; however, these are non-operational and should be removed as they serve no purpose. Fully functional access control measures are not applied to the openings providing no restricted entry into or to rooms</p>	<p>Remove all non-operational keypads as they serve no purpose to the security operation. Develop security standards and apply access control measures as the standards determine. Recommend replacement of the existing audio intercom with a</p>	1
