Riverside City College Academic Senate

FINAL REPORT

Riverside Community College District (RCCD) has assigned Salas O'Brien Engineers, Inc. and Aanko Technologies (SOBE/Aanko) to conduct a comprehensive physical security program review of all District campuses to establish a baseline status that can be used as a foundation to develop, grow, and strengthen its District-wide physical security program to better protect and serve its communities. This security program review involves site visits, existing documentation evaluation and stakeholder interviews to evaluate physical components including security electronic systems, policies and procedures, socio-environmental conditions, training programs, and security staffing levels. The physical site assessments for all campuses were conducted during their typical hours of operation, before and after hours of typical operation, with the assumption that the security components and electronic systems were in good working order and functioning normally.

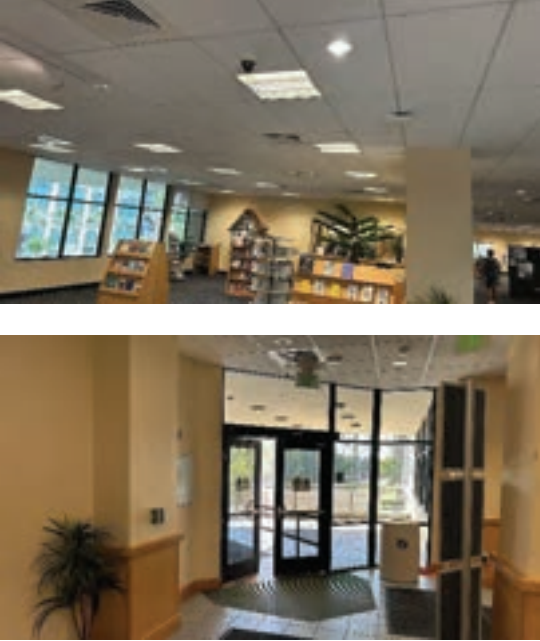
<p>Access control into the main entry of the library on the second level is unlocked on schedule. There is a single video surveillance camera that is assumed non-operational, mounted in the main entry ceiling. Side rooms are equipped with passage locksets that provide no ability to lock from the interior. Visibility into the spaces is completely unrestricted with no window treatments applied. Each room is unlocked manually daily and remains in this state until relocked at the end of the day.</p>	<p>Consider replacement of passage locksets at all office spaces with internal thumb turn and lever interior locking hardware. Install window film on side room windows to restrict visibility in the event of a lockdown. Consider installation of additional video surveillance within the library area, providing visibility of general activity.</p>	4

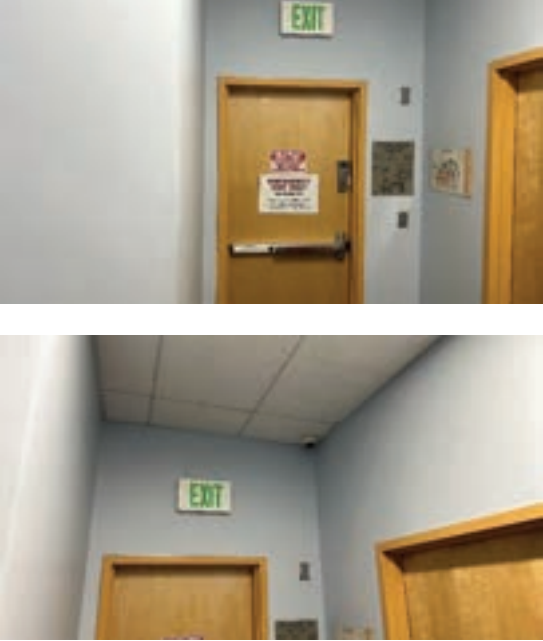
67

<p>The stairwell exit at the library second floor is clearly defined with exit signs above each opening and further reinforced physically at the initial stairwell exit door on both sides. There is a local door alarm that sounds if the stairwell door is opened. Signage clearly communicates visually the operational intent of the opening. Video surveillance installed in the stairwell is assumed to be non-operational. There have been concerns raised regarding the lack of re-entry available into the library space at this opening upon exiting. The opening functions as it should from a security perspective, re-entry should be through the main entry point only.</p>	<p>Install video surveillance in all stairwells typical.</p>	2

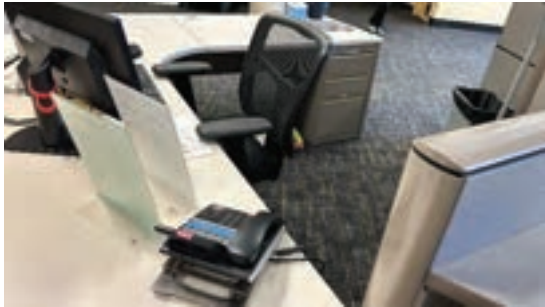
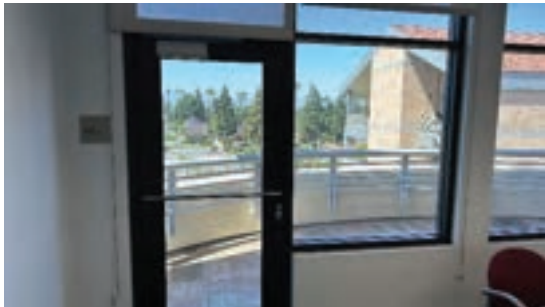
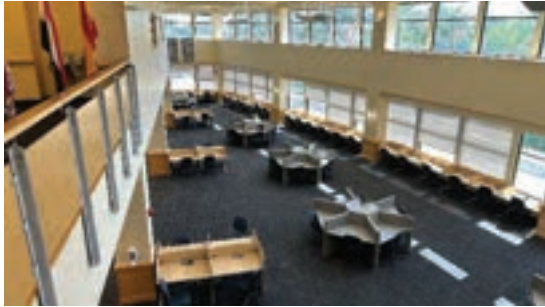
70

<p>Access to the fourth level is completely unrestricted using the main stairwell and presents significant liability and concern regarding suicide by jumping from the structure as experienced several times at the campus parking garage. The access point leading to the room that provides access to the balcony is a staff break room and controlled with a card reader but unlocked on schedule.</p>	<p>The staff lounge is unlocked on schedule as indicated in the photo with the green LED illuminated. Recommend that this opening remain locked at all times and be accessible by presentation of a security credential only. Consider controlling access to the patio with a card reader to provide additional restriction on access. Free egress from the patio shall be maintained, install video surveillance on the exterior of the patio and within the hallway leading to the staff lounge. Access control and video surveillance should be integrated to provide camera call-up if a door forced, or door held alarm is activated.</p>	4

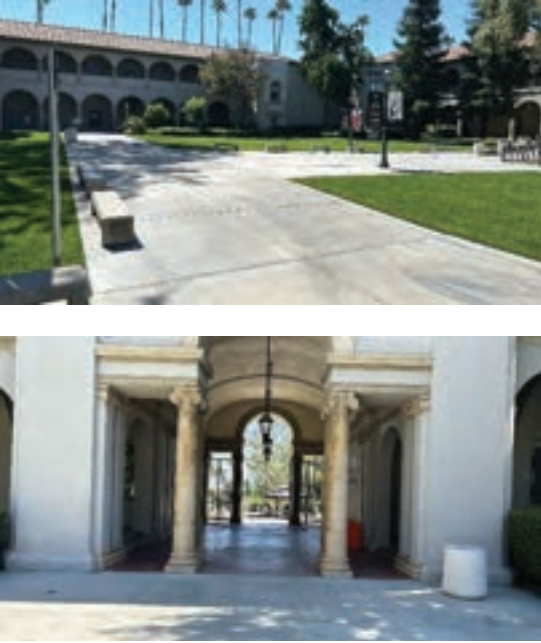
<p>Access into the quad area can be achieved through several entry gateways. The gates are locked with chain and padlocks daily, with no electronic access control measures in place. Natural surveillance within the area is excellent with a seating area for students provided. The quad has a second-floor balcony providing access to rooms, also providing unrestricted visibility from a vantage point into the inner quad area. There is no video surveillance installed within the quad monitoring activity.</p>	<p>Install video surveillance.</p>	2
72

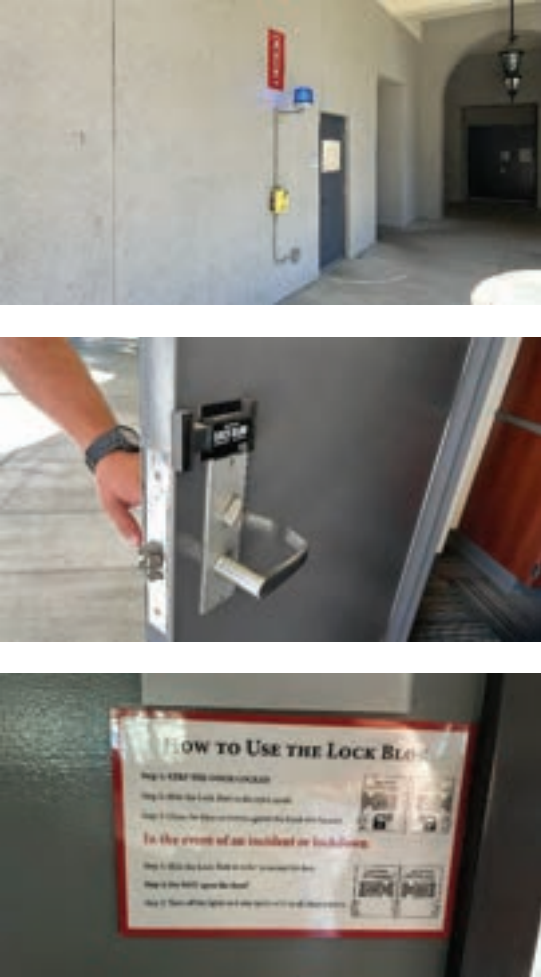
<p>Classroom doors are unlocked and opened daily by campus police and then the lock reactivated so that the doors remain in a locked state. Doors are equipped with lock blocks that support immediate closure and latching upon retraction. If a door is closed and positively latched a call has to be made to the police to come and unlock the door from the exterior as brass keys are not distributed to faculty at this building. Free egress from the interior is always maintained. Emergency blue phones are installed on both the first and second floor with the blue strobes turned on at all times, supporting ease of phone location identification. The strobe mounting heights appear close to the minimum headroom clearance required by code of 80", strobe mounting heights are not standard across campus</p>	<p>Consider providing brass keys to faculty to unlock classroom doors eliminating the need for doors to remain in an open status throughout the day. Review the mounting height of the emergency phone blue strobes to ensure that they are compliant with code driven mounting heights. Install video surveillance to provide visibility of access within the exterior walkways.</p>	3

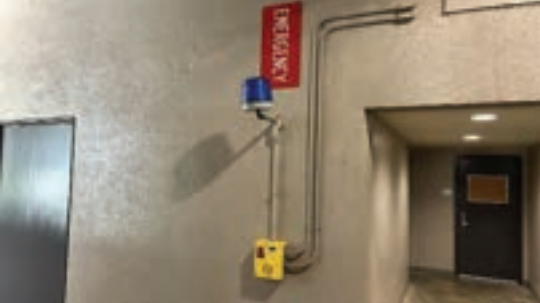
<p>Exterior walkway emergency telephone with blue strobe unlit demonstrates inconsistency in operational state of emergency phones and strobes across the campus.</p>	<p>Refer to recommendation #72 regarding height of the strobe mounting. Consider remounting of the strobe with a more robust wall mount arm.</p>	2

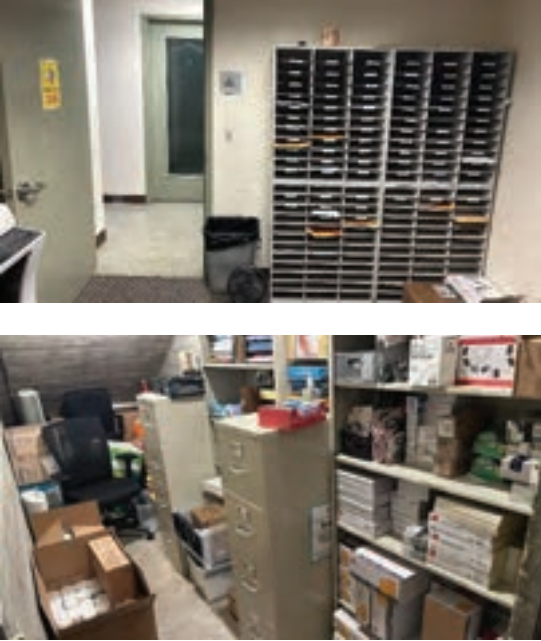
<p>The Mail Rm. within the basement is freely accessible as the door is propped open and unlocked. There have been known vandalism issues occur within this space and there are no controls restricting access to authorized persons only. There is no video surveillance of activity in this area.</p>	<p>Recommend that all mail rooms be controlled access with access control card readers. Video surveillance should be installed within the space to monitor activity. General public should not be able to access mail rooms. Locate future mail rooms away from main entrances and areas containing critical infrastructure, utilities, distribution systems, and other important assets.</p>	3
77

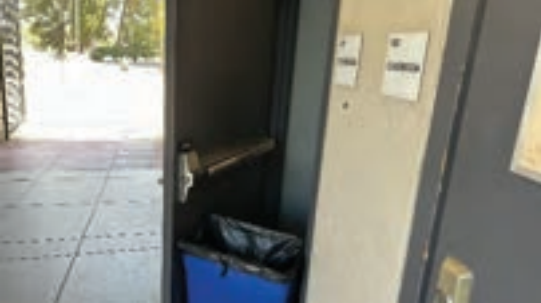
<p>Rm. 100 has access control applied to it and was originally intended to serve as the Mail Rm., the controls are appropriate for a Mail Rm. A lock blok has been installed on the controlled entry door which could inadvertently hold the door open providing unauthorized access. Access control doors at non-</p>	<p>Review the policy and protocol regarding the application of lock bloks, they should not be in use at openings that are electronic entry and unoccupied spaces. All access control doors should have door closers installed on them as standard, this should be captured within security design standards. The mail room is</p>	3

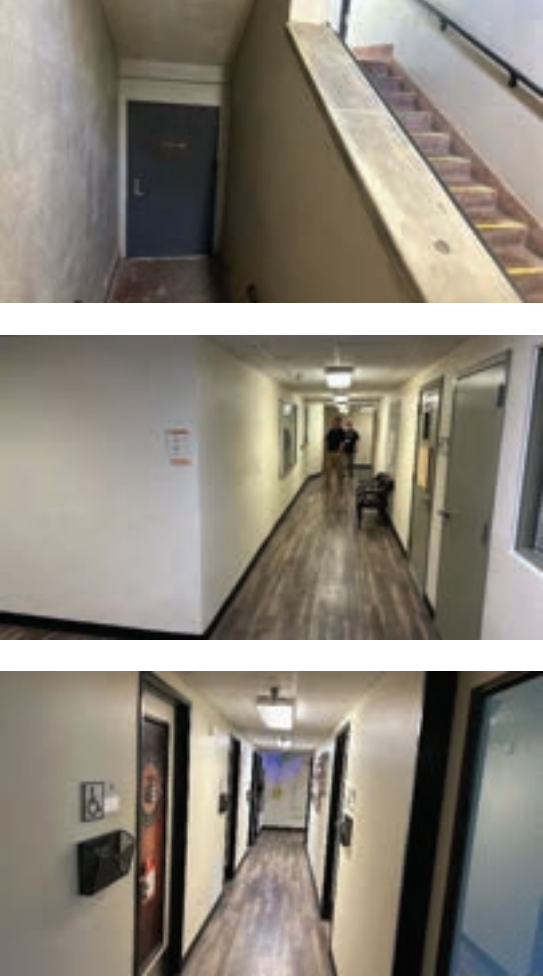
<p>Faculty offices located in the basement are accessible 24/7 with no video surveillance monitoring activity. The lockset is passage function and cannot be locked by key. Emergency lighting is activated 24/7.</p>	<p>Replace existing passage lockset hardware with locking hardware. Consider controlling the exterior entry door with an access control card reader to provide audit capability, and authorized controlled entry that can be locked and unlocked on schedule. Video surveillance should be installed within the basement corridor.</p>	3

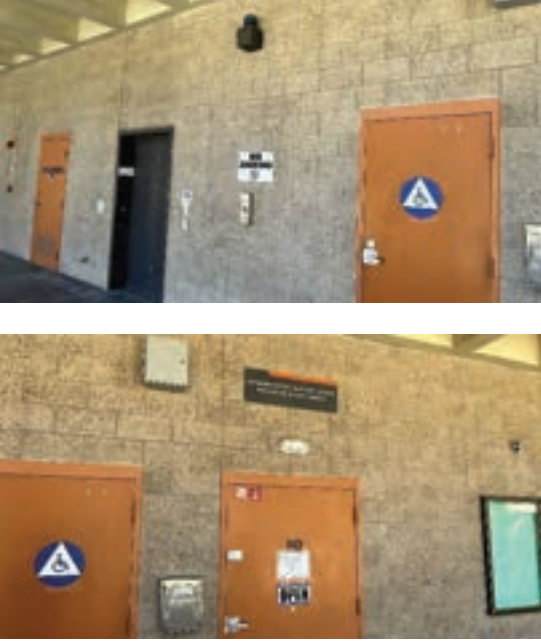
<p>The emergency phone blue strobe at the Business Education building is inoperable. There is no video surveillance monitoring any activity in the vicinity. Signage above the administrative support center is clean and well displayed, however the text is small and not easily readable from a distance. Emergency lighting is installed along the underside of the exterior walkway ceiling.</p>	<p>Design text and finishes on signs for clarity and ease of reading. Perform a maintenance review of the emergency phone blue strobe to identify if it is operable or not. Develop operational standards regarding operational state and functionality of emergency phones and blue strobes. Provide consistency in application.</p>	3
80

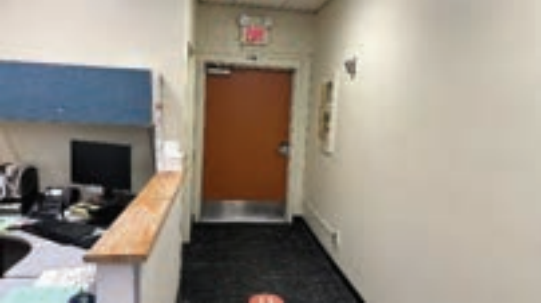
<p>The Administrative Support Center exterior opening is equipped with a lock blok, providing ease of ingress for convenience. The door, however, at the time of assessment was found in an unlocked state requiring a person with a key to exit from the interior to secure the door before reentering potentially placing themselves in danger in a lockdown. Room numbers are stenciled onto the exterior of each door, door numbers should correlate with emergency evacuation and incident response plans for ease of identification. Stenciling font and size is inconsistent across campus.</p>	<p>Create governance that provides direction and clear communication to faculty, staff, and other campus users regarding the operational expectation of openings equipped with lock blocks. Consider replacing the door hardware at this opening with interior locking hardware to eliminate the potential risk of having to secure the door from the public side in the event of a lockdown. Design text and finishes on signs for clarity and ease of reading.</p>	4

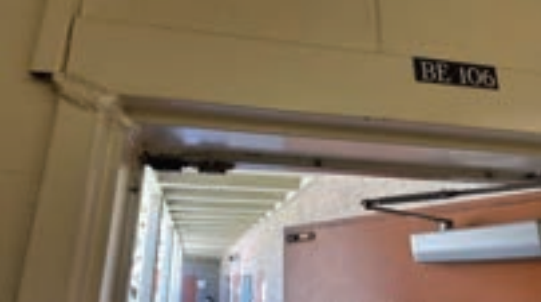
81

<p>Classroom BE106 is equipped with door position monitoring contacts, they are legacy as this building envelope is not monitored on the intrusion detection system. Door hardware at classrooms is traditional classroom function with no ability to lock from the interior. Lock blocks are installed.</p>	<p>It is the assessment teams understanding that this building will be decommissioned. If the building is to continue to be used, recommend that the door hardware be changed to provide interior locking capability.</p>	2

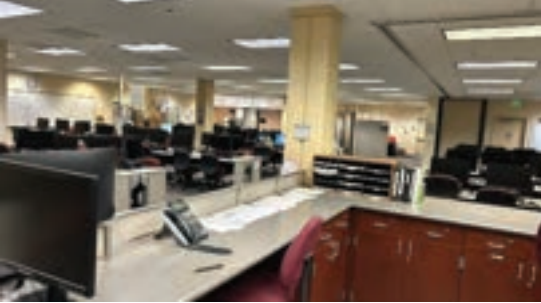
<p>There is no video surveillance monitoring any activity that occurs within this space. Expensive IT equipment is located here. A telephone is available at the main desk, and offices within the space are key accessed and telephones are installed within them.</p>	<p>Consider installation of video surveillance to provide situational awareness visibility and forensic reviewing capability.</p>	2
87

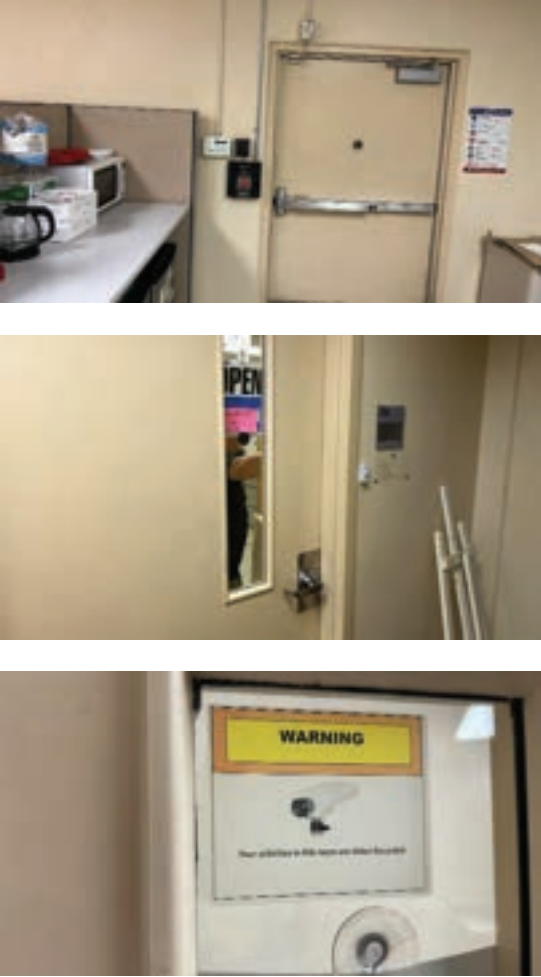
<p>Tech Center Network Rm. 214 is accessible via brass key, this door should be controlled with an access control card reader. There is a separate DMP arming station with card reader that allows security credential or manual code input arming/disarming of the intrusion detection system. Exterior openings are monitored by door position monitoring contacts. Signage indicating that video surveillance is in use is incorrect as the camera located within the space is inoperable. The doorbell is provided to notify occupants that assistance/entry is required/requested.</p>	<p>Develop security standards that apply security electronics to all network and data rooms. Signage should only be installed if in fact it does support the deployment of video surveillance. There is potential liability impact of signage being present without ability to provide video recorded if subpoenaed to do so. Recommend replacing the doorbell with a video intercom that provides ability for occupants on the secure side to communicate with persons requesting entry prior to providing access.</p>	3

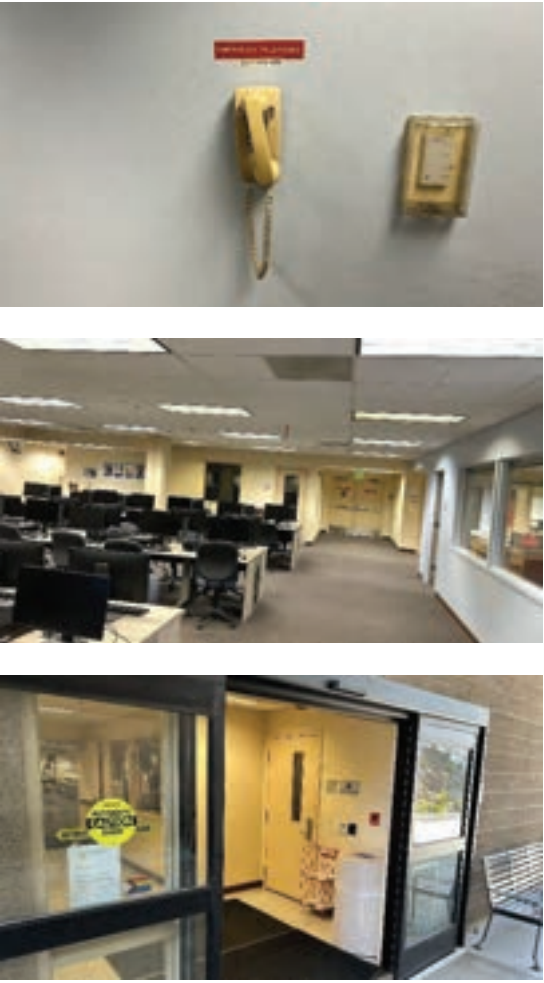
<p>Level one of MLK could be accessed from level two via the elevator only, there are no stairs leading down leading down. The main point of entry into level one is via the sliding doors which provide unrestricted access via the motion sensor positioned on the door header. The intrusion detection system can be armed as on level one with a security credential at the card reader or manual input of a code. There is an emergency phone located on the interior wall, this is not consistent in form factor with other emergency phones observed across campus. There is no operable video surveillance within the building.</p>	<p>Consider applying access control to the level one main entry opening to support ability to lock and unlock on schedule. Perform a maintenance review of all video surveillance cameras across campus to verify if cameras are operational or not.</p>	3

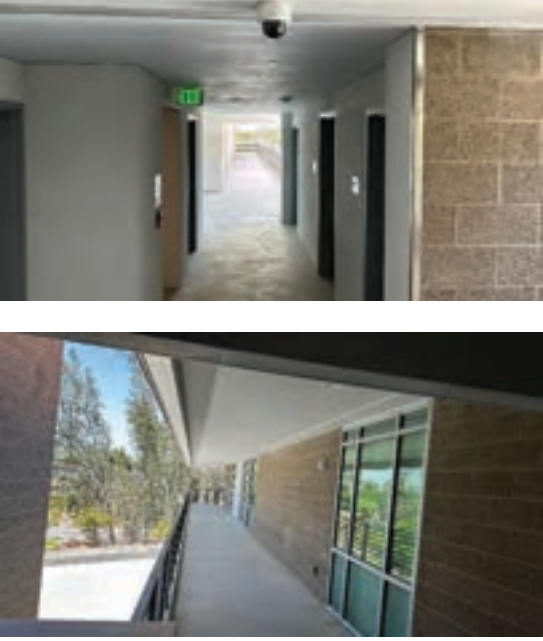
<p>Cameras have been applied to monitor activity at the exterior restroom entry points and exterior walkways. This approach on a new building is excellent but emphasizes a lack of standard application of security technology across campus. Cameras have not been installed in the exterior stairwells. Public address has not been installed into the refurbished space.</p>	<p>Develop security standards to provide minimum baseline expectations of application of security electronics to all buildings. The deployment at this building appears to have been given thought regarding the application of video surveillance to monitor access points and areas of pedestrian activity. There are still gaps in the deployment in the video surveillance that should be corrected i.e., stairwell coverage.</p>	3

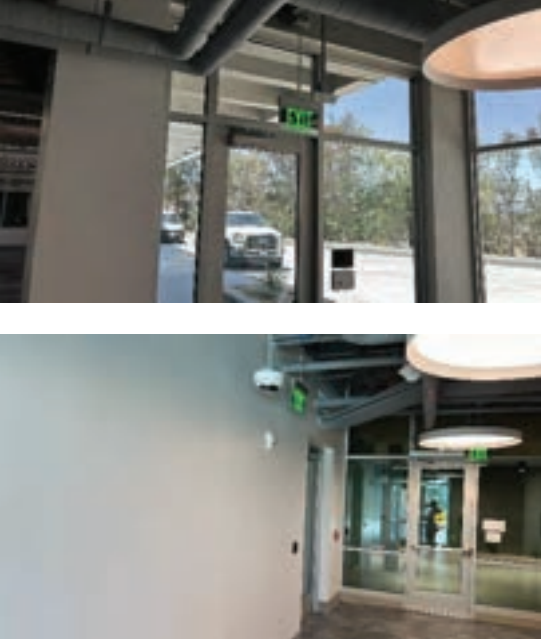
ID#	PHOTO	OBSERVATION	RECOMMENDATION	RISK
96

<p>The request to exit motion detector (REX) is mounted on a pole from the ceiling, the REX can be avoided by walking directly adjacent to the wall behind it to exit the building. Bypassing the REX will cause nuisance door forced alarms on the access control system. The Tyco multisensor video surveillance camera is pole mounted approximately 8' above finished ground and is easily within reach to be damaged/tampered with.</p>	<p>The deployment of the new security equipment has some challenges from an operational state. Consider adjustment of the REX sensor to the door frame header ensuring that all persons exiting will trigger a door contact shunt within the access control system to eliminate false alarm events. Minimum camera installation heights should be 10' AFF. Development of security standards would help provide direction and minimum installation expectation for future systems upgrade and roll out. Final systems testing reports should identify if the REX sensor has been bypassed on exit and door forced alarm events received.</p>	2

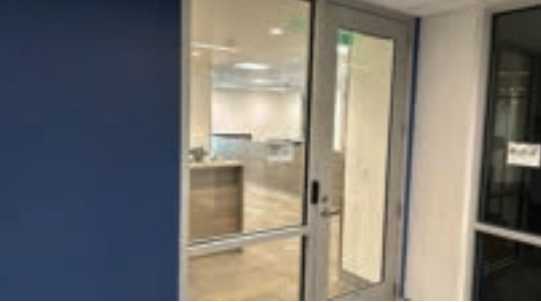
<p>The Deans Suite will operate in an unlocked state during typical business hours. There is no panic button located at the suite main reception desk and it is assumed that there is one within the Dean's Office. There is no ability on the interior of the suite to monitor general area activity using video surveillance, this is a high-profile occupancy space.</p>	<p>Install a panic button at the main reception desk to provide potential early notification of request for assistance. Recommend that a video monitor be installed at the reception desk to provide visibility of activity in the immediate area of approach to the suite. Although the intent is for the suite to be accessible to all during normal hours of operation, consider installation of a video surveillance intercom with remote release unlocking of the door to provide ability to screen persons prior to gaining entry.</p>	4

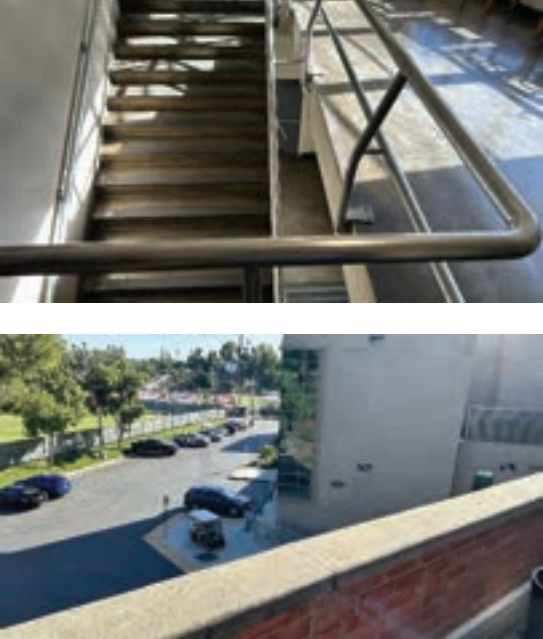
<p>Entry into the Gymnasium (WG) can be achieved at several points of entry. There are access control measures applied with electrified hardware. There is no pattern of video surveillance being installed at access-controlled entries to monitor ingress/egress activity. Some controlled entry points are unlocked/locked on schedule for convenience of staff, faculty, and student access. The building has an intrusion detection system that can be armed/disarmed using a security credential or manual code input. A video surveillance camera was observed within the learning center space, this is an anomaly across campus where interior cameras are typically not monitoring internal working/learning space.</p>	<p>The security electronics in use at the gymnasium are excellent, recommend that integration of video surveillance with the access control and intrusion systems occurs. Future security standards should provide direction regarding application of video surveillance to monitor controlled entry points providing camera call up ability.</p>	2

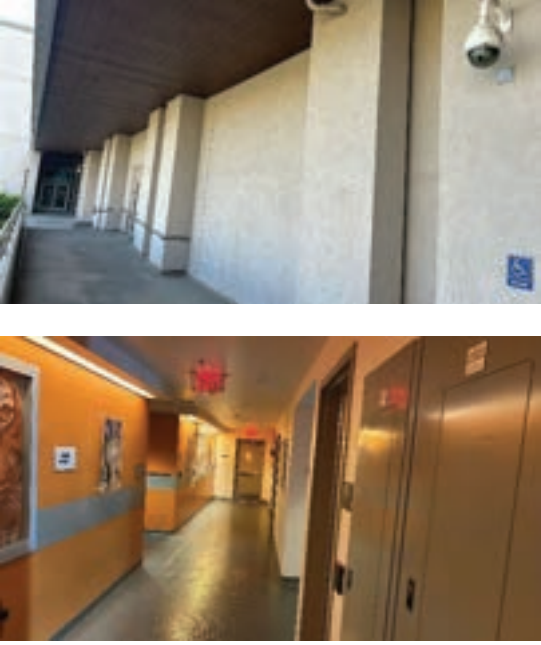
113

<p>Wall mounted PTZ cameras are located adjacent to each controlled entry point on the north side of the building, overlooking the parking area. It is not possible to determine if the cameras are in a "home" position or if the field of view is being controlled remotely. Access control is applied to openings within the space, with access to the teaching area and gymnasium is typically unlocked on schedule.</p>	<p>Develop security standards that provide direction and guidance on how PTZ cameras should operate. Recommend where PTZ cameras are installed that supplementary fixed field of view cameras also be installed monitoring-controlled entry points.</p>	3
114

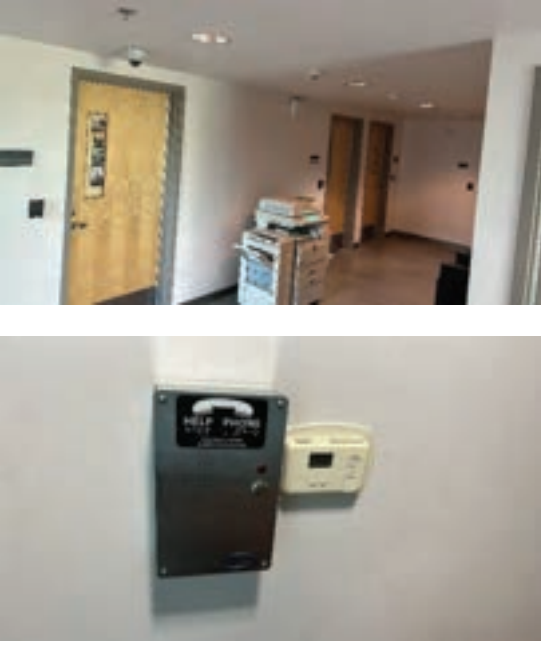
<p>The gymnasium level two elevator landing adjacent to offices which are all equipped with access control card readers is monitored by a video surveillance camera. A "Help Phone" installed on the wall does not provide any identification or instruction relating to who will respond to the call when activated. Camera call-up with the video surveillance camera is not available.</p>	<p>Apply signage above the help phone that provides information on where calls will be answered when placed. Consider future systems integration allowing camera call-up capability when door forced, or door held alarm events are received within the access control and intrusion detection systems.</p>	2

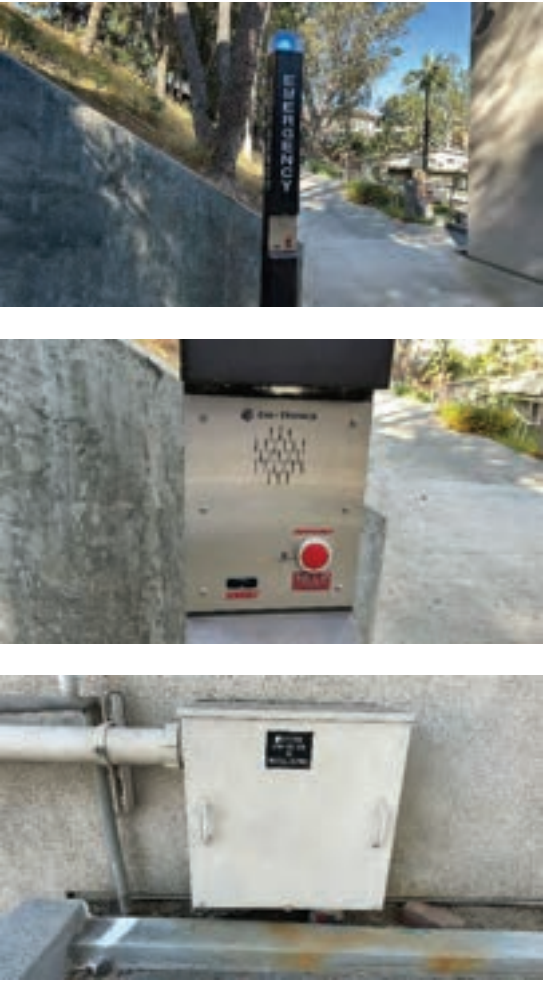
<p>Emergency phone call tower located at the rear of the gymnasium is another example of inconsistent tower coloring, inconsistency in manufacturer unit being used, and the blue strobe is illuminated. The data access enclosure is not secured with a padlock and easily accessible for tampering with cable.</p>	<p>Reference previous recommendations provided regarding standardization of emergency phone towers. Apply a padlock to the cable access enclosure.</p>	4

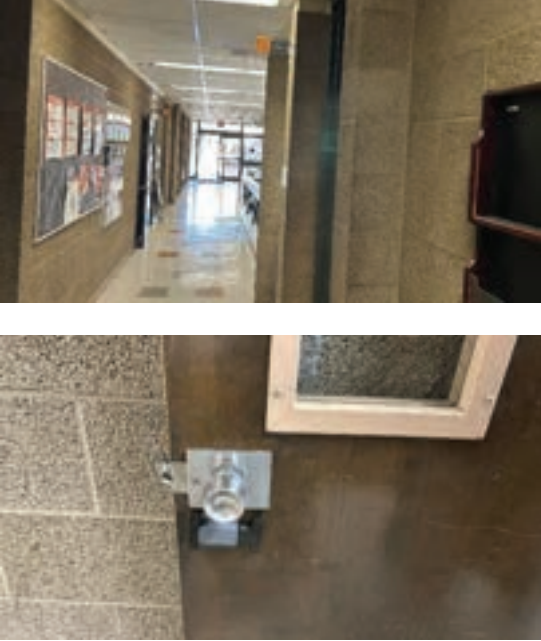
<p>The Student Center Building is unlocked/locked on schedule manually by brass key by the campus police department. Interior offices are key controlled with lock blocks installed, there is no ability to lock the doors from the interior of each office space. This building has no access control, intrusion detection, or video surveillance applied to it. Unrestricted ingress is available from the moment that the exterior doors are unlocked.</p>	<p>Consider application of access control to support remote unlocking/locking on schedule. Install intrusion detection to monitor the building outside of normal hours of operation. Install video surveillance integrated with access control and intrusion detection systems for real-time situational awareness and forensic viewing capability. Upgrade existing door hardware to provide interior locking capability at offices and learning spaces.</p>	4

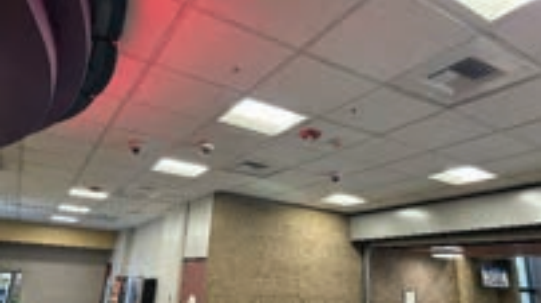
119

<p>Video surveillance cameras within the Cafeteria terminate within the office of the Food Services Director. This is a standalone system not accessible by campus safety or campus police. Network cables are clearly labeled terminating into the patch panel in the wall mounted data rack that was</p>	<p>Incorporate the video surveillance cameras into a campus wide and district video surveillance system.</p>	3

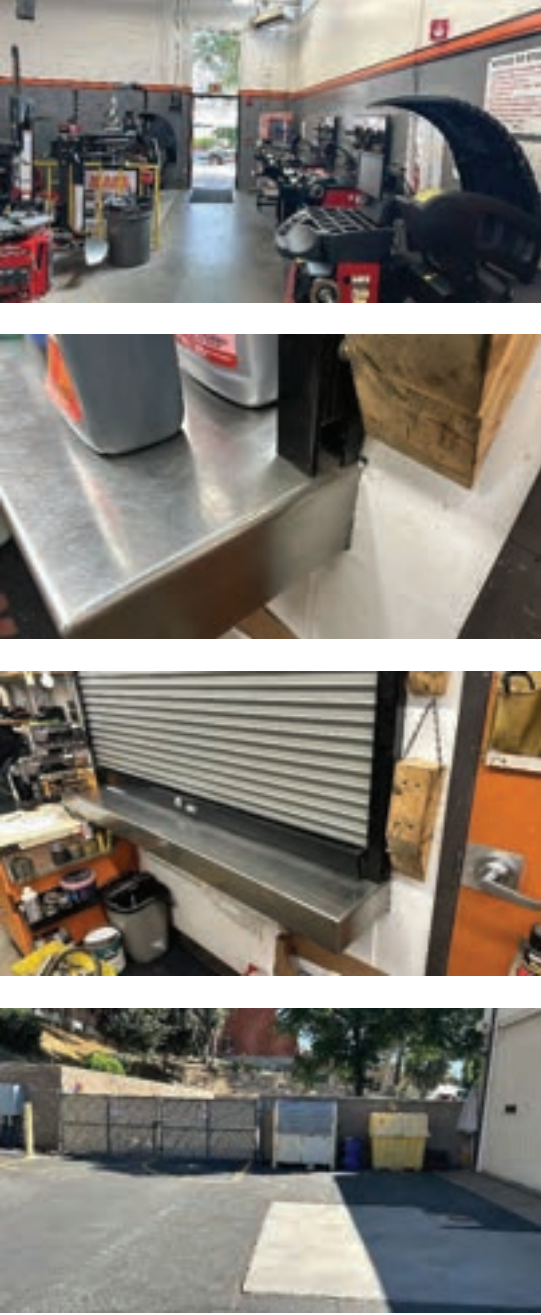
<p>NEC private branch exchange (PBX) will soon become obsolete; and telephone lines are also being discontinued by AT&T as they go out of service. A portable generator is located outside of the building to provide power in the event of a power outage.</p>		
122	 	<p>The Automotive Technology Building (AT) houses some of the most valuable equipment on campus. The space is completely open to public access during the hours of operation and there is no access control, video surveillance, or intrusion detection systems installed. Access into the yard can easily be achieved from above, and the</p>	<p>Consider installation of all security electronics systems to provide controlled access into the space after normal hours of business, unlock/lock of the space on schedule, and provide video surveillance monitoring of activity. Minimum 8' high fencing and gates should be installed around the entire perimeter of the AT building.</p>	3

<p>perimeter wall can simply be scaled as it is no higher than 7'. Gates are closed and locked with a padlock; however, they are chain-link and could easily be driven through from the exterior or interior sides using a vehicle. There have been documented thefts of equipment from the space over the years; AT spaces typically would be monitored for unauthorized activity.</p>		
123

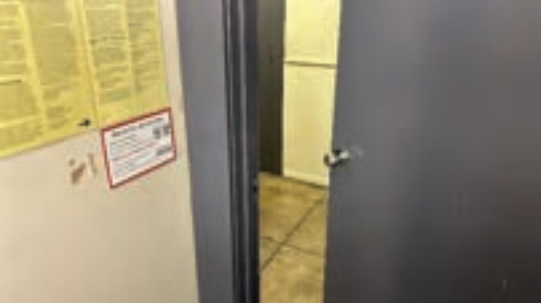
<p>Lock bloks are deployed at Technology A (TECH A) classrooms however, some classrooms have recently had doors repainted and the lock bloks need to be reapplied. There is high value equipment within this building, including welding and HVAC and it is recommended that security technology be applied, at</p>	<p>Reapply the lock bloks and install an intrusion detection system with the roller doors monitored with surface mount door monitoring contacts.</p>	4

<p>minimum an intrusion detection system. Roller doors leading directly to the exterior are not monitored and provide ease of access to remove equipment if breached.</p>		
124

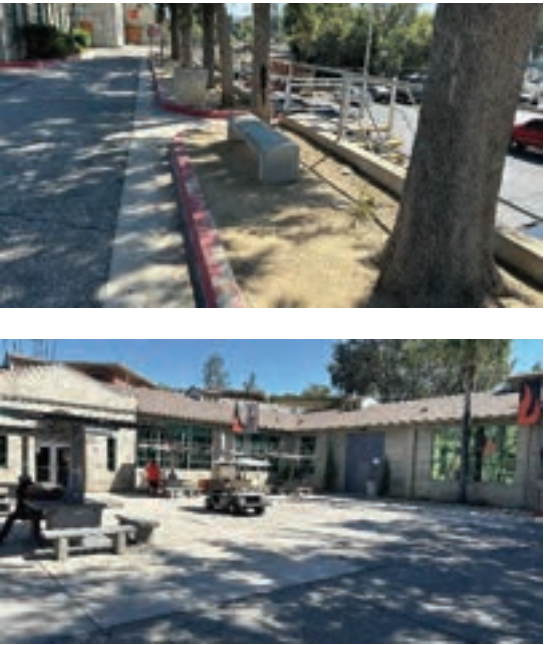
<p>Benches and seating areas provide areas of excellent natural surveillance and eyes on activity. Power is provided at the covered workstations supporting use of the tables for students to use. The seating area is elevated providing excellent visibility of the parking lot on the lower campus. The pole mounted emergency phone does not have any signage clearly indicating that the emergency phone is located here, and the blue strobe is not illuminated. The call station is manufactured by Trigon and is no longer available.</p>	<p>Perform a review of all emergency phone towers and call stations. Standardize on one product manufacturer and replace end of life and non-operational emergency phones with new. Install signage that clearly indicates the location of the emergency phone tower.</p>	4

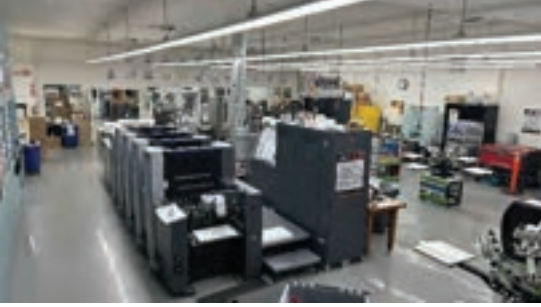
125	 	<p>As with Tech A, the Tech B building has zero security electronics installed and monitoring or notification of activity cannot be monitored in real-time or forensically. There is a vantage point that provides oversight of activity of the yard below. Chain-link fencing surrounds the yard area and is secured in the evening. Scaling of the fence and gates can easily be achieved as height is approx. 6'.</p>	<p>Consider installation of all security electronics systems to provide controlled access into the space after normal hours of business, unlock/lock of the space on schedule, and provide video surveillance monitoring of activity. Recommend fence line height be a minimum 8' in height.</p>	3
126	 	<p>The district printing and graphics area located within Tech B houses expensive equipment. At a minimum intrusion detection should be applied to this space, and the space designated as a single zone. Access into this space is via brass key only issued to restricted authorized personnel.</p>	<p>Install both intrusion detection and access control systems to this space. Ability to be alerted and notified if unauthorized entry is achieved should be available. Video surveillance should monitor activity on the exterior of the space.</p>	3

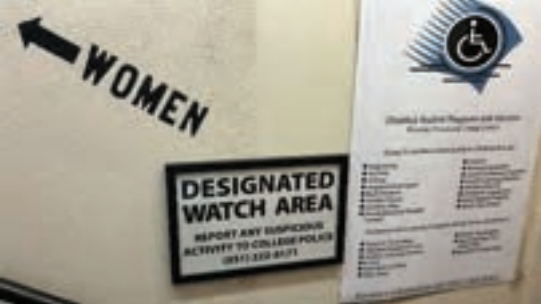
127

<p>A sign indicating that the space within Tech B is a designated watch area is an anomaly across campus. This sign was not observed in any other location.</p>	<p>General observation.</p>	0
128

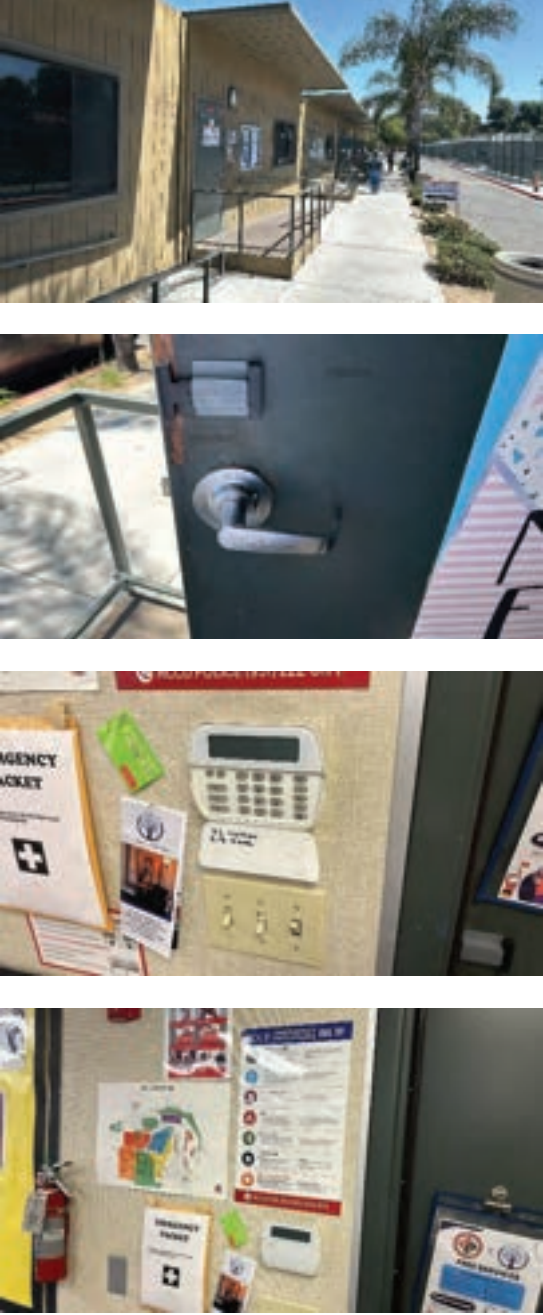
<p>The Gateway School utilizes the portable classrooms L4 through L9 with a combination of offices and classrooms. Classroom doors cannot be secured from the interior side however, they are equipped with lock blocks, offices do not have lock blocks. The school staff are part of the RAVE mass notification application opt-in program. There is a legacy DSC intrusion arming system installed however, this is non-operational, and the portables are not monitored on the district intrusion system. There are no access control and video surveillance measures in place.</p>	<p>General observation. The Gateway School determine their own operational policy and protocol.</p>	0
130

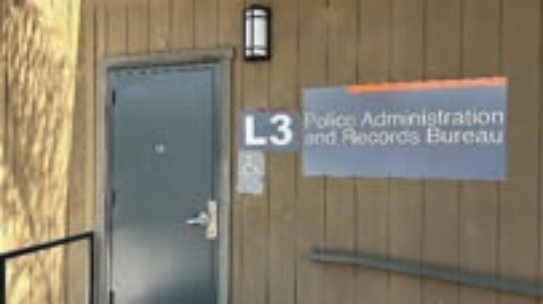
<p>Campus Police occupy the portable spaces L1, L2 and L3. They operate with their own independent keyway with limited district access. No access control, intrusion detection, or video surveillance is applied to these portables. Doors are equipped with latch guards that prevent potential forced entry by tampering with the latch. The</p>	<p>Recommend that the campus police offices be accessible by access control, and intrusion detection be installed with exterior video surveillance. Campus police should be provided access to monitor all security electronic systems.</p>	0

ID#	PHOTO	OBSERVATION	RECOMMENDATION	RISK
		<p>campus police are not on campus 24/7 so times of inoccupation of the space is frequent. Direction to the Campus Police Offices is not provided throughout the campus, minimal wayfinding signs and maps make it difficult to know where to locate campus police. The portables windows are hardened with metal grates placed over them, visibility in is not possible from the public side.</p>		
131	 	<p>Restrooms adjacent to portables L12, L13, and L14 are unlocked by campus police daily and remain unlocked throughout the day. The restrooms are freely available to campus users and the public. There is no video surveillance deployed in the vicinity that provides both situational awareness and forensic viewing capability. An emergency telephone is located on the edge of portable L14 however this is not visible from any other area along the adjacent road and is the only emergency phone located in the immediate vicinity of the portables and tennis courts. Signage does not provide any direction to the emergency phone location.</p>	<p>Install video surveillance to provide monitoring of activity on the exterior of the restrooms. Consider relocating the emergency phone into a more prominent position that better serves the area adjacent to all of the portables. Provide signage that clearly indicates the location of the emergency phone.</p>	2

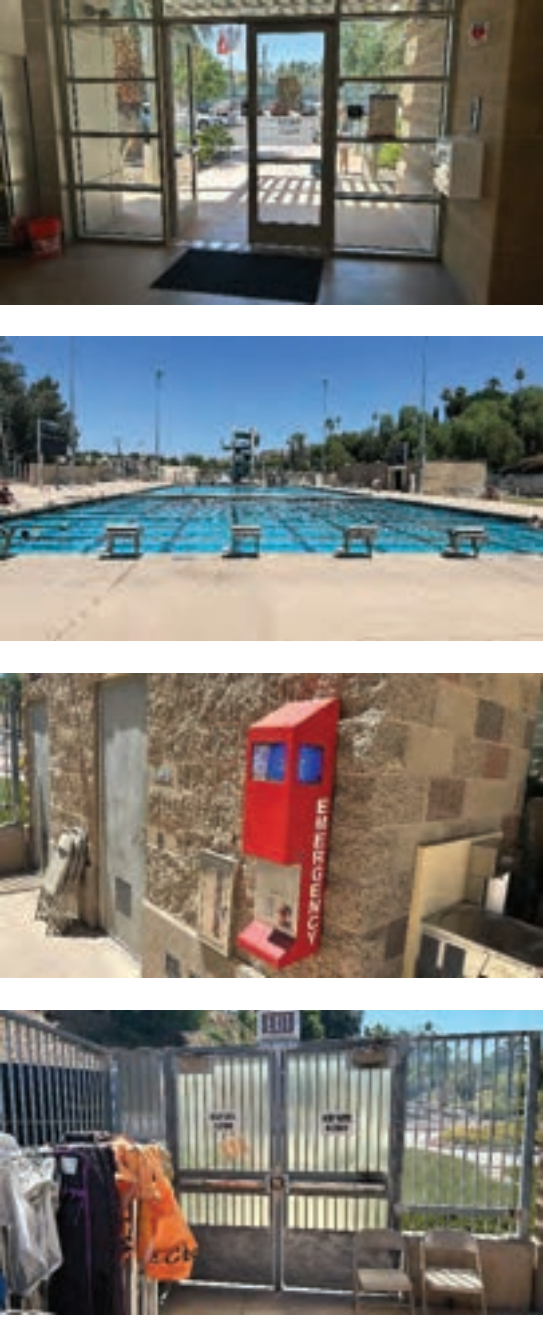
132	 	<p>The Riverside Aquatics Complex (RAC) has no security technology applied to it. Swimming pools are typically high liability impact areas that education institutions seek to have visibility of activity and restrict unauthorized access into. There is a known incident of an unauthorized user using the facility and causing themselves harm. The perimeter fencing is decorative and has a flat top rail that supports easy scaling, the exterior gates can also be easily scaled. Emergency phones appear to protrude more than 8"</p>	<p>Install security electronics to the RAC, consider replacement of the existing fence line with new increasing the height and reducing the ease of current scaling. If needed engage with the City to ensure that there is full agreement on application of security measures. As stated, this area present significant liability to the district and should be addressed. Video surveillance should be installed on both the exterior of the RAC and within the pool deck.</p>	4

<p>from the wall and may require review against ADA "cane wall" mounting code. Visitor parking spaces are identified across campus by the white bays and yellow bays for faculty/staff, this system was observed at the RAC. The RAC is a shared use facility with the City of Riverside, it does upon discussion with faculty/staff appear that the City take on a rental approach with the district rather than ownership. This perspective may be damaging if an incident occurs that results in the City pushing liability onto the district.</p>		
133
